**Stone deterioration and replacement of natural building stones  
at the Cologne cathedral  
A contribution to the preservation of cultural heritage**

Dissertation  
zur Erlangung des mathematisch-naturwissenschaftlichen Doktorgrades  
„Doctor rerum naturalium“  
der Georg-August-Universität Göttingen

Göttingen, 2013

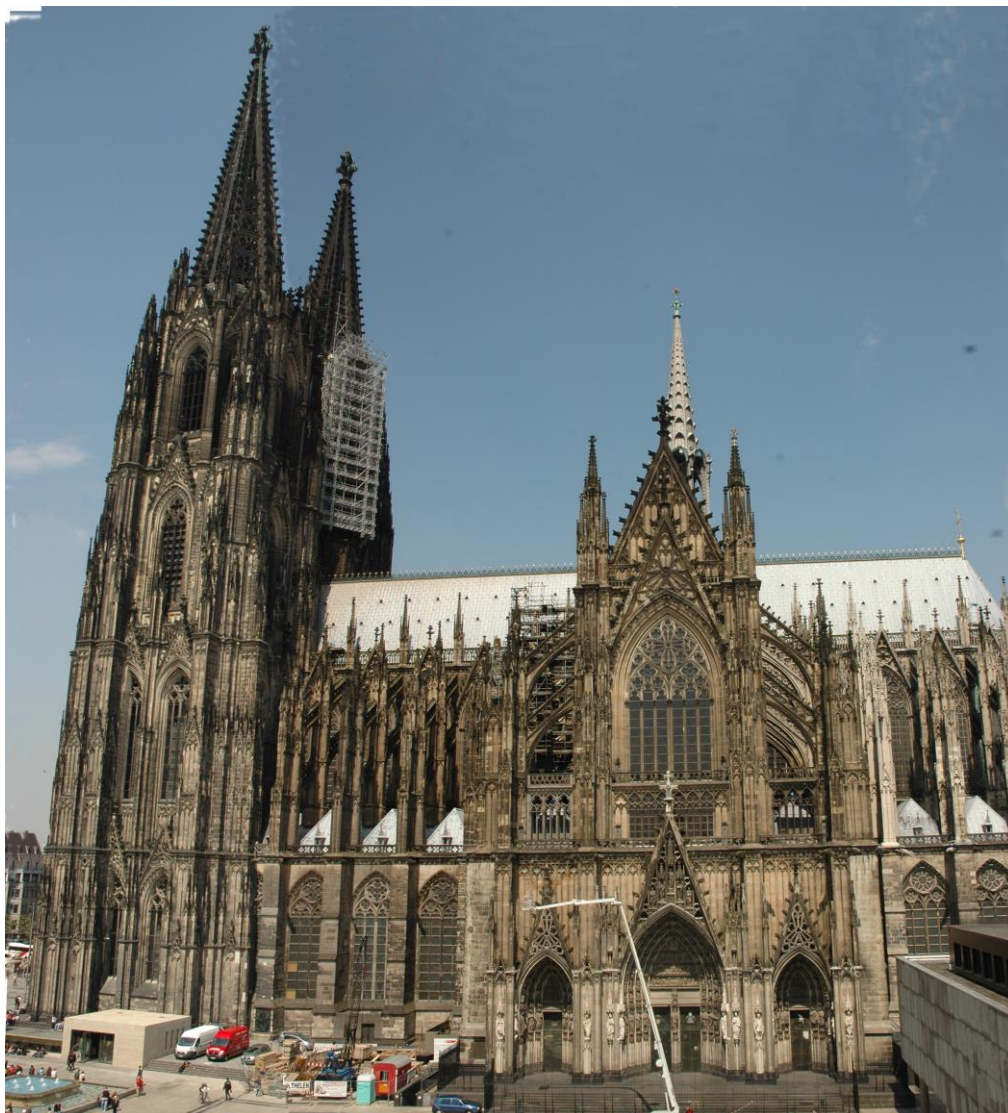
**Figure 2.1** South elevation of the Cologne cathedral

Cologne cathedral (Fig. 2.1) represents the archdiocese of Cologne. Its present day form stems from 1248 following the demolition and burning of parts of the original cathedral.

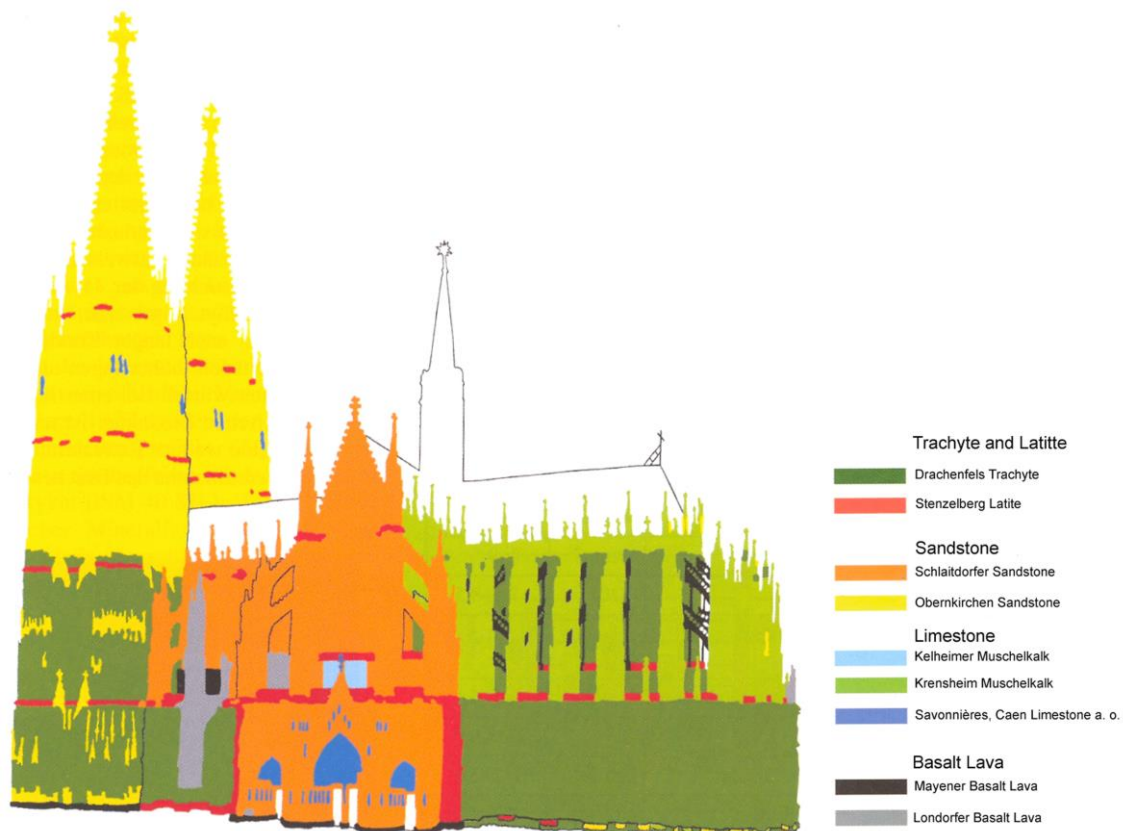
**Figure 2.4** Lithological map of the south elevation of the Cologne cathedral (Windscheid (2004) after Wolff and Luckat 1973)

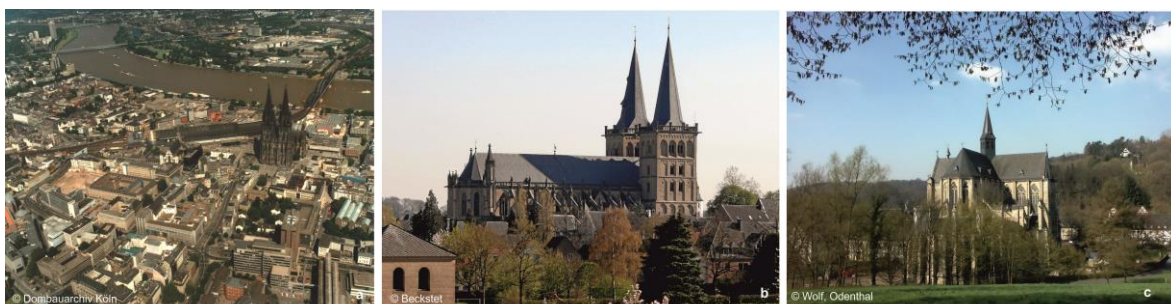
The three buildings are located in very different environmental settings (Fig. 3.1). Cologne cathedral (53 m above *NN*) is located in a metropolitan center with one million inhabitants next to the river Rhine. Xanten cathedral (22 m above *NN*) is the Catholic church of a small city on the Lower Rhine with 18,000 inhabitants and with smaller industrial effects (Arnhem, NL), while Altenberg cathedral (149 m above *NN*) is situated in a greenfield setting surrounded by forested mountains in the “Bergisches Land”.

**Figure 3.1** The cathedrals and their environmental settings: a. Cologne, b. Xanten, c. Altenberg.

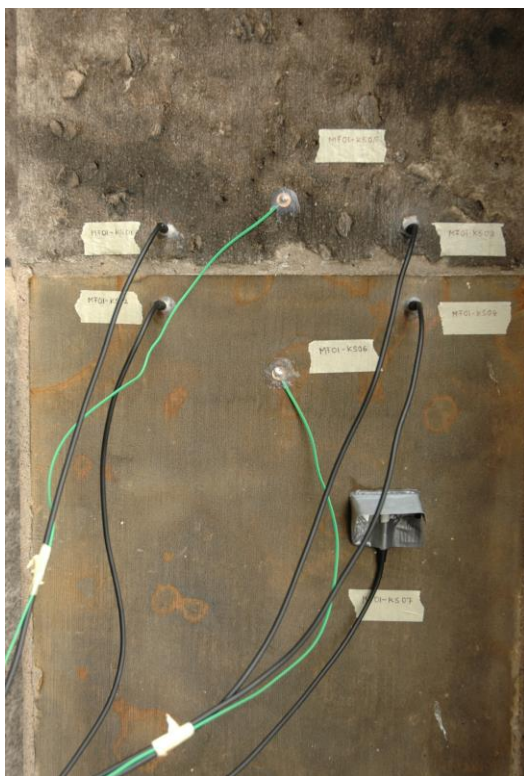
**Figure 3.4** Installation of the sensors in MF01 in Drachenfels trachyte and Obernkirchen sandstone

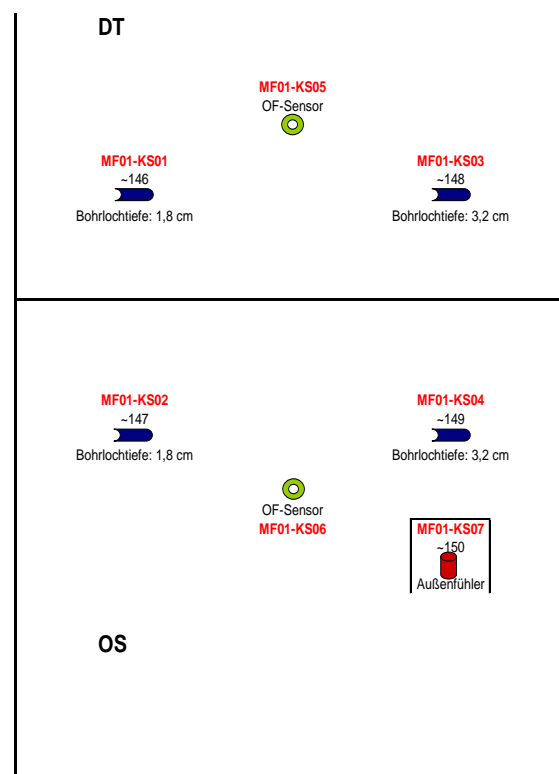
**Figure 3.5** Scheme of the installation of the sensors (KS) in MF01 in Drachenfels trachyte (DT) and Obernkirchen sandstone (OS)

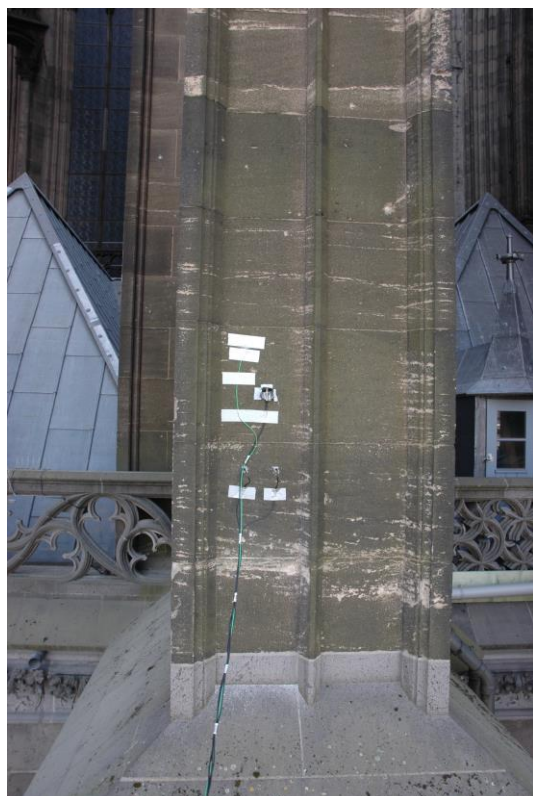
**Figure 3.6** Installation of the sensors in MF02x in Drachenfels trachyte and Schlaitdorf sandstone

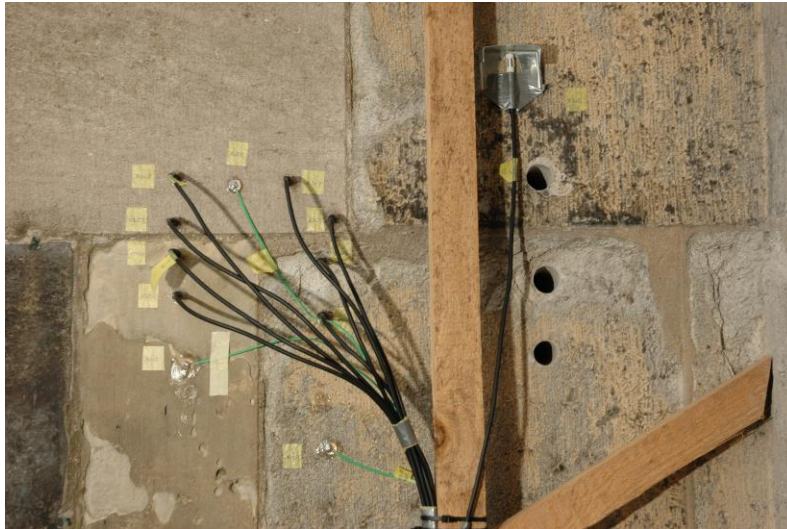
**Figure 3.8** Installation of the sensors in MF04 in Drachenfels trachyte, Obernkirchen sandstone and Krensheim Muschelkalk

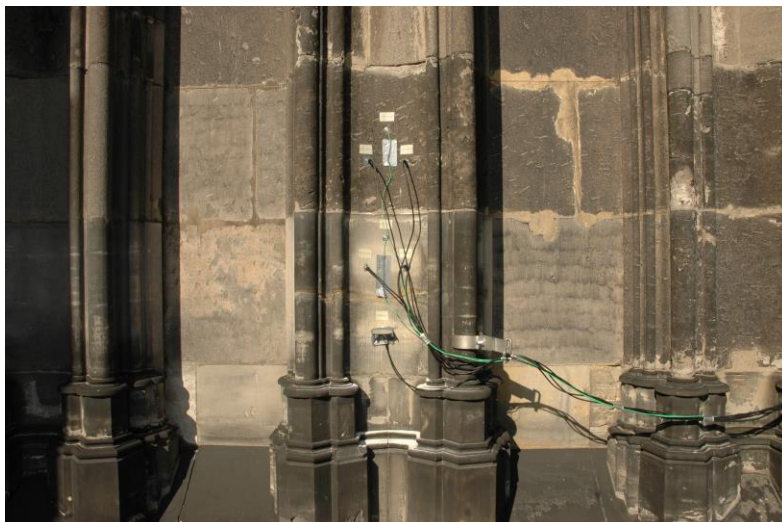
**Figure 3.10** Installation of the sensors in MF07 in Drachenfels trachyte and Obernkirchen sandstone

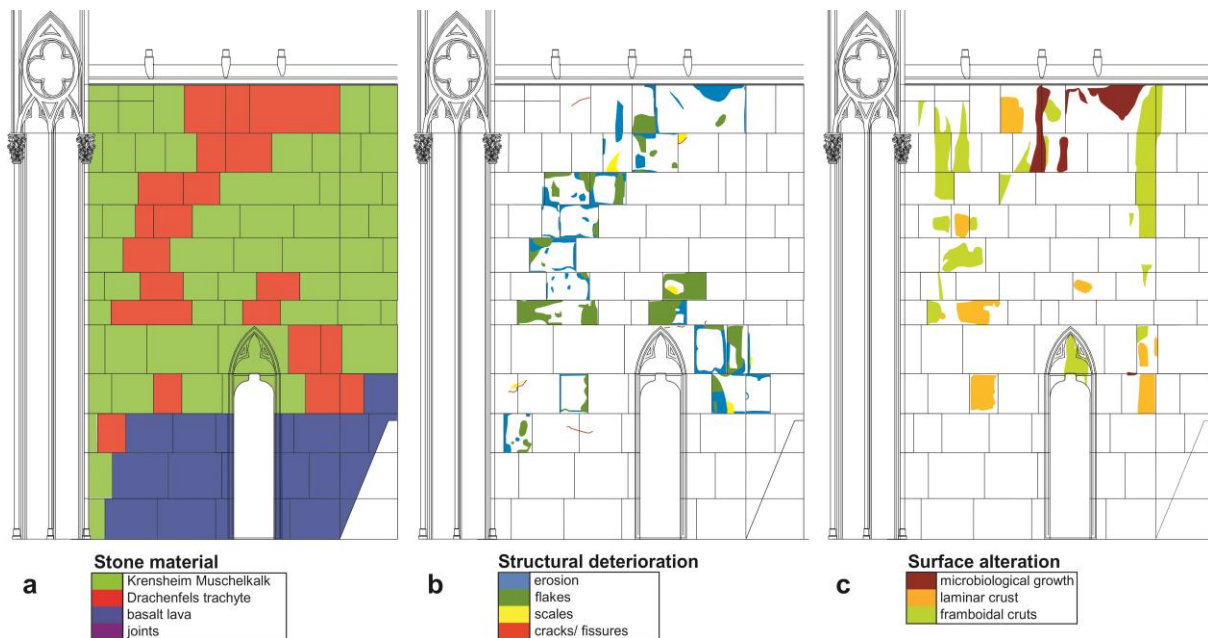
**Figure 4.2** Mapping of a flying buttress of the choir at Cologne cathedral: **a.** lithology: Drachenfels trachyte (red), Krenshelm Muschelkalk (green), basalt lava (blue), joints (purple); **b.** structural deterioration: erosion (light blue), flaking (green), scaling (yellow), cracks (red); **c.** surface alteration: microbiological infestation (dark red), laminar crusts (orange), framboidal crusts (light green).

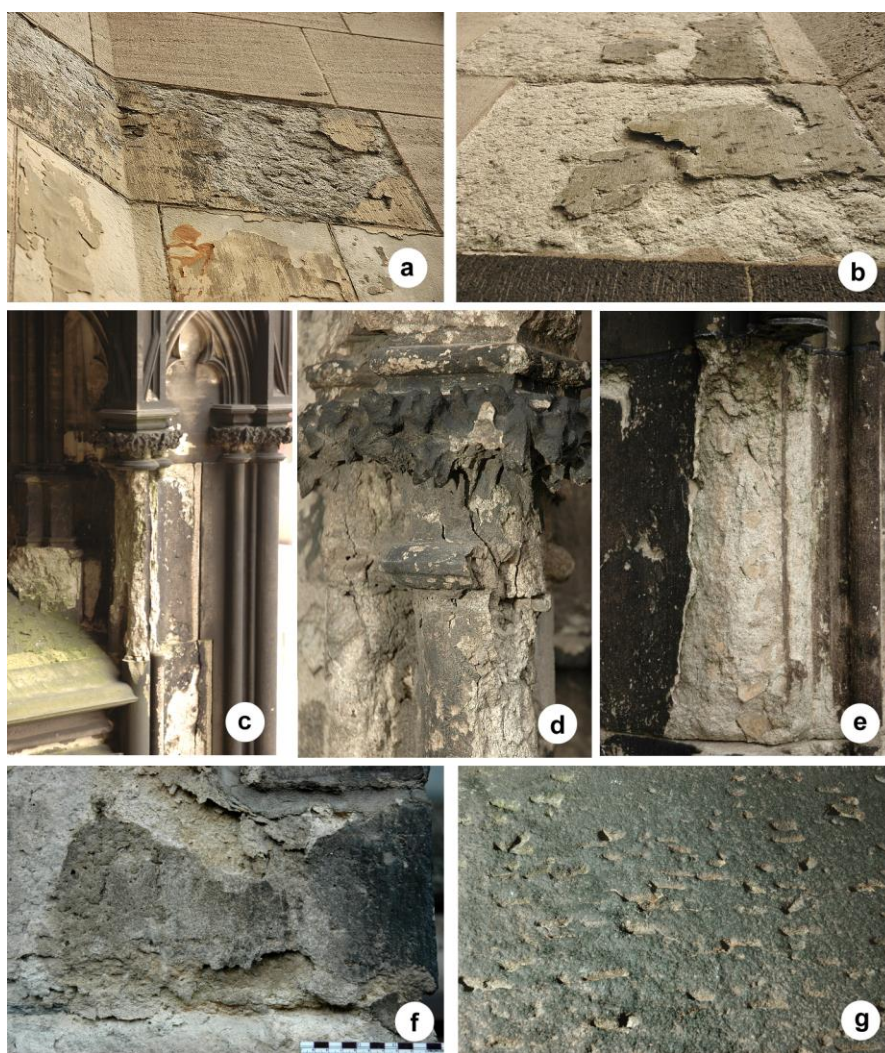
**Figure 4.3** Deterioration phenomena: **(a)** overview: scaling and flaking of Drachenfels trachyte (center); scaling of Obernkirchen sandstone due to surface treatment (lower part); and Krenshelm Muschelkalk (upper part); **(b)** Drachenfels trachyte: scaling; **(c)** Drachenfels trachyte: surface recession and structural disintegration (deteriorated pilaster strip); **(d)** Drachenfels trachyte: pronounced decay in form of microcracks, crumbling to total collapse; **(e)** Drachenfels trachyte: pronounced erosion due to the placement direction with surface planar sanidines; **(f)** Drachenfels trachyte: flaking; **(g)** Drachenfels trachyte: weathering out of sanidines

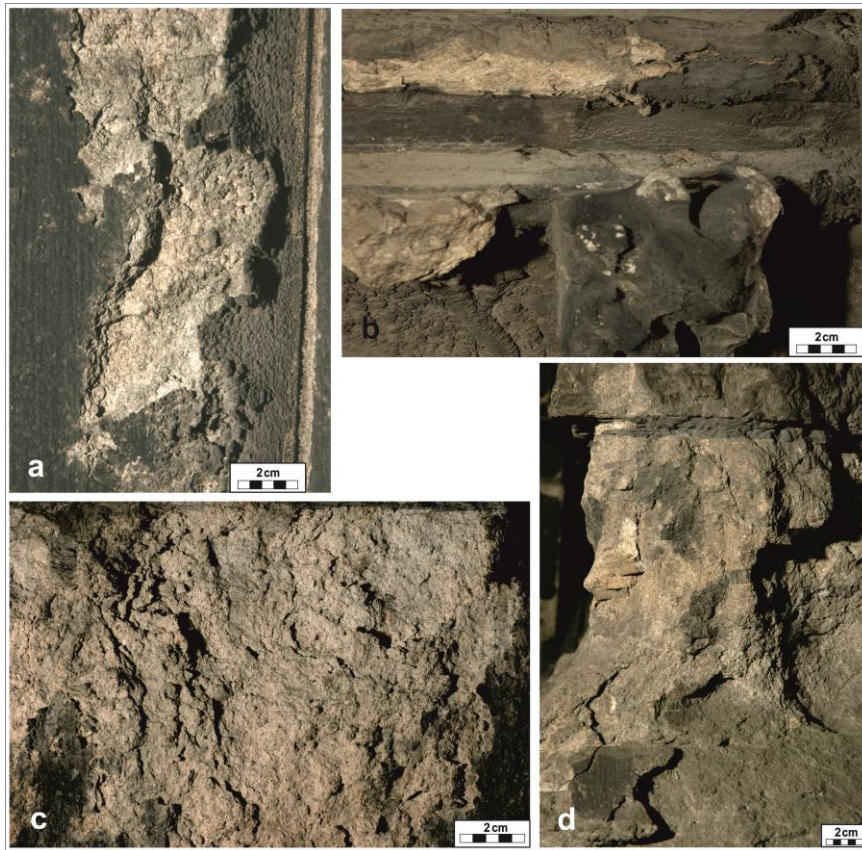
**Figure 4.4** Weathering forms of Drachenfels trachyte. **(a)** framboidal weathering crust, showing bulging and flaking of the rock underneath; **(b)** weathering crust, bulging and flaking in decorated part; **(c)** erosion and flaking; **(d)** structural disintegration and crumbling to total fabric collapse.

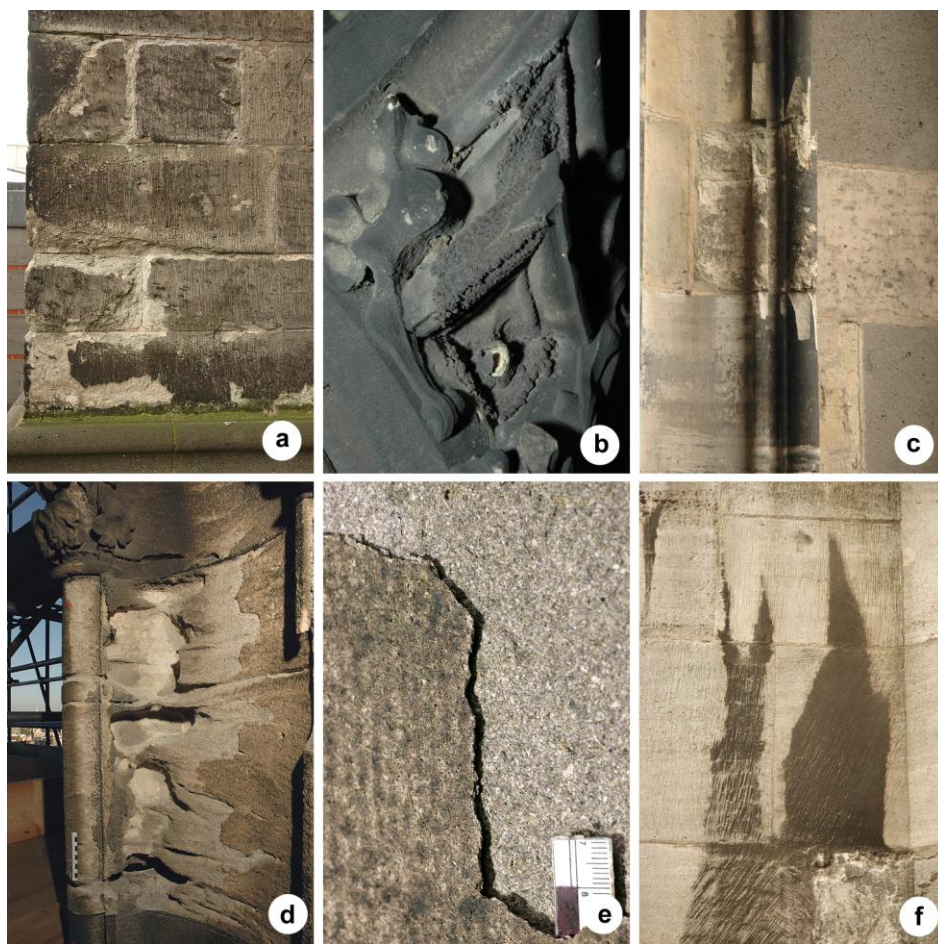
**Figure 4.5** Deterioration phenomena: **(a)** Drachenfels trachyte: deterioration starting from the joint; **(b)** Obernkirchen sandstone: black dirt and gypsum crusts; **(c)** Obernkirchen sandstone: break-outs due to spalling along joints; **(d)** Schlaitdorf sandstone: scaling, granular disintegration to sand and relief due to rounding and notching; **(e)** Stenzelberg latite: scaling; **(f)** Krensheim Muschelkalk: black gypsum crusts

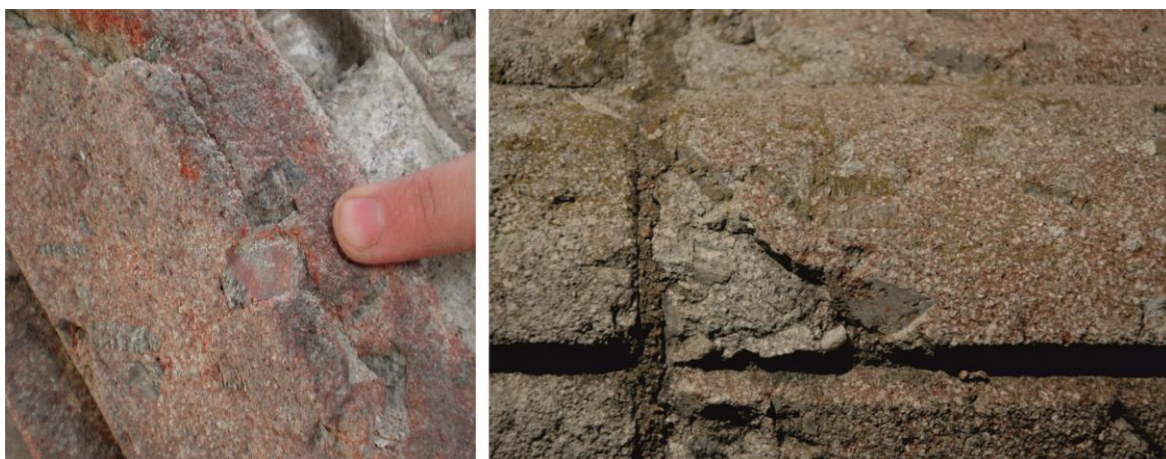
**Figure 4.6** (a) Orange-red discoloration underneath a removed black weathering crust with intensive discoloration on the sanidine (Dombauhütte Köln 2006); (b) brownish-orange discoloration on the surface of the Drachenfels trachyte

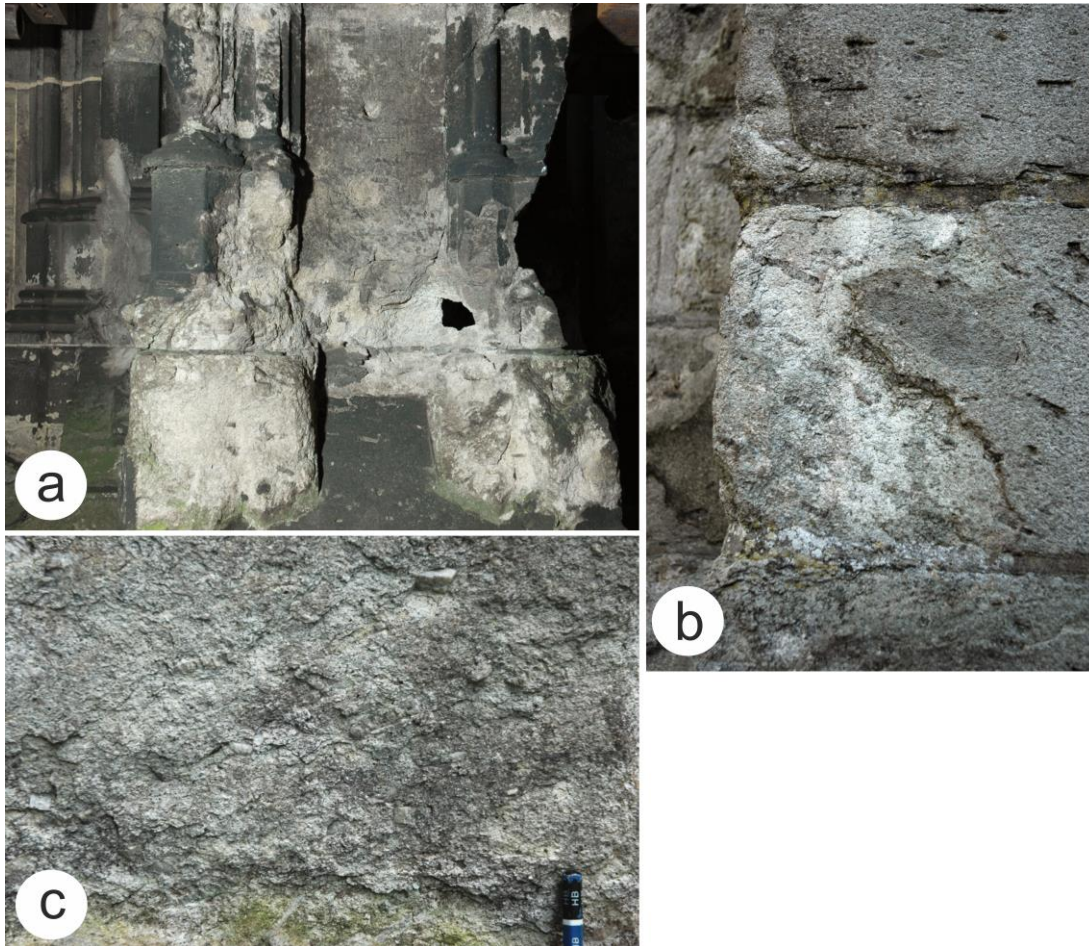
**Figure 4.7** (a) Crumbling and total fabric collapse observed at Cologne cathedral; (b) scaling at Xanten cathedral; (c) flaking at Altenberg cathedral

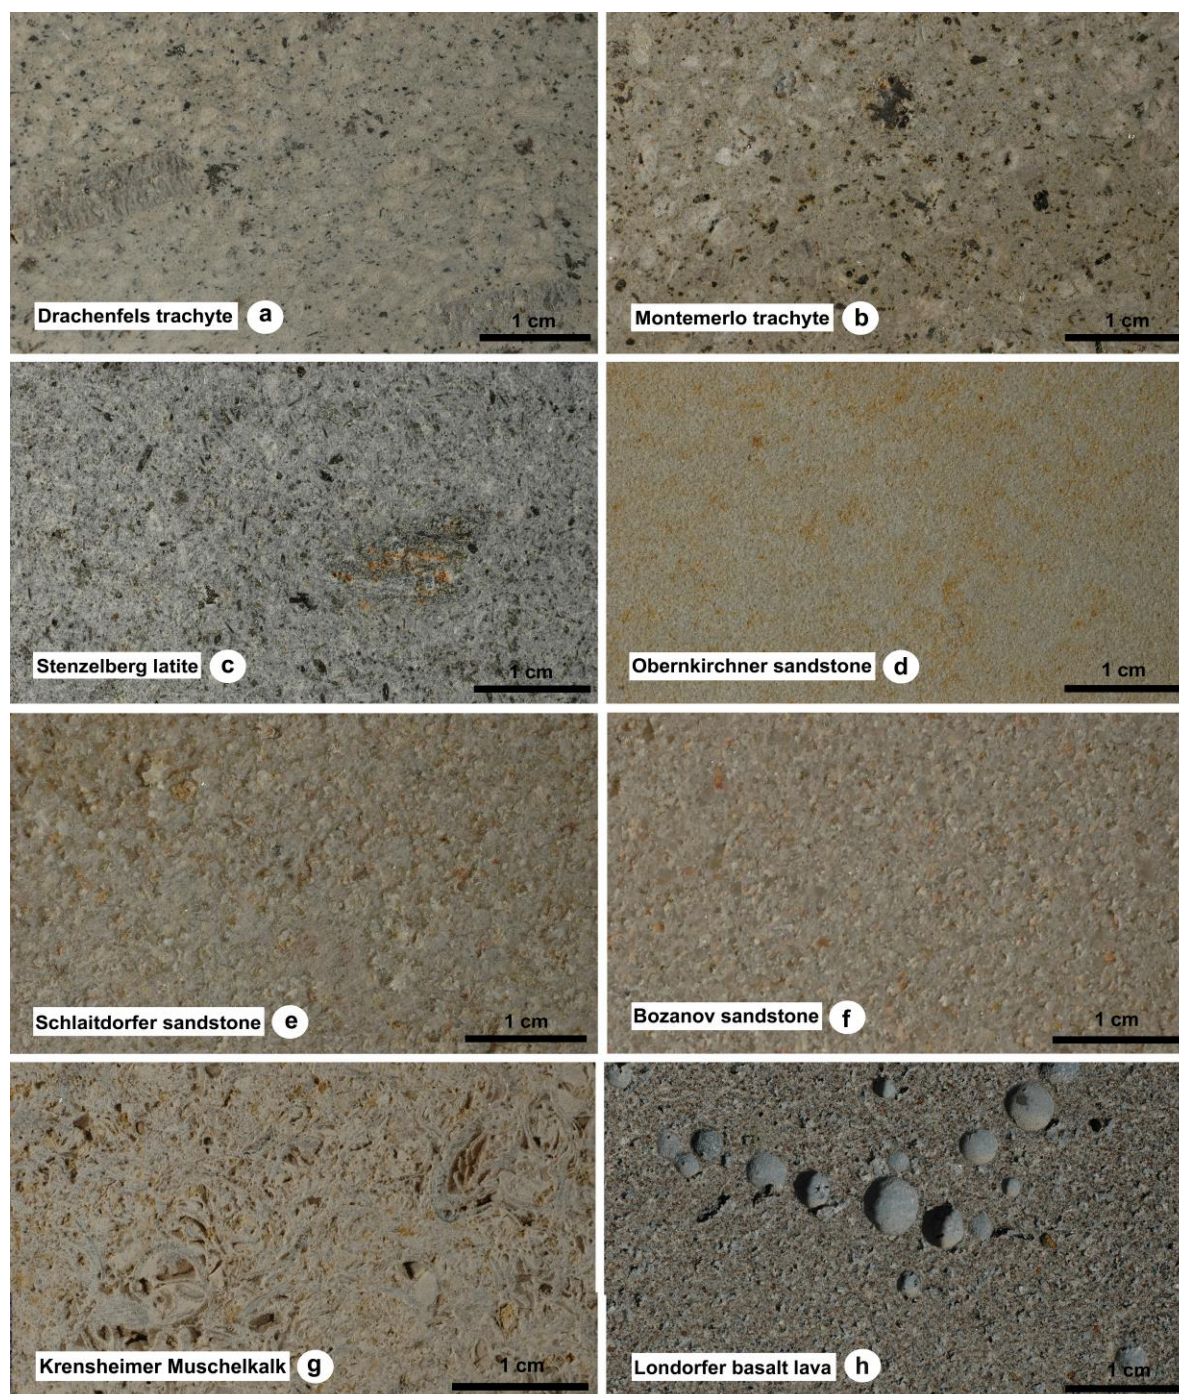
**Figure 5.1** Cut sections of the investigated stones from Cologne cathedral (a) Drachenfels trachyte, (b) Montemerlo trachyte, (c) Stenzelberg latite, (d) Obernkirchen sandstone, (e) Schlaitdorf sandstone, (f) Bozanov sandstone, (g) Krensheim Muschelkalk and (h) Londorf basalt lava

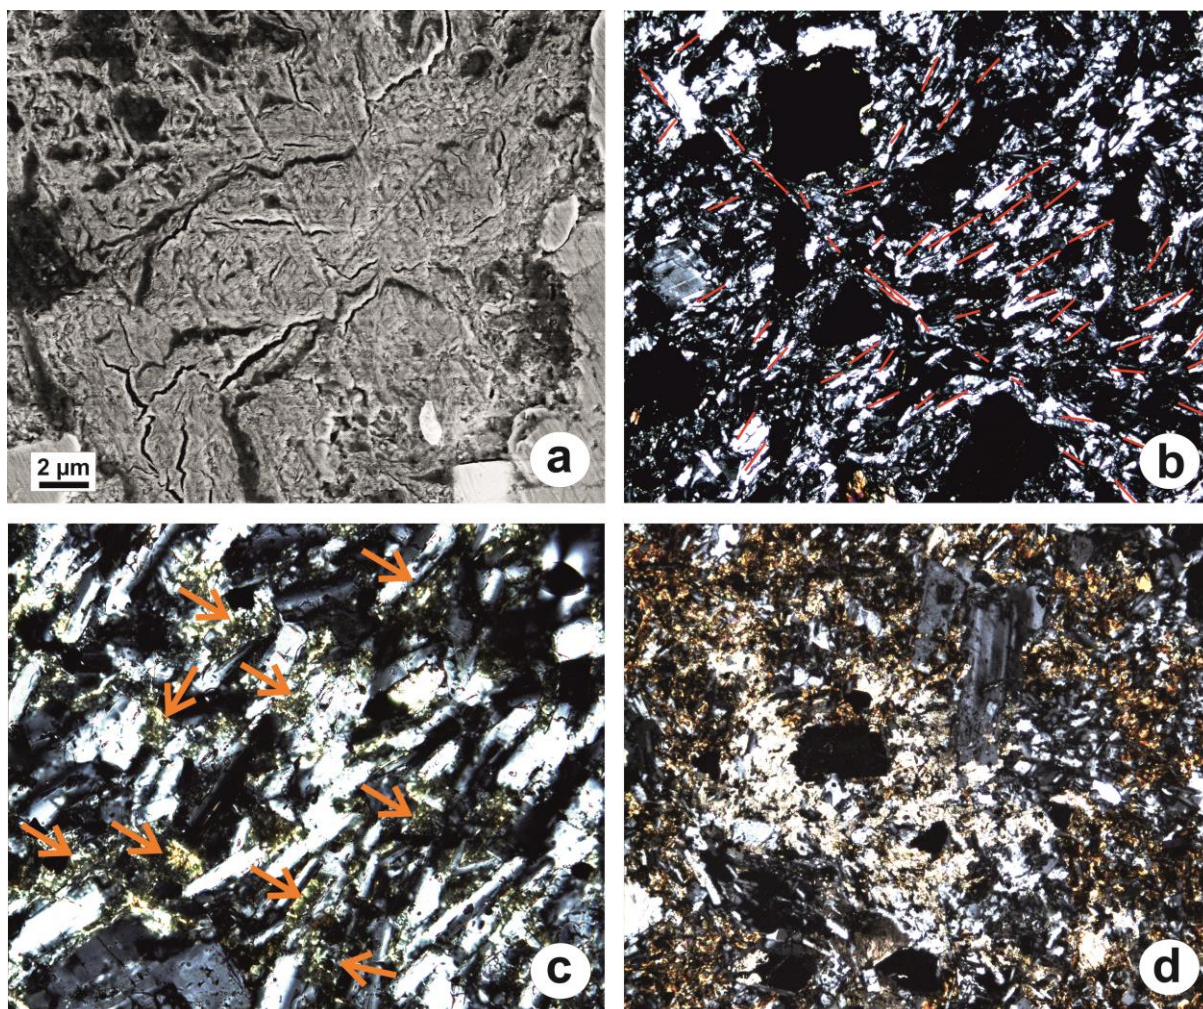
**Figure 5.2** (a) Secondary electron picture of Drachenfels trachyte – altered volcanic glass fractions in the interstitial areas are much fractured, showing a very distinct porosity; (b) the fluidal structure of the groundmass produces several textural domains with preferred orientation of the groundmass feldspar laths (marked with red lines) (crossed polars; image width 1.68 mm); (c) recrystallized and altered volcanic glass fractions in an unweathered rock sample, showing high interferences in crossed polars (marked with arrows; image width 0.42 mm); (d) accumulation of calcite and Fe-oxides as a result of alteration processes (crossed polars; image width 1.68 mm).

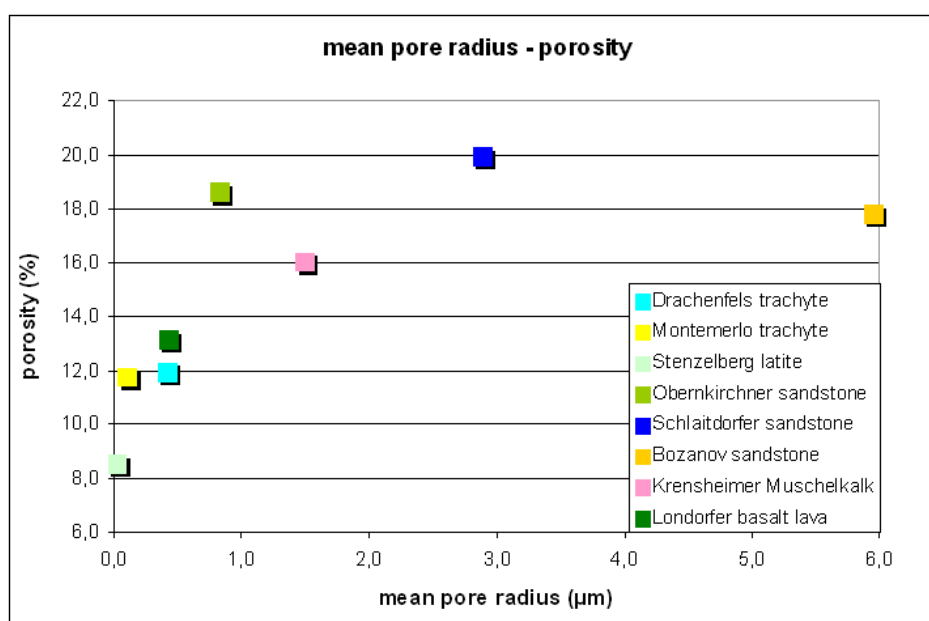
**Figure 5.4** The investigated natural building stones show a tendency of higher porosity correlated to a higher mean pore radius

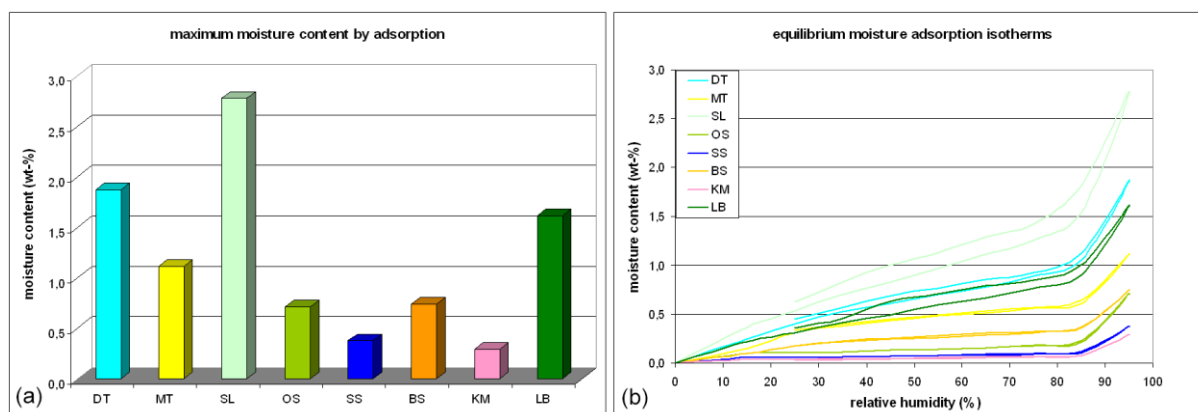
**Figure 5.5 (a)** The diagram shows the moisture content of the stones by moisture adsorption (sorption) at 95% relative humidity. **(b)** Equilibrium moisture sorption isotherms, showing a significant increase at relative humidity levels > 85% reflecting capillary condensation. Drachenfels trachyte (DT), Montemerlo trachyte (MT), Stenzelberg latite (SL), Obernkirchen sandstone (OS), Schlaitdorf sandstone (SS), Bozanov sandstone (BS), Krensheim Muschelkalk (KM) and Londorf basalt lava

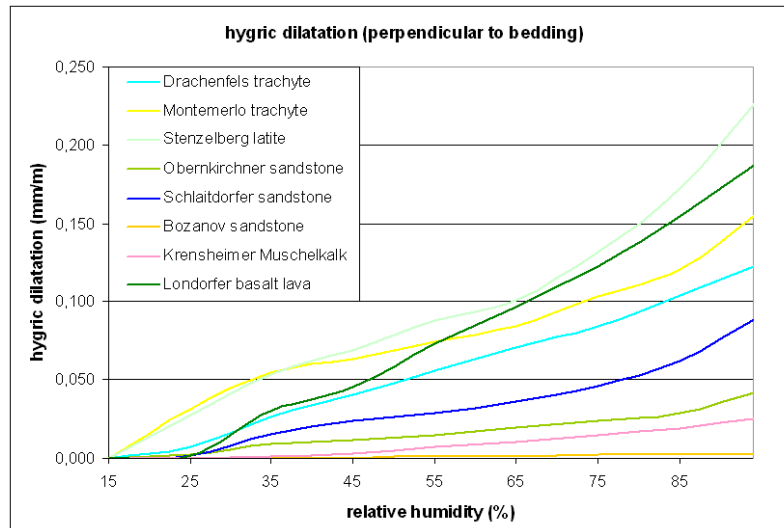
**Figure 5.7** Hygric dilatation perpendicular to the bedding of the stones with relative humidity ranging of 15–95%

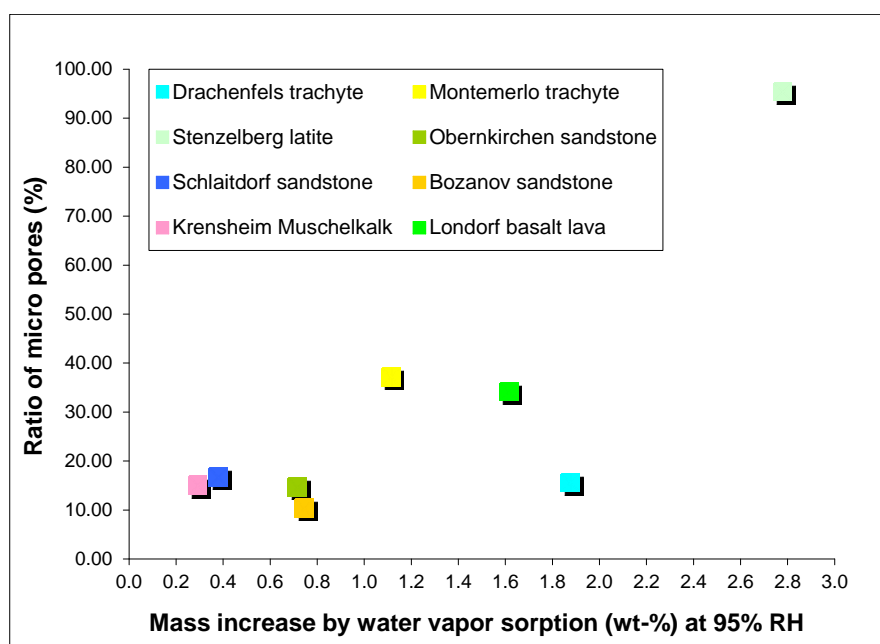
**Figure 5.8** The investigated stones of the Cologne cathedral show a tendency towards a higher percentage of micropores correlated to a higher water adsorption due to capillary condensation. However, the ratio of micropores in the Drachenfels trachyte would suggest a lower sorption.

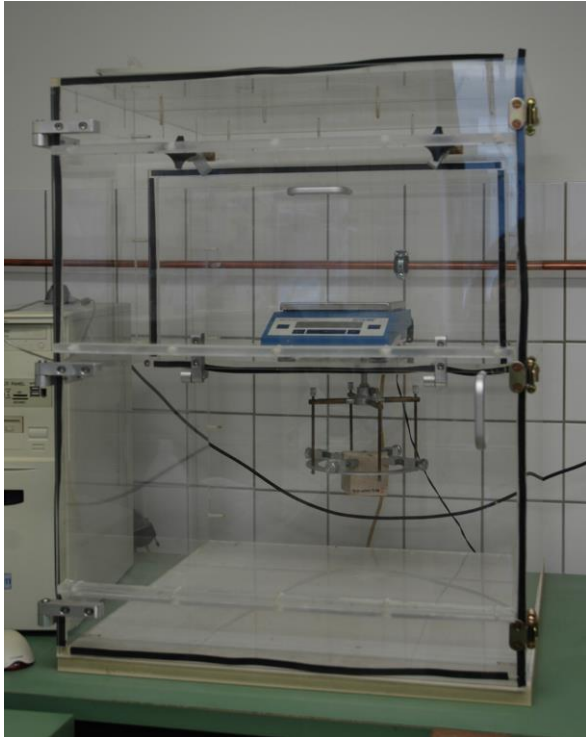
**Figure 6.2** Drying was measured in a closed cabinet

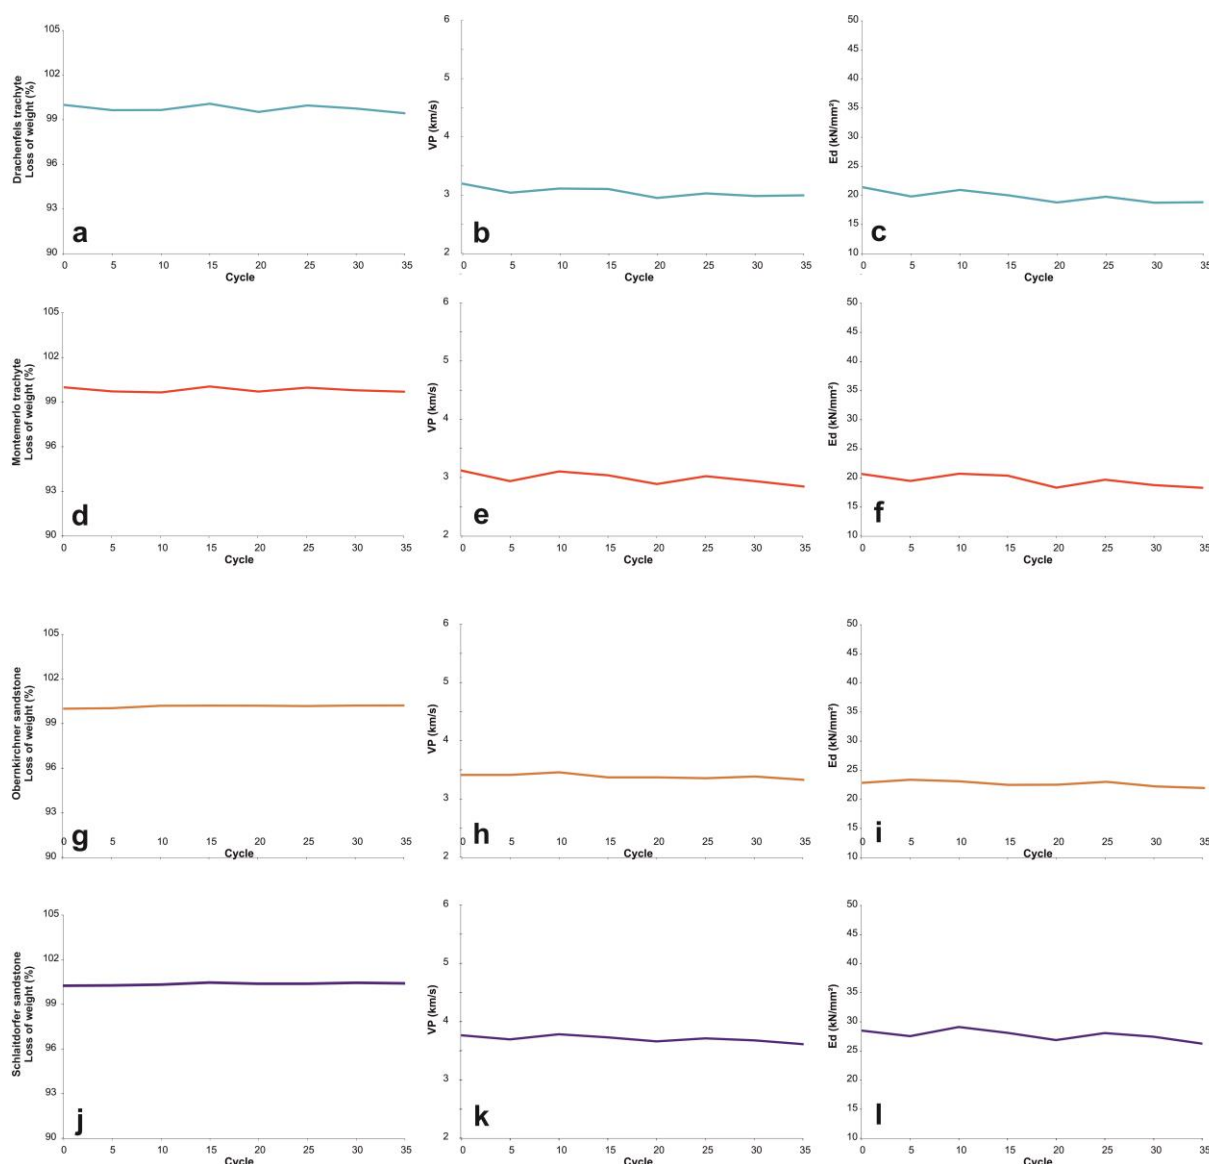
**Figure 6.3** Freeze-thaw test: The graphs show the changes in the weight loss, the compressional wave velocities (Vp) and the dynamic Young's modulus (dE) of the eight stones investigated

**Figure 6.3** continued. Freeze-thaw test: The graphs show the changes in the weight loss, the compressional wave velocities (Vp) and the dynamic Young's modulus (dE) of the eight stones investigated

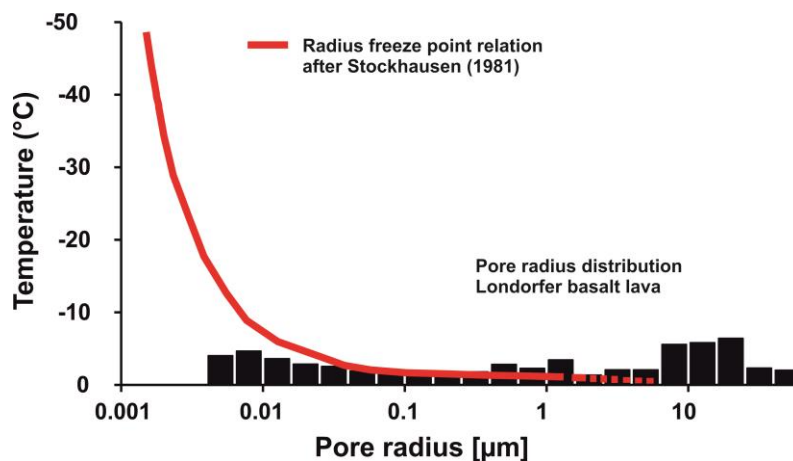
**Figure 6.4** The radius freeze point relation, following Stockhausen (1981)

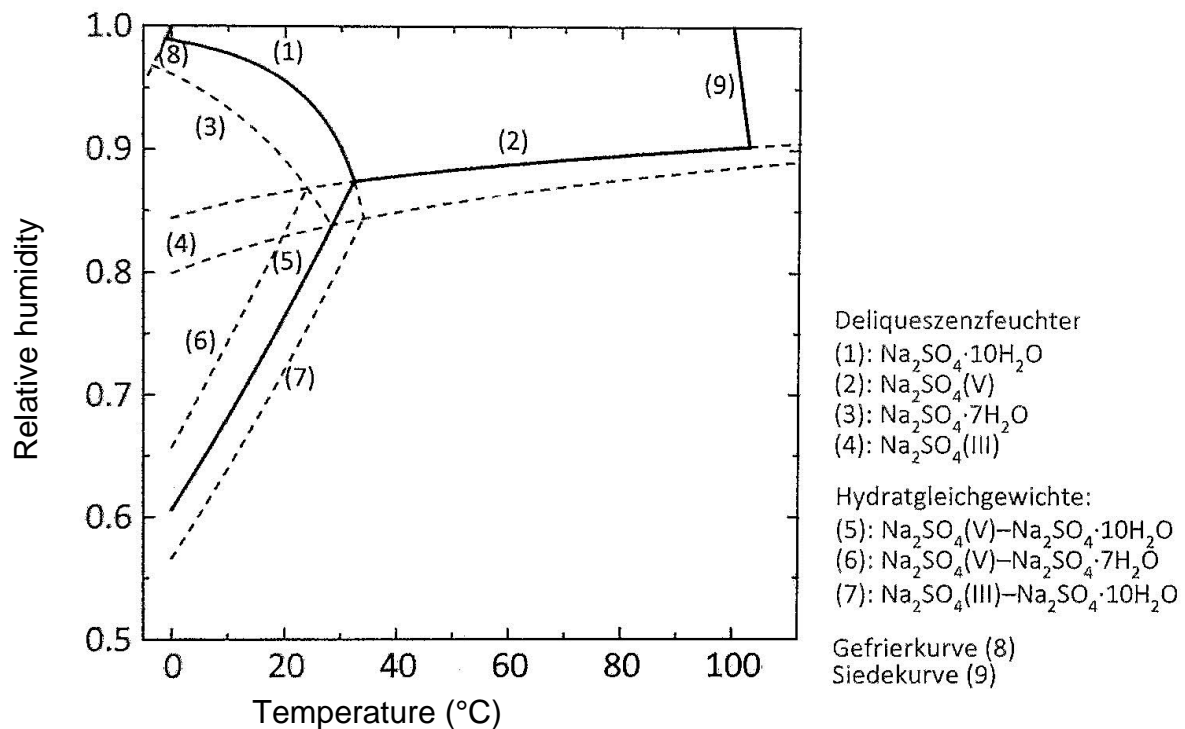
**Figure 6.6** Deliquescence humidities of the system  $\text{Na}_2\text{SO}_4 - \text{H}_2\text{O}$ , stable equilibrium: solid line; metastable equilibrium: dashed line (from Steiger 2009)

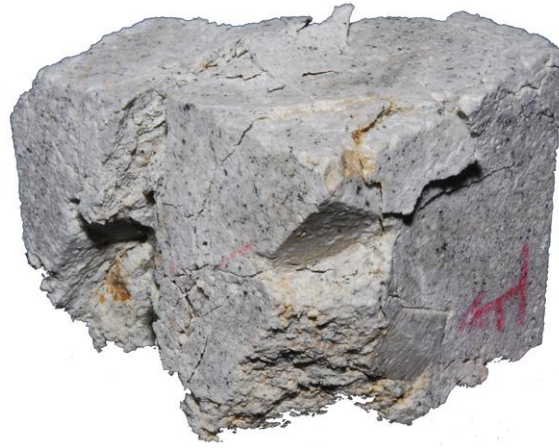
**Figure 6.8** Salt-weathering test: Deterioration in the Drachenfels trachyte sample showing fissures and crack formation alongside large phenocrysts and in the matrix as well.

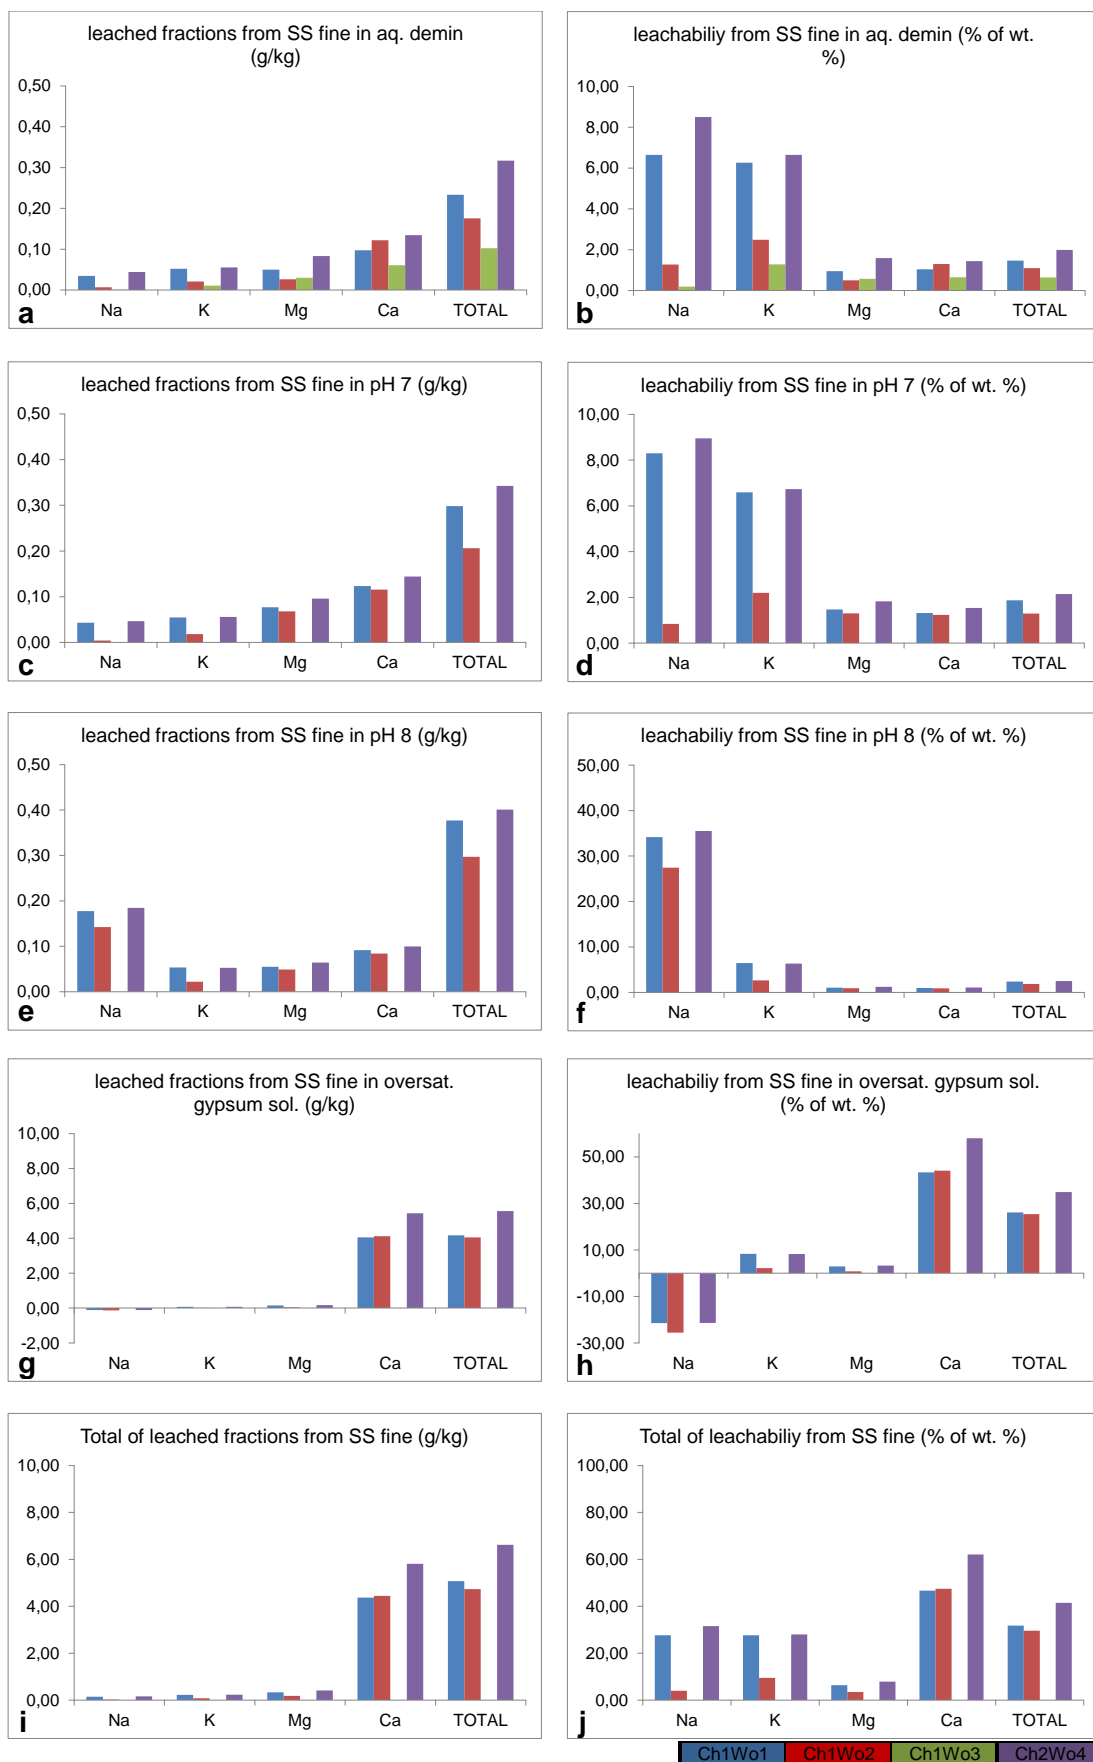
**Figure 7.9** Concentrations (g/kg) and leachabilities (% of wt. %) of the leached elements from the fine sample fraction from the Schlaitdorf sandstone (please note the different scales).

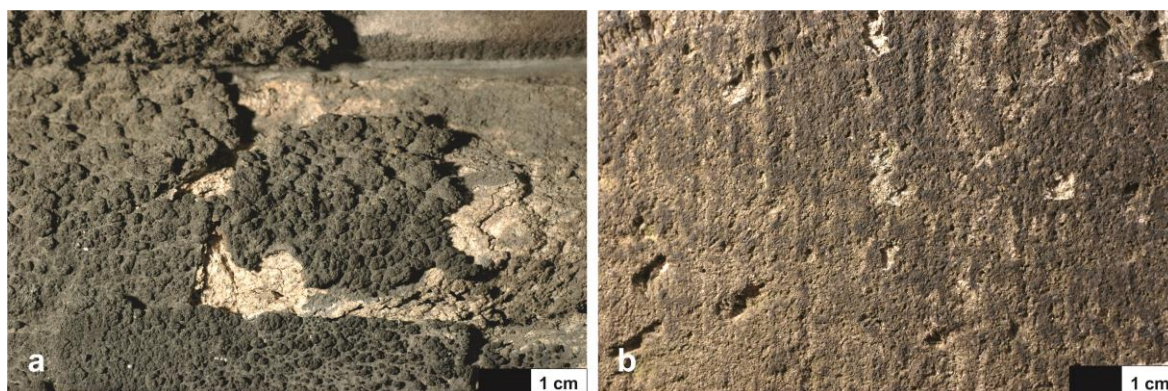
**Figure 8.1** a. Cauliflower-like or framboidal crust on Drachenfels trachyte contributing to the disintegration of the stone and leading to flaking and material loss; b. laminar crust on Drachenfels trachyte tracing the stone surface, where working traces are still visible.

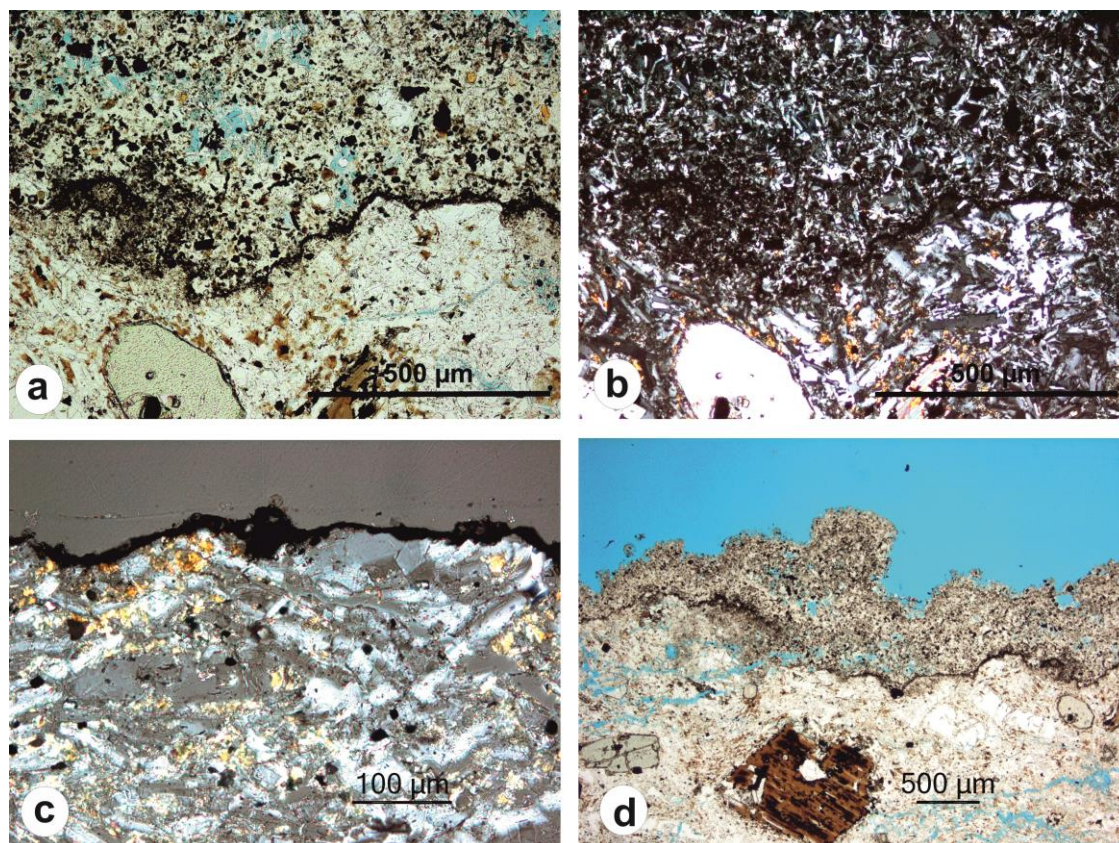
**Figure 8.2** Black weathering crusts on Drachenfels trachyte: **a.** framboidal crust (transmitted light) black interface layer, very porous poly-mineral composition with heterogeneous particle size; **b.** framboidal crust – same detail as Fig. 7a (crossed polars); **c.** laminar crust on Drachenfels trachyte, very thin opaque surface layer (crossed polars); **d.** thick framboidal crust with a black interface layer and surface parallel cracks in the host rock (crossed polars).
