**Stone deterioration and replacement of natural building stones  
at the Cologne cathedral  
A contribution to the preservation of cultural heritage**

Dissertation  
zur Erlangung des mathematisch-naturwissenschaftlichen Doktorgrades  
„Doctor rerum naturalium“  
der Georg-August-Universität Göttingen

Göttingen, 2013

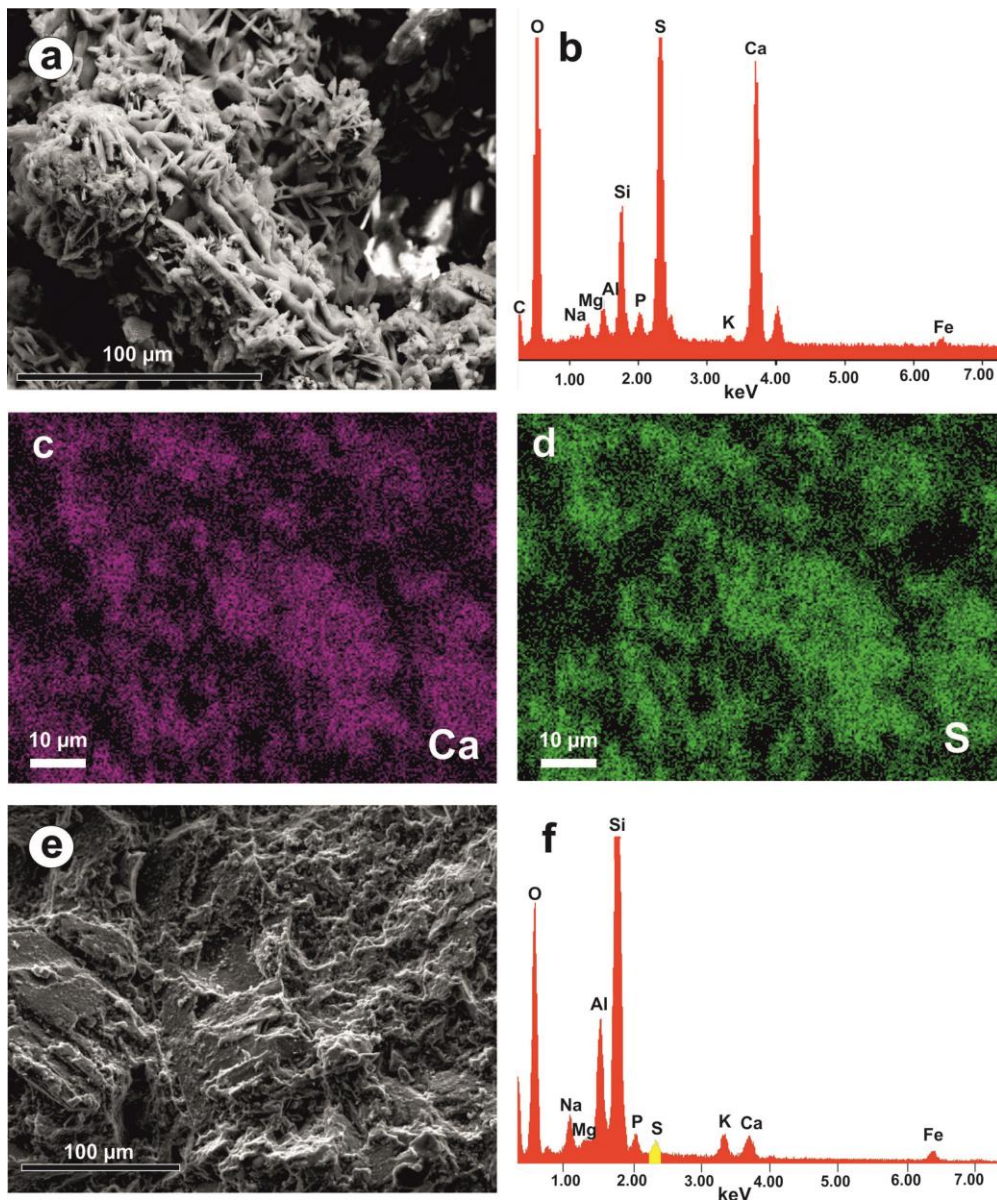
**Figure 8.3** Surface detections of black weathering crusts on Drachenfels trachyte: **a.** SEM picture (SE detection) of the outer surface of a framboidal crust; **b.** EDX spectrum of the outer surface of a framboidal crust; **c.** EDX map (calcium) of the outer surface of a framboidal crust; **d.** EDX map (sulfur) of the outer surface of a framboidal crust; **e.** SEM picture (SE detection) of the outer surface of a laminar crust; **f.** EDX spectrum of the outer surface of a laminar crust.

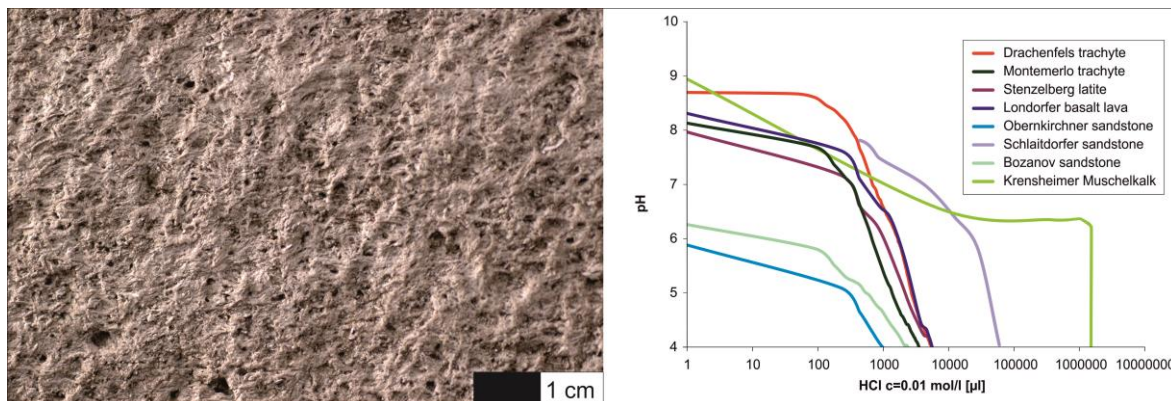
**Figure 8.8 (a)** Weathered surface of Krensheim Muschelkalk showing surface roughness; **(b)** tests on the acid binding capacity showing the extent of material solution.

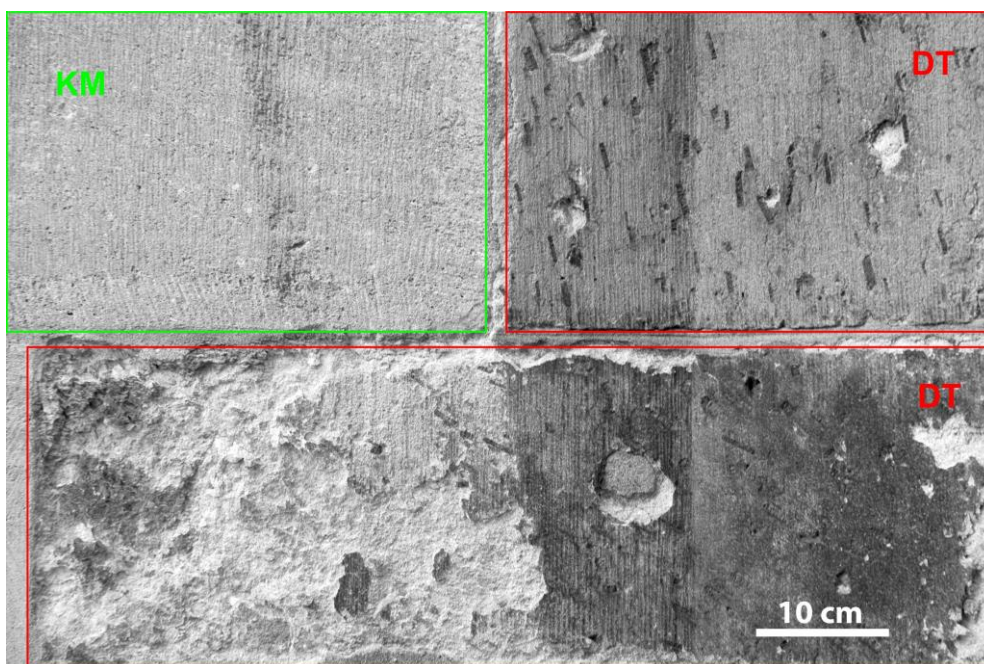
**Figure 8.9** Wall section at Cologne cathedral. Upper left stone: Krensheim Muschelkalk (KM); upper right and lower layer stones: Drachenfels trachyte (DT). The left side of the lower Drachenfels trachyte is in the flow direction of ion-loaded water from the limestone, which enhances the crust formation and decay. Also, a stronger deterioration of the Drachenfels trachyte is observed close to the joints, where alkaline leaching products of the mortar might have a certain impact. The massive erosion on the left side of the lower layered Drachenfels trachyte correlates with the coverage of the top Krensheim Muschelkalk.

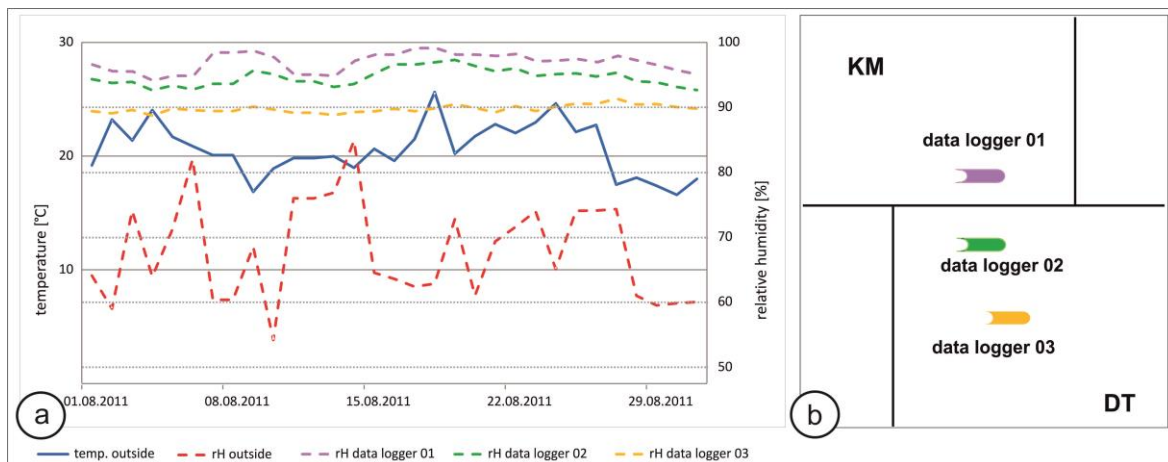
**Figure 8.10 (a)** *In situ* measurements of temperature and relative humidity (rH) at Cologne cathedral, August 2011: outside temperature (blue), outside rH (red), data logger 1 rH (purple), data logger 2 rH (green), data logger 3 rH (yellow); **(b)** scheme of sensors: data logger 1 is placed in the Krensheim Muschelkalk (KM), data logger 2 is placed in the Drachenfels trachyte (DT) with little distance to Krensheim Muschelkalk (KM) and the joint, and data logger 3 is placed centered in the Drachenfels trachyte (DT).

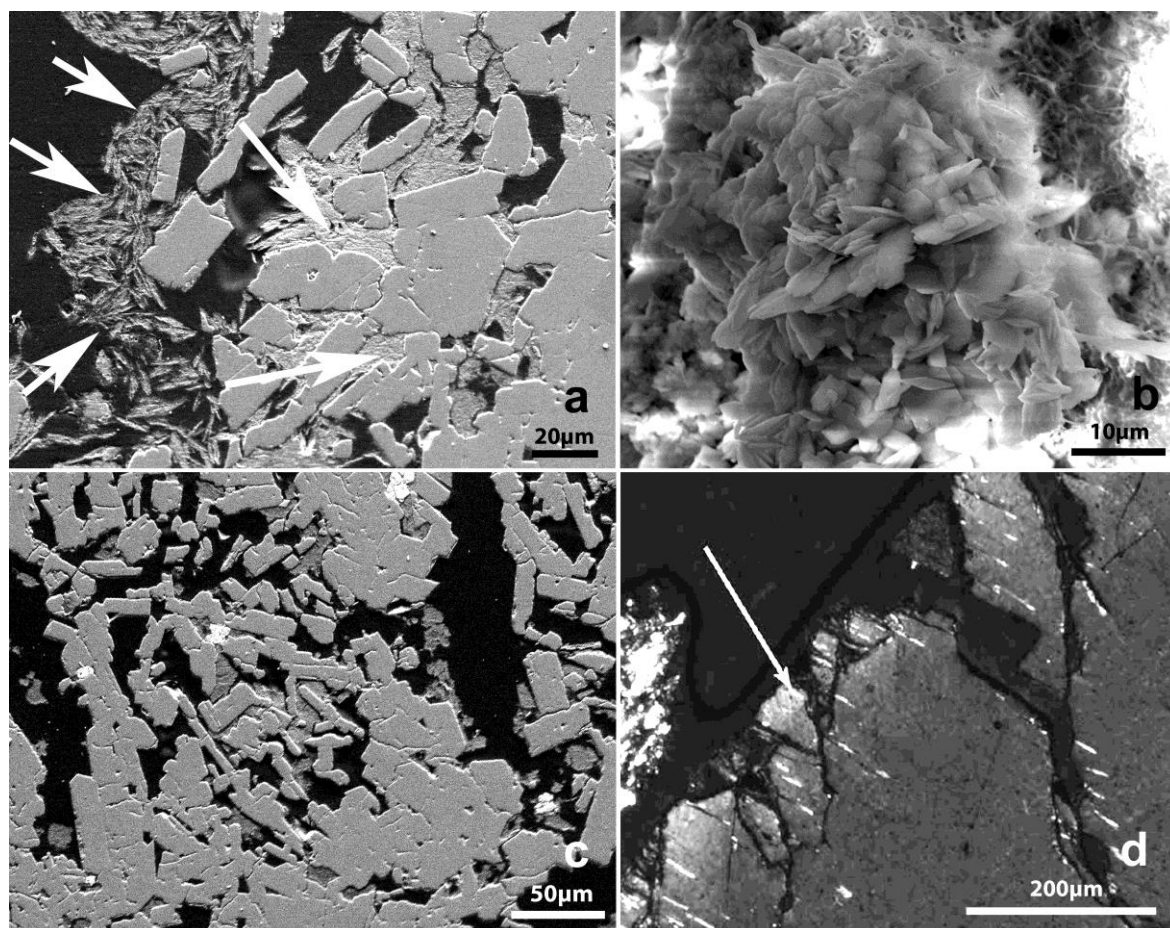
**Figure 8.11** (a) Gypsum (marked by arrows) is enriched in the crust as well as in the cracks (SEM); (b) rosette-shaped gypsum crystals on the reverse of a scale (SEM); (c) structurally disturbed zones where no gypsum is detected, indicating corrosion of feldspar grains (SEM); (d) fine-grained birefringent secondary minerals (marked by arrow) formed along the cleavage surfaces of sanidine phenocryst.

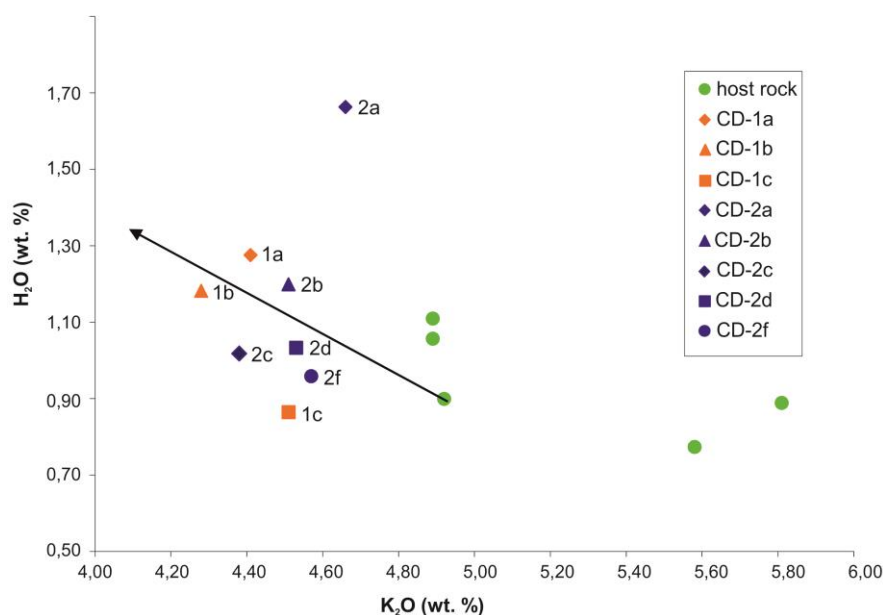
**Figure 8.13** K<sub>2</sub>O depletion and H<sub>2</sub>O increase in deterioration samples indicating the formation of phyllosilicates (sample index see Table A8.1 in the appendix).

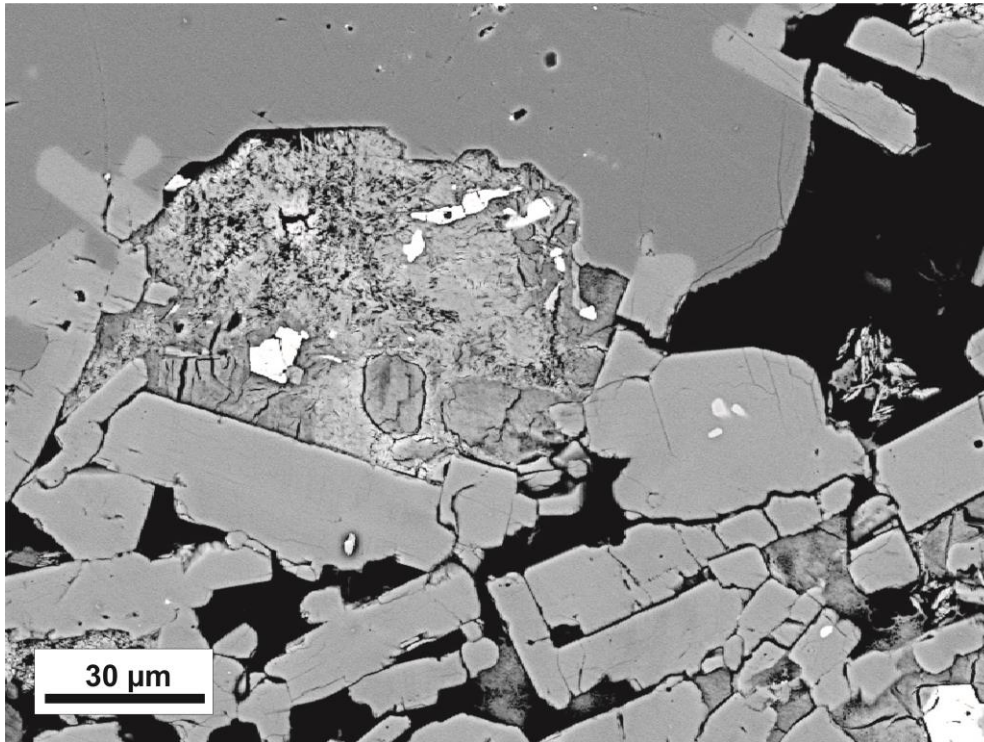
**Figure 8.14** The very fine recrystallized grain structure of the altered volcanic glass fractions in the interstitial area of the Drachenfels trachyte show high and distinct porosity and alteration to montmorillonite (microprobe backscattered electron image in composition mode).

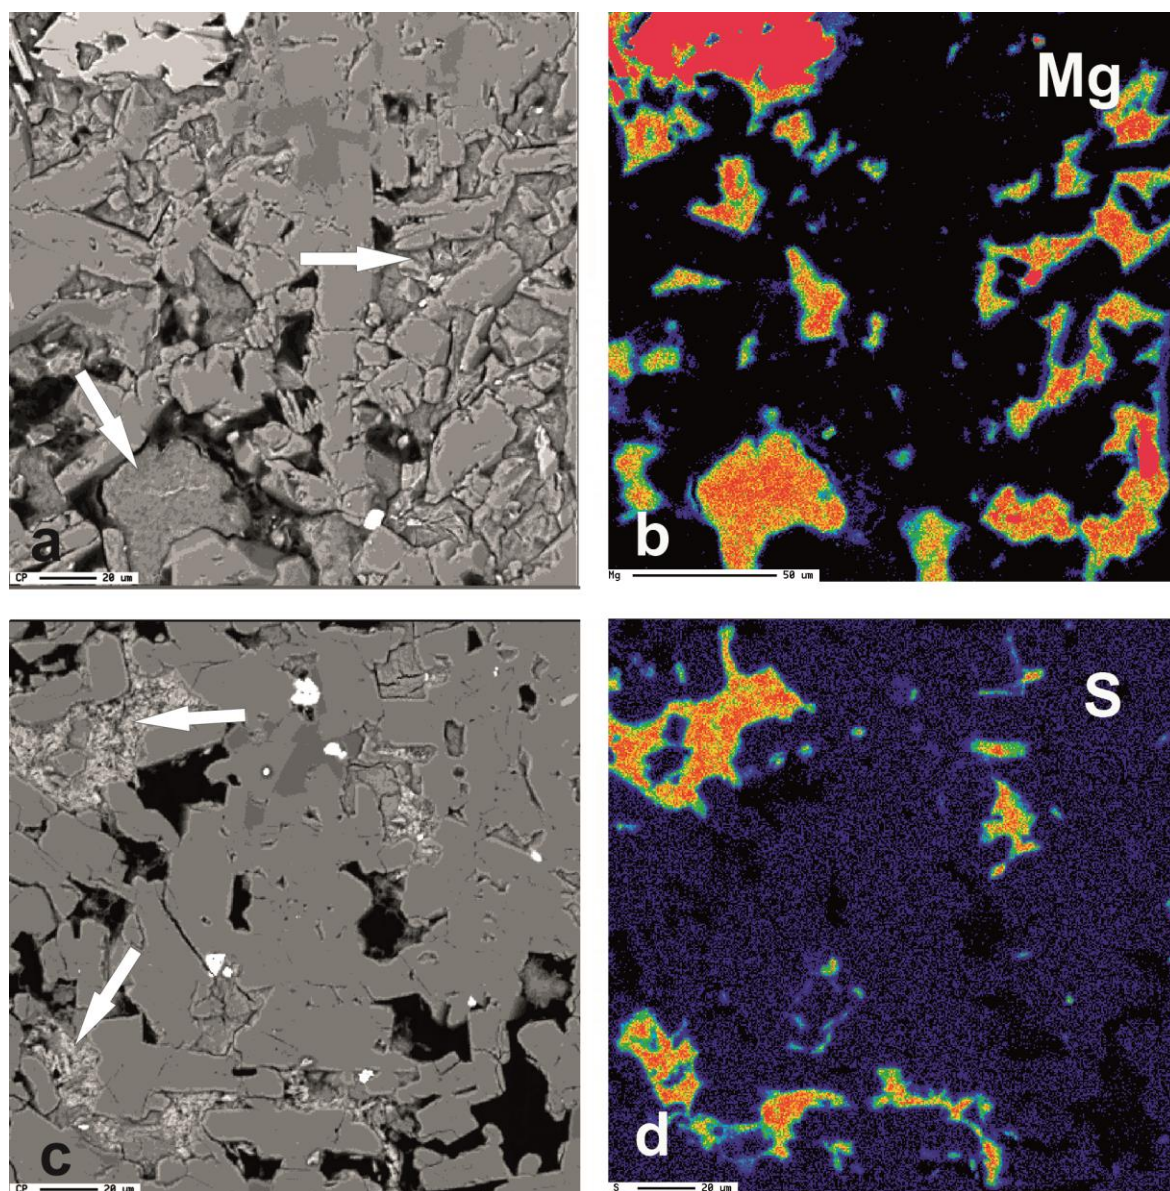
**Figure 8.15** Microprobe mapping **(a)** Backscattered electron image in composition mode of unweathered Drachenfels trachyte, *arrows* marking areas of volcanic glass fractions altered to montmorillonite; **(b)** magnesium mapping of the same area as Fig. 8.15a, the *yellow-orange-red* areas indicating higher magnesium concentration of the altered volcanic glass fractions (montmorillonite); **(c)** backscattered electron image in composition mode of weathered Drachenfels trachyte, *arrows* marking areas of pore spaces filled with gypsum –the altered glass fractions are originally located in these interstitial areas, but are now replaced through secondary gypsum formation; **(d)** sulfur mapping of the same area as Fig. 8.15c, the *yellow-orange-red* areas marking higher sulfur concentration as an indication of gypsum

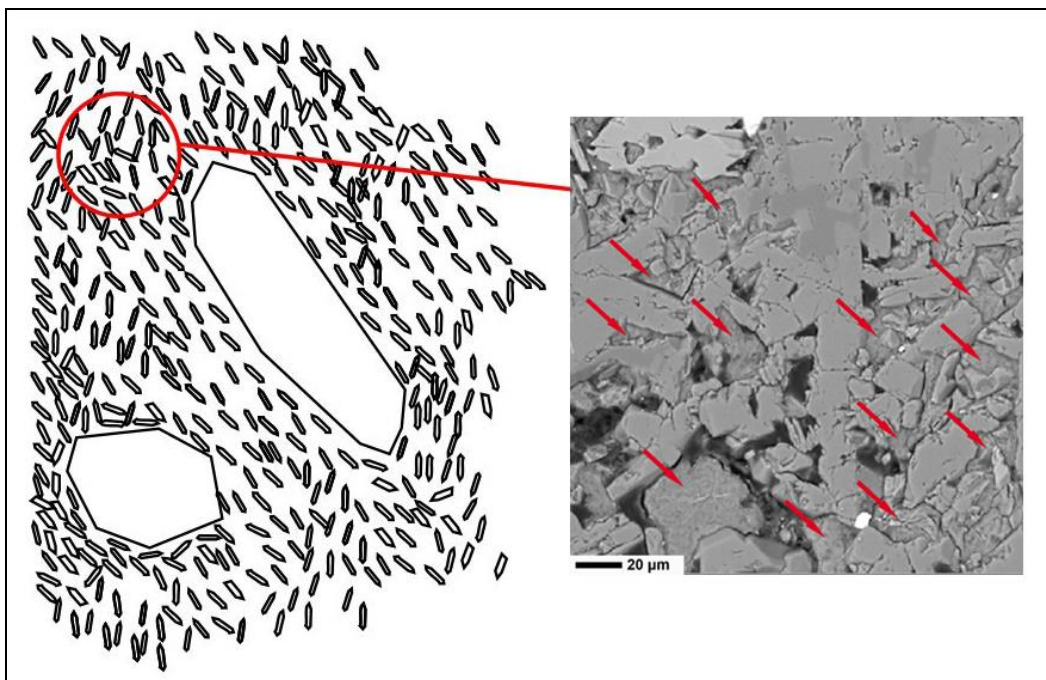
**Figure 8.16 (a)** Deterioration model of the Drachenfels trachyte: The unweathered trachyte has a porphyritic texture with feldspar phenocrysts tracing the flow direction. The small lath-shaped feldspars of the groundmass show a local flow fabric around the larger crystals forming interstitial areas. In these interstitial areas volcanic glass is detected, which is partially altered to montmorillonite (marked with red arrows).
