WEATHERING AND CONSERVATION OF MONUMENTS  
CONSTRUCTED FROM TUFF AND SANDSTONE  
IN DIFFERENT ENVIRONMENTAL CONDITIONS

Case Studies from Mexico, Germany, Jordan and Cambodia

Dissertation

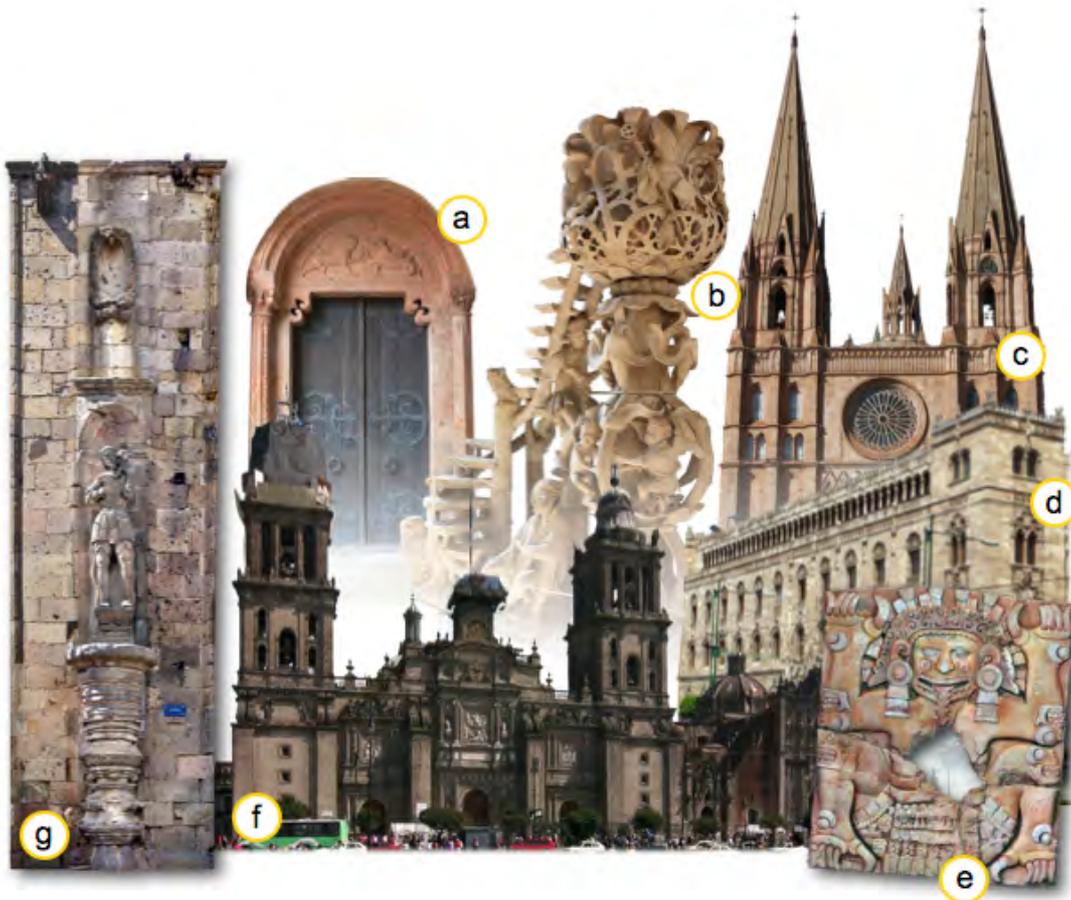
**Figure 2:** Volcanites used as building stones and for artwork: a) Rochlitz Tuff, RP (portal at monastery Wechselburg/Germany), b) Hilbersdorf Tuff, HD (tulip pulpit in cathedral of Freiberg/Germany), c) Cantera Rosa San Miguel el Alto, CR (cathedral Arandas/Mexico), d) Blanca de Pachuca Tuff, BP (Palacio Postal Mexico City), e) Tenayocátetl Tuff, TY (Aztec sculpture Tlatecuhtli, Templo Mayor, Mexico City), f) Chiluca, CH, and Cantera Gris de los Remedios, GR (cathedral of Mexico City), and g) Cantera Amarilla Tuff, CA (Santa Monica Church, Guadalajara/Mexico).

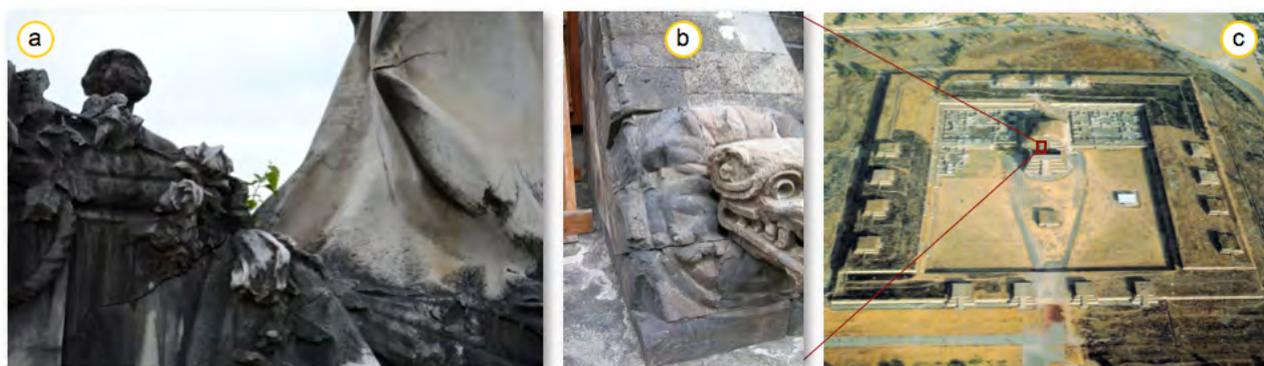
**Figure 9:** a) Cracks formed in a statue of marble in Lugano (Switzerland) probably due to thermal stress, b) massive cracks and material lost at the stair stringers of the Quetzalcoatl Pyramid of Teotihuacan (Mexico) and c) the Quetzalcoatl complex.

In rocks with many crystals or minerals with a high thermal expansion coefficient like marble (calcite), this expansion and contraction can cause mechanical fracturing and cracks like it is shown in Figure 9 a (Siegesmund *et al.*, 1999). Cyclic temperature changes are generally assumed to drive stone decay through the temperature gradients generated within the stone and the thermal expansion mismatch between minerals (e.g. Halsey *et al.*, 1998). In interaction with humidity the effect of expansion decreases (Weiss *et al.*, 2004). Also the color of the stone as well as the density plays a critical role. Black stones with a high density or a closed porosity are susceptible to cracking resulting in fluctuations of the surface temperature.

Good examples where thermal expansion may be the main deterioration process for cracking phenomena are the stair stringers of the Quetzalcoatl Pyramid of Teotihuacan, Mexico (Fig. 9 b and c). The main facade of this building is subject to complex deterioration phenomena that include decay caused by the presence of water and soluble salts, as well as inappropriate conservation treatments carried out in past decades (Villasenor 2006).

While most of the decorations are made from tuff, the stair stringers are made from black basalt containing non-cross linked gas pores. During the daytime in April and May the temperature can reach around 27 °C and can cool down to around 7 °C at night. Surface temperature on the dark colored stone varieties can reach nearly 70 °C because the main facade is oriented towards the west and heats up until the afternoon. At around 3:00 pm the lower part of the stair stringer facade is in shadow because another building is located right in front of it (Fig. 9 c). This leads to a significant decrease of surface temperature and probably leads to the shrinking, cracking and scaling of the stone (Fig. 9 b).

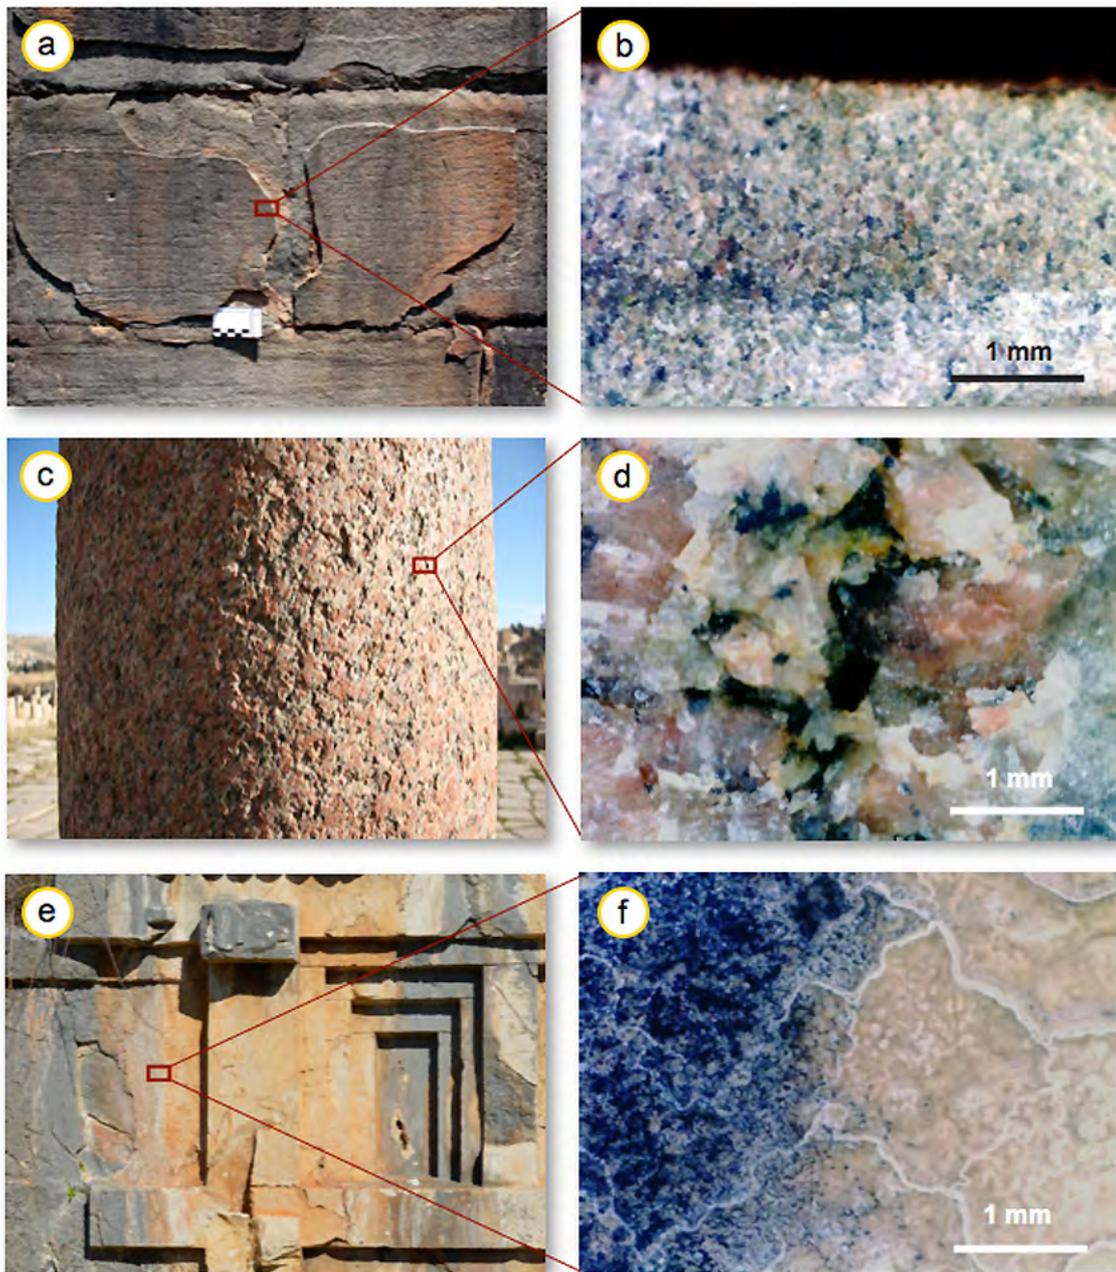
**Figure 10:** a) Discoloration by iron oxidation and contour scaling at the Phnom Bakheng Temple in Angkor (Cambodia) and b) zonation of the weathering crust. c) Granite weathering of an ancient column in Jerash (Jordan) and d) weathering of biotite and feldspar crystals. e) Weathering crusts at a Lycian monument in Myra (Turkey) and f) amorphous precipitations and discolorations probably due to micro-biological growth.

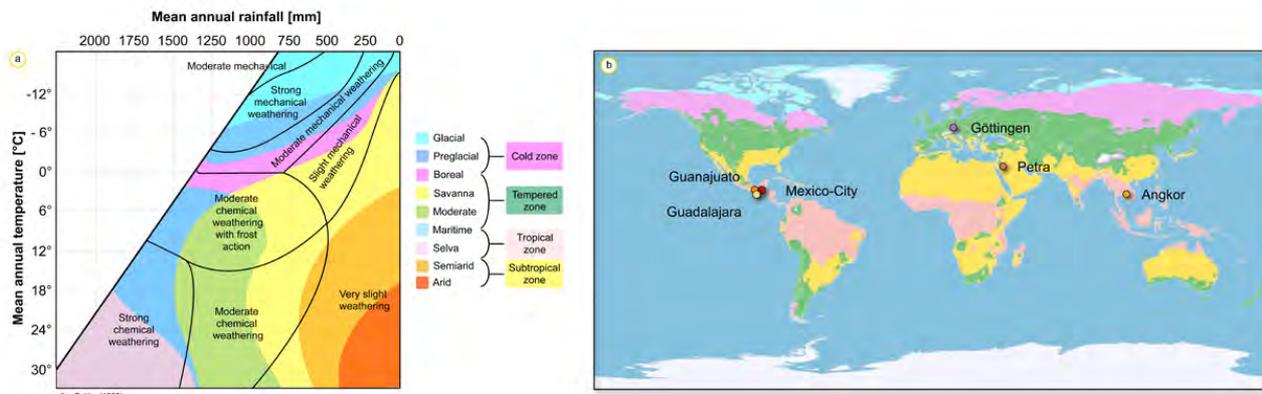
**Figure 12:** a) Weathering model after Peltier (1950) and b) the locations of the case studies within the different climatic zones.

Temperature and humidity are the main factors that control the intensity of weathering in regards to the climatic impact. Geomorphology seeks to understand why landscapes look the way they do. In geomorphology weathering is discussed in the context of the weathering of landscapes. Conservation science focuses mainly on the weathering factors affecting monuments. Most of the processes involved in the development of landscapes are controlled by the topography and climate. Four different climatic zones are defined: cold zones, tempered zones, tropical zones and subtropical zones (Fig 12 a). Within these zones nine different types of latitudinal regions, defined by Trewartha and Trewartha and Horn (1966, 1980) can be found as shown in Figure 12 b. Peltier (1950) presented a model that shows the intensity of weathering related to climatic conditions and different types of climate provinces (Fig. 12 a). The case studies investigated in this study are located in three different climatic zones (Fig. 12 b). The three Mexican case studies and the Cambodian case studies are located in the tropical zone, the Jordan one in the subtropical zone and the German one in the tem-

pered zone (Fig. 12 b).

The case studies discussed in this thesis are located in three different climatic zones and various landscape types with five different climates as shown in Figure 12 b and listed in Table 1. According to the Holdridge life zone system, the case studies can be divided into six different zones (Fig. 14, Tab. 14).

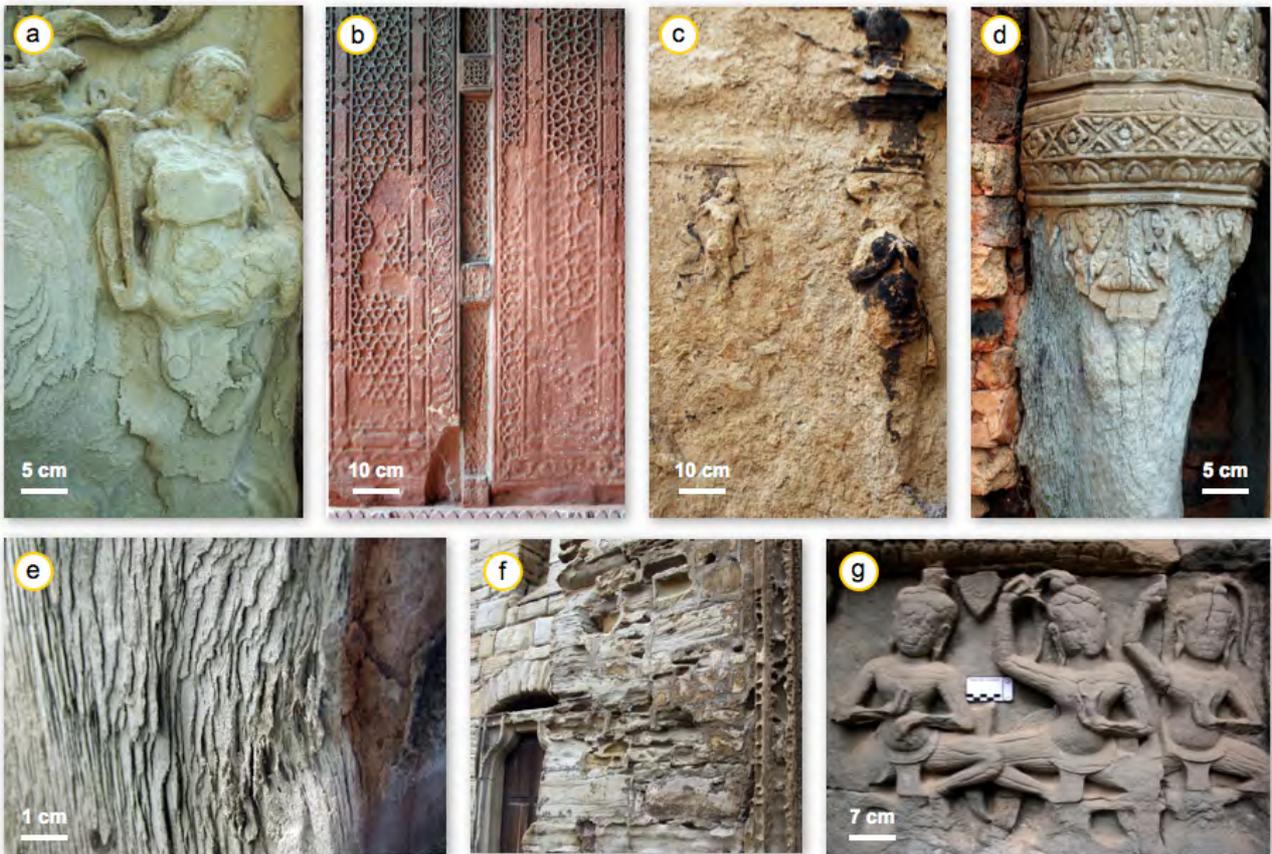
**Figure 16:** Weathering phenomena in sandstones: a) delamination parallel to the surface (Zeitz, Germany). b) Sanding parallel to the surface (Fatehpur Sikri, India). c) Flaking (Wittenberg, Germany). d) Crust formation, cracking and lamination parallel to the bedding (Angkor, Cambodia). e) Lamination parallel to the bedding (Goettingen, Germany). f) Alveolar weathering (Zeitz, Germany). g) Cracking and contour scaling (Angkor, Cambodia).

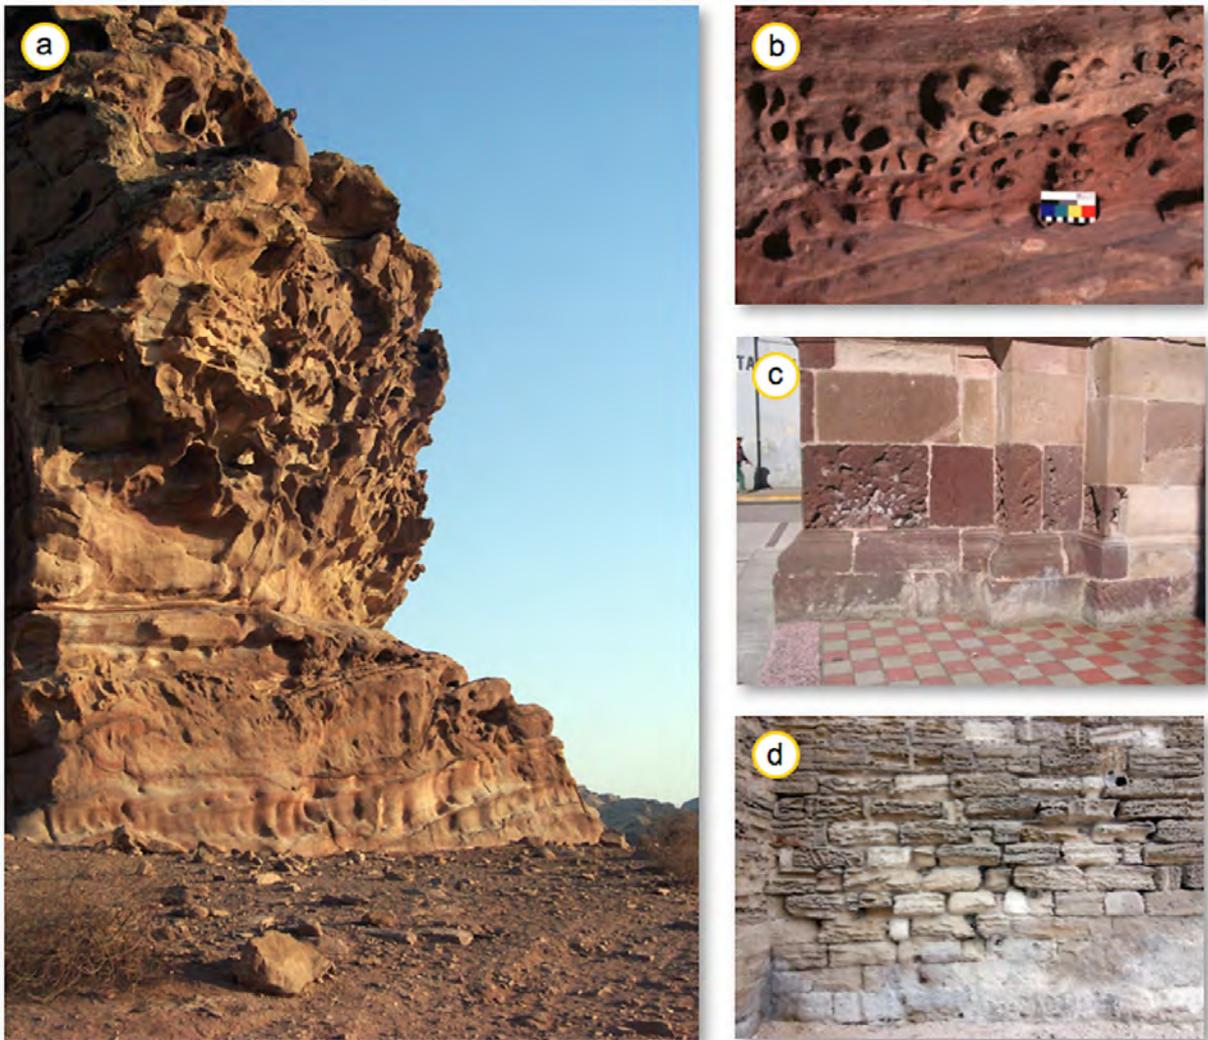
**Figure 18:** Tafoni and alveolar weathering. a) Tafoni weathering in the region of Petra (Jordan), b) alveolar weathering in Petra, c) alveolar weathering of tuff at the San Francisco Church in Zamora, Michoacan/Mexico and d) alveolar weathering at the historical city wall of Avignon (France).

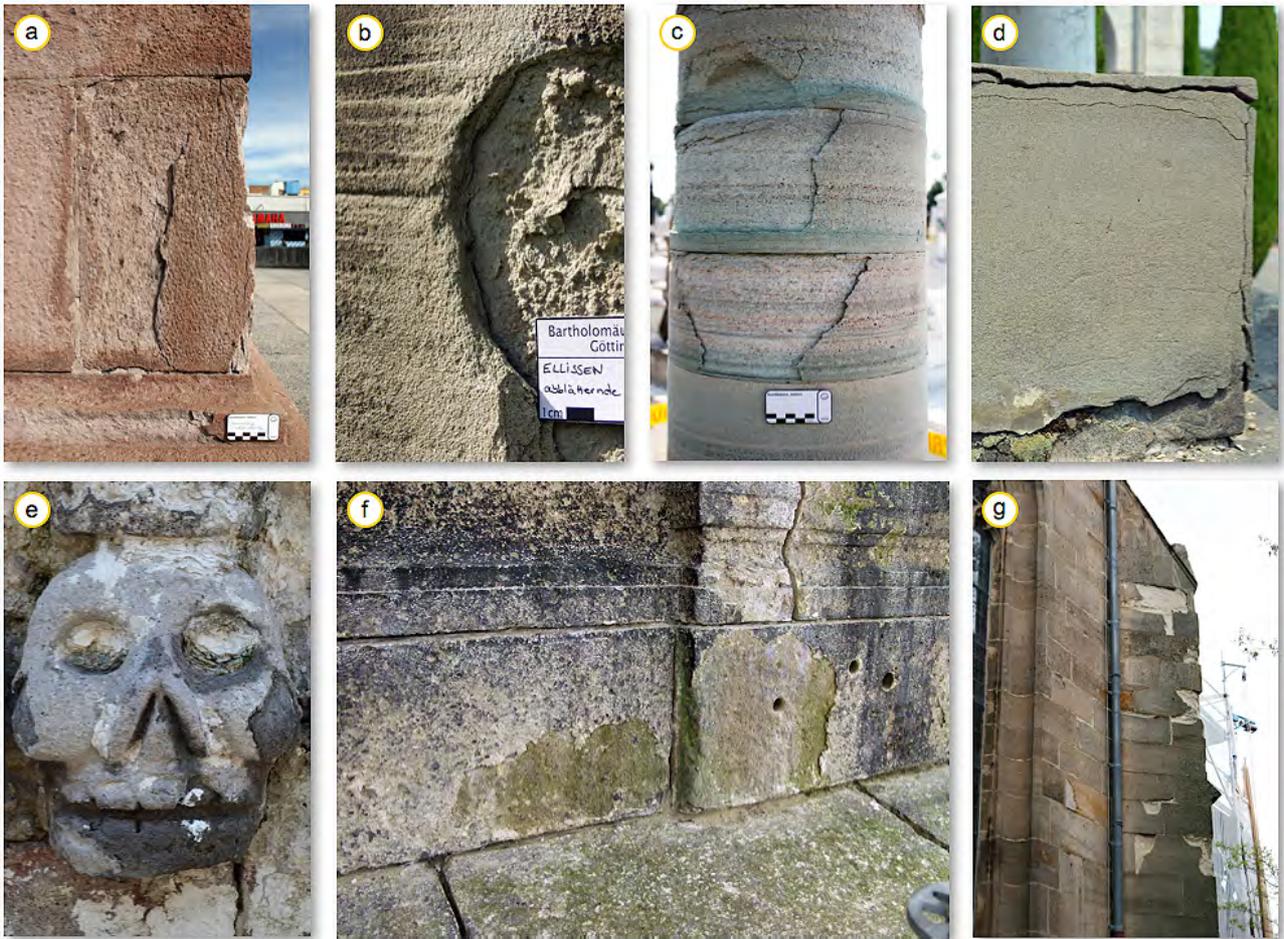
**Figure 19:** a) Scale formation due to gypsum accumulation at the monument of independence in Guadalajara, Mexico (tuff), and b) perpendicular to the bedding due to gypsum accumulation at a sandstone tomb in Göttingen, Germany. c) Contour scaling perpendicular to the bedding due to calcite accumulation at a tomb in Guadalajara, Mexico (tuff). d) Massive crust formation and contour scaling at a tomb in Lugano, Switzerland (clay-rich sandstone). e) Contour scaling due to hydrophobization at the Templo Mayor in Mexico City, Mexico (tuff), and f) at the Charlottenburg Gate in Berlin, Germany (tuff) as well as g) at the Servatius Church in Duderstadt, Germany (sandstone).

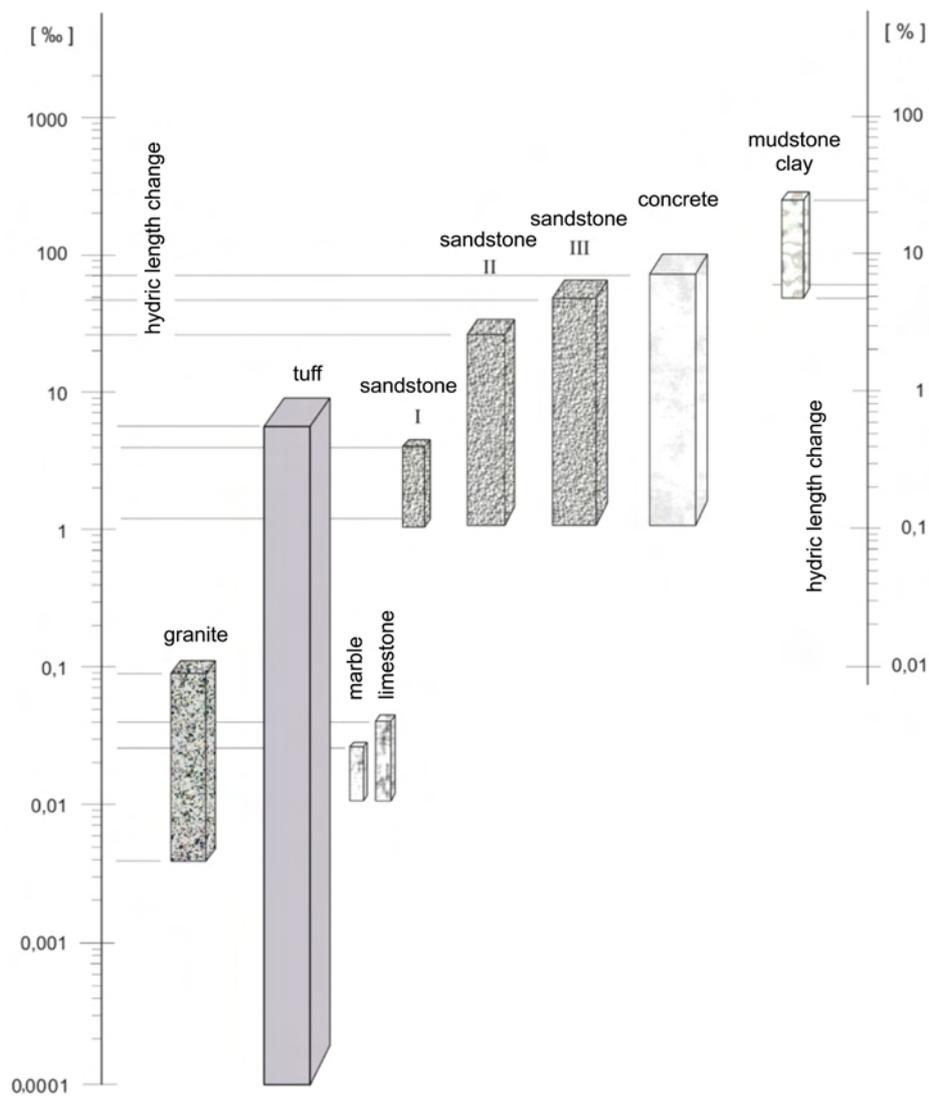
**Figure 24:** Swelling and moisture expansion of building stones (data from different authors and from this study). Modified from Kocher (2005): Granite, marble und sandstone I from Hockmann and Kessler (1950), from Snethlage (1984), limestone from Lukas (1990), sandstones II from Schuh (1987), sandstones III from Snethlage and Wendler (1997), concretes from Wesche (1977), mudstones from Madson (1976) and Madson and Nueesch (1990).

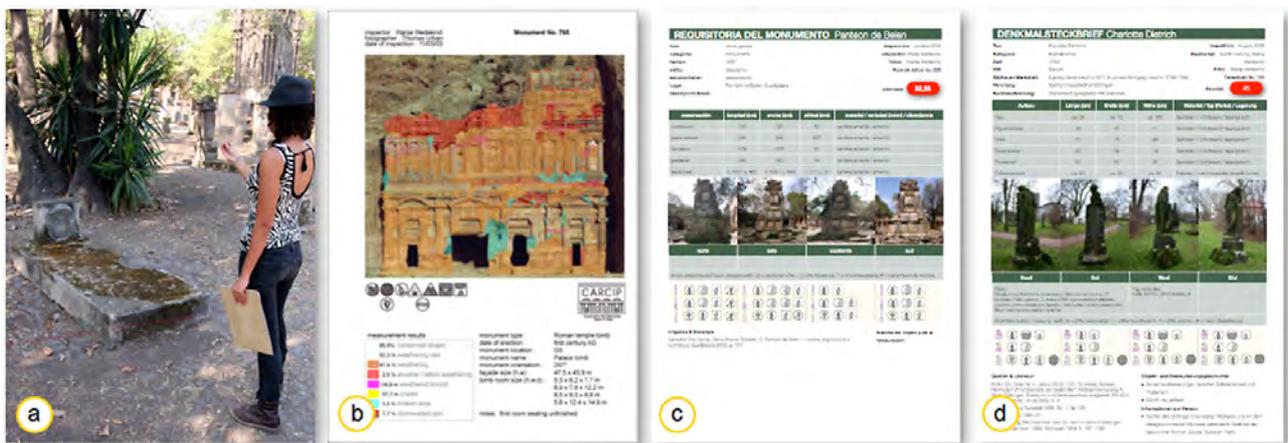
**Figure 32:** Conservation inventory. a) Practical mapping and quantification of a tomb at the Panteón de Belén-cemetery in Guadalajara, Mexico. b) Data sheet of the palace tomb in Petra, Jordan, c) data sheet of a monumental tomb at the Belem-cemetery and d) data sheet of a sculptural tomb at the Bartholomew-cemetery in Goettingen, Germany.

UNESCO (UNESCO 1976). Following in their footsteps, the German National Commission for Heritage Conservation provided further recommendations on this topic (Deutsches Nationalkomitee 1982), and the International Commission on Monuments and Sites, ICOMOS, adopted guidelines for the recording of monuments (ICOMOS 1996). Based on these general guidelines a documentation system was developed which attempts to collate all the relevant information on the investigated objects, in the case of the present study (Petra, Jordan and the Bartholomew Cemetery in Goettingen, Germany). The conservation inventory used includes the name of the monument and in the case of a tomb the name of the buried person, together with details on the type of monument, date of erection, current or historical inventory numbers, artist, sculptor or builder, location and a short inscription (Fig. 32 b-c). The date of inspection and the people in charge are also documented. All the details concerning the dimensions of architectural building parts, the type of materials, varieties and their manufacture are tabulated. Centered photos of the object are inserted corresponding to the date of erection of the monument. Below these photos information is provided on all inscriptions, including details of the font, font style, damaged or missing characters and extended words as well as their sources. Key information for future planning is given by the evaluation of the state of preservation by the observation and quantification of different weathering forms (Fig. 32 a).

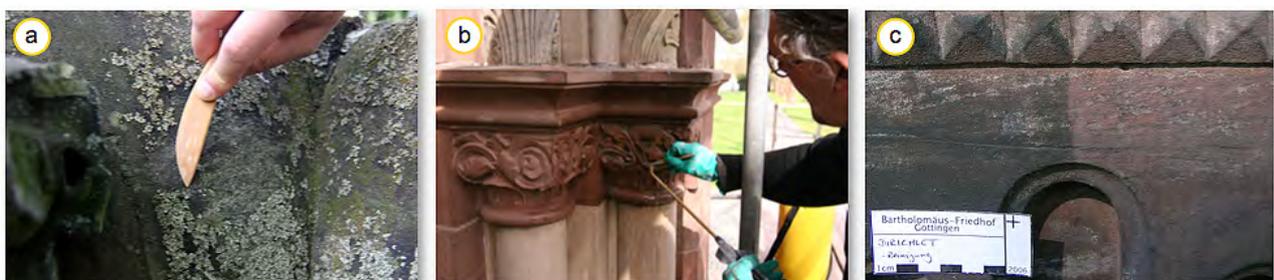
**Figure 33:** a) Cleaning of microbiological growth with a wooden tool. b) Wet cleaning of dust and loose deposits. c) Cleaning effect by using the micro-abrasive method on sandstone.

Different methods including physical, manual (Fig. 33 a), chemical (Fig. 33 b) and abrasive proce-

dures (Fig. 33 c) are at one's disposal for cleaning and removing the weathered or damaged surfaces. These include conventional manual cleaning methods using the appropriate brushes, scrubbers and sponges as well as more mechanical procedures involving the use of the micro-dry blasting process, steam cleaning and the vacuum washing method.

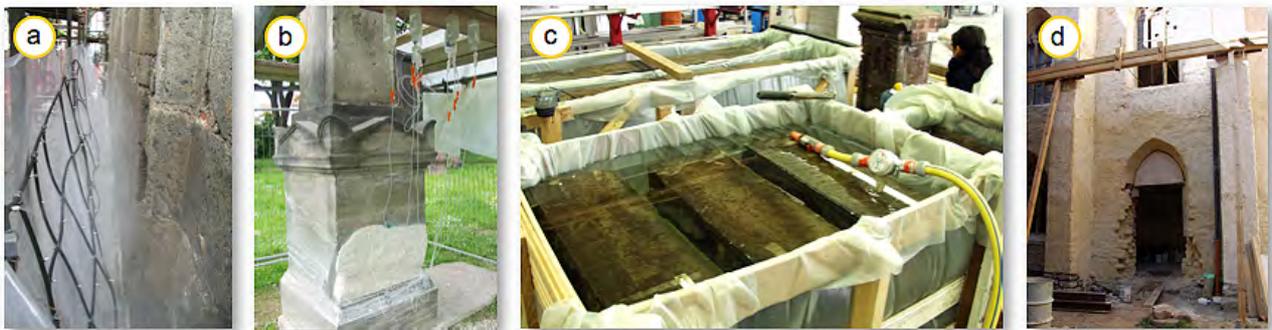
**Figure 34:** Different methods of desalination. a) sprinkling, b) combined injection and poultice method, c) desalination bath and d) poultice.

Methods applied include the application of a sacrificial plaster layer, compresses (Fig. 34 b and d), the washing and sprinkling procedure (Fig. 34 a), the desalination bath (Fig. 34 c), chemical salt conversion and the process of electro-osmosis. Through architectural and other technical means the interior climate can be adjusted and kept constant. Thus damaging salts can become ineffective.

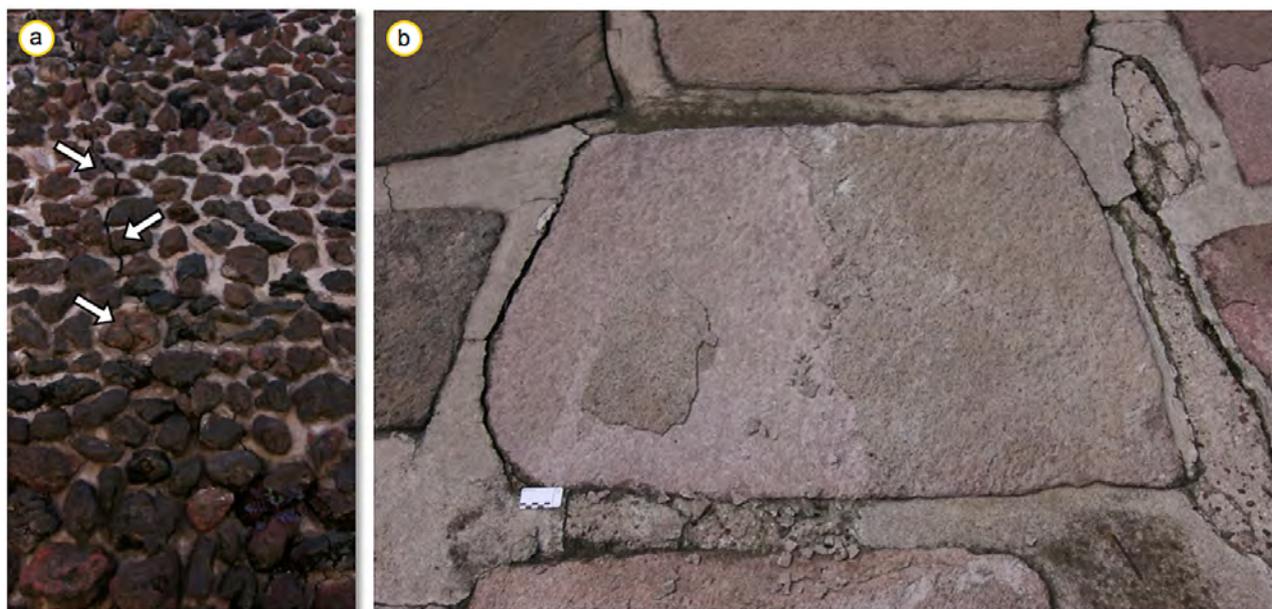
**Figure 45:** a) Structural cracks observable in the tezontle (arrows) and b) scaling of tenayocátetl plates parallel to the surface.

The most recognizable deterioration in the tezontle consists of fractures and cracks (Fig. 45 a), whereas the weathering feature observable in the tenayocátetl is a scaling parallel to the surface with a thickness of 2–5 mm (Fig. 45 b). Both weathering forms are specific for each single type of stone. Especially in the case of the tenayocátetl, the damages are observable on many plates in the platform. In this study, tezontle from a quarry in the state of Mexico D.F., which is used for restoration projects today, and the tenayocátetl from the Templo Mayor have been investigated.

The stone shows two different stages of weathering. After the 14<sup>th</sup> cycle some grains are lost at the edges (Fig. 55). The Tenayocátetl tuff first develops a crust on the surface of the material even perpendicular to the bedding. After this, the crust splits away in scales and by the 35<sup>th</sup> cycle a rounding by flaking takes place (Fig. 55). Both weathering forms can be found in the field, e.g. at the Templo Mayor in Mexico City (Fig. 45 b).

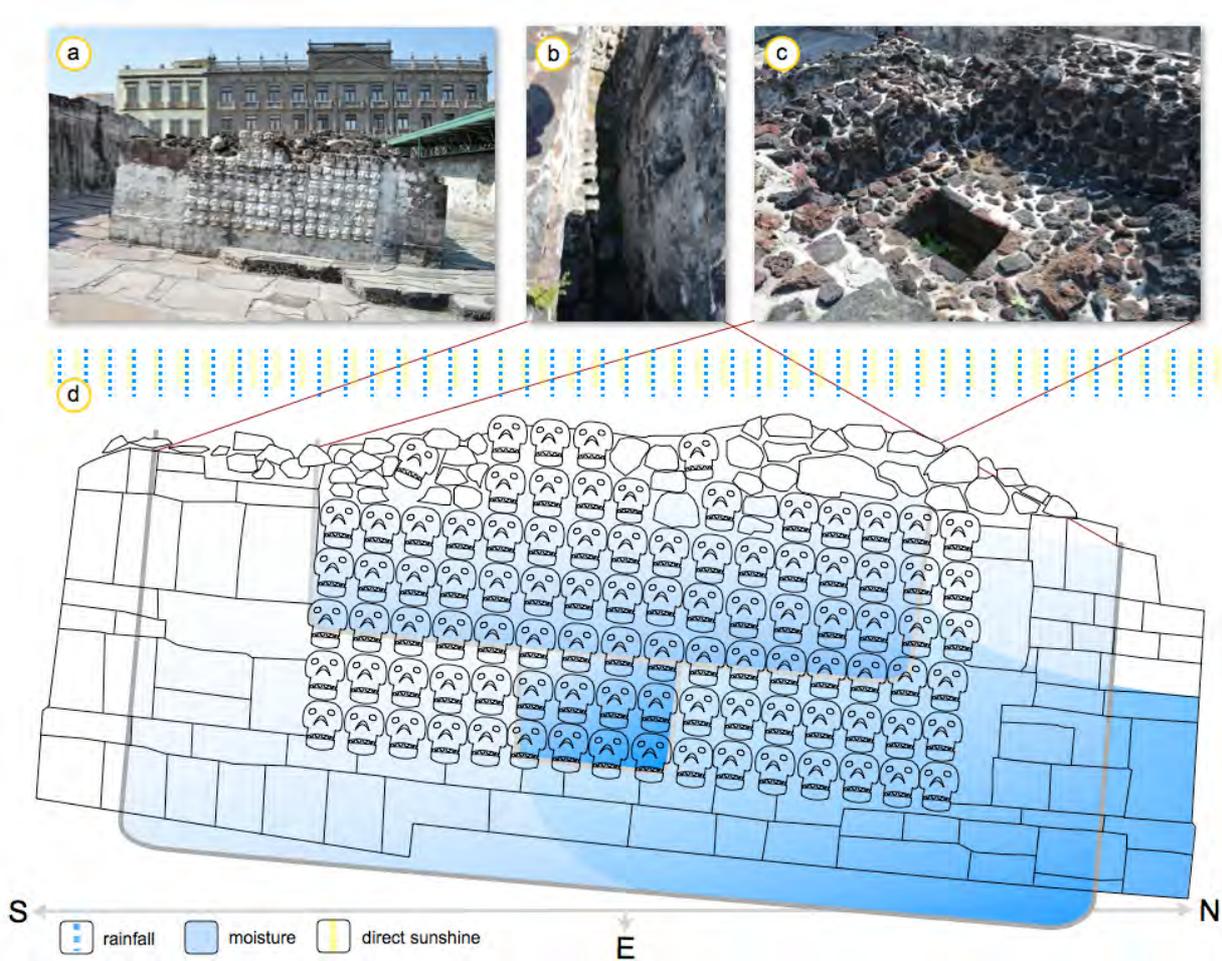
**Figure 46:** a) The movement of the whole structure of the Tzompantli altar is noticeable by the historical buildings in the background. b) The trench-like structure behind the east side. c) The stepwise lowered building structure at the top of the center. d) The hydrological situation of the Tzompantli Temple leads to an accumulation of humidity at the north side.

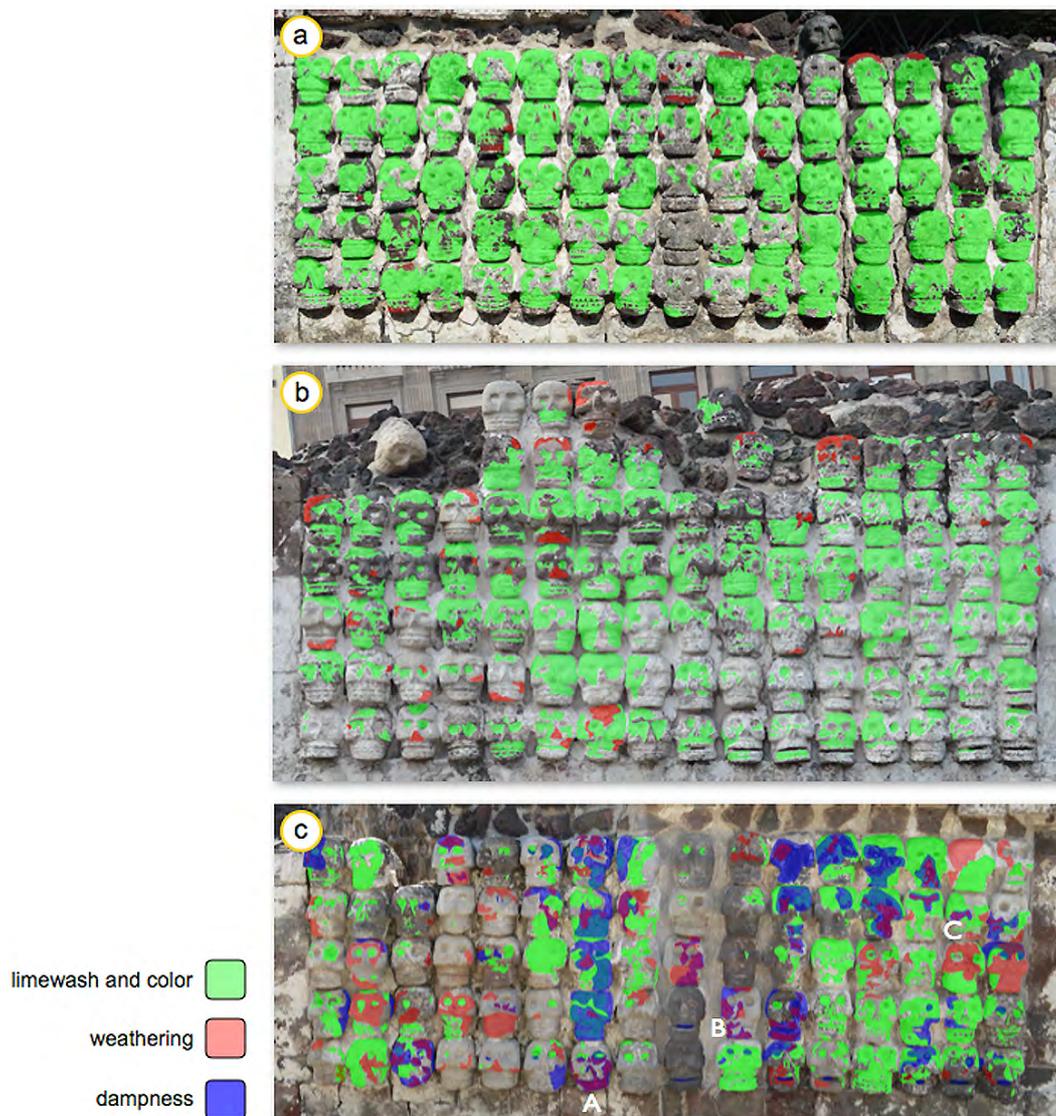
**Figure 47:** a) The skull wall at the south side with forms of weathering and conditions, b) the east side and c) the north side, complete with the sampling points of the salt samples.

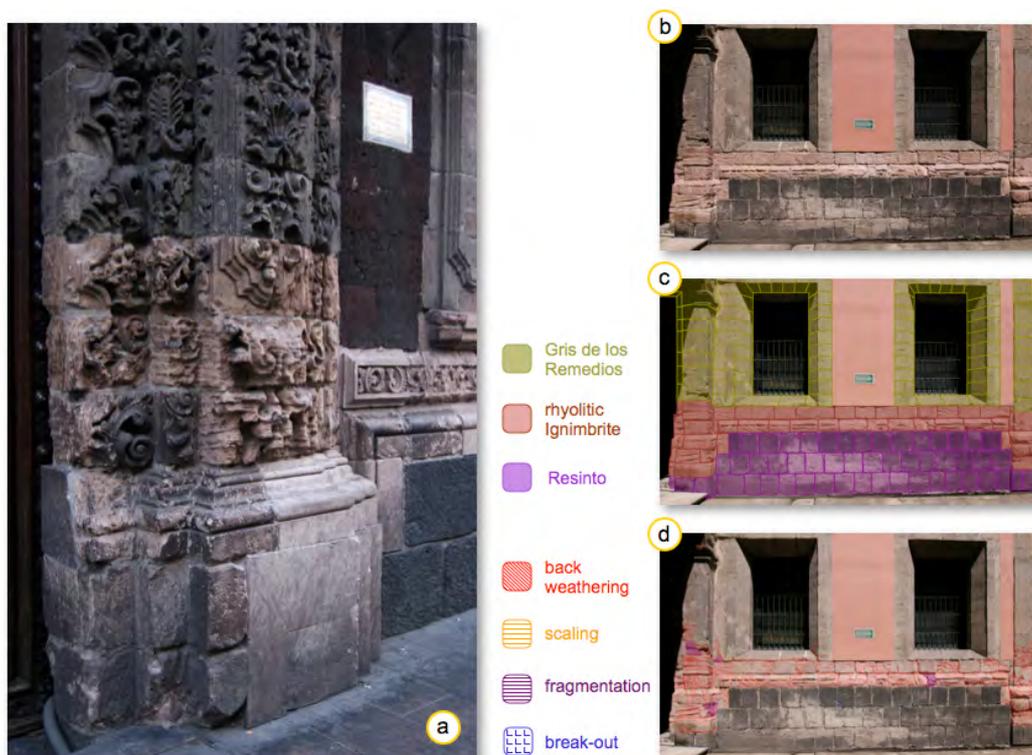
**Figure 48:** a) Weathered and replaced building stones at the ground level, b) mapping area, c) lithographic mapping, and d) map of damages.

Natural building stones were selected in colonial times not only because of their use for decoration but also for building construction purposes. This systematic construction also exemplifies the mapping of the pedestal area as well as the first floor of the Palace of Heras Soto (Fig. 48 c, d). Basalts like Recinto with a low capacity for water uptake and a high resistance towards hygric swelling were mostly used for the basement area followed by an array of an andesitic variety (Figs. 48 c, 5b). To this day the different basaltic varieties show almost no weathering.

bond of the matrix and the inclusions. Both components are closely connected. This bonding seems to be why we find no back-weathering of clastic material. Normally the clastic material weathers out. This is an often recognized phenomenon of many rhyolitic tuffs (Toeroek *et al.*, 2005) and is also found in different tuff varieties of Mexico, like for example in Guadalajara (Jáuregui, Wedekind 2009). Compositionally the stone is classified as an andesitic or trachytic andesitic tuff (Ordoñez, Ezequiel 1996). The tuff shows a low residual strain, but hair cracks or craquele, which are often found in sun-exposed surfaces of different Mexican tuff varieties, could not be observed. The field observations and the results of the investigations lead to the conclusion that hygric expansion probably in combination with the action of salt weathering is the main factor for the weathering of the tuff variety Gris de los Remedios. Salt efflorescences can often be recognized in combination with weathering phenomena and are an indicator for wet–dry conditions. This hypothesis is confirmed by the use of the tuff variety as a part of the architectural structure: The Remedios tuff was mainly used for architectural sculptures in areas that are not directly affected by water. In the tuff that was used for the ground floor in the Palace of Heras Soto weathering can be recognized. This part of the building is affected by wet–dry conditions (Fig. 48 c).

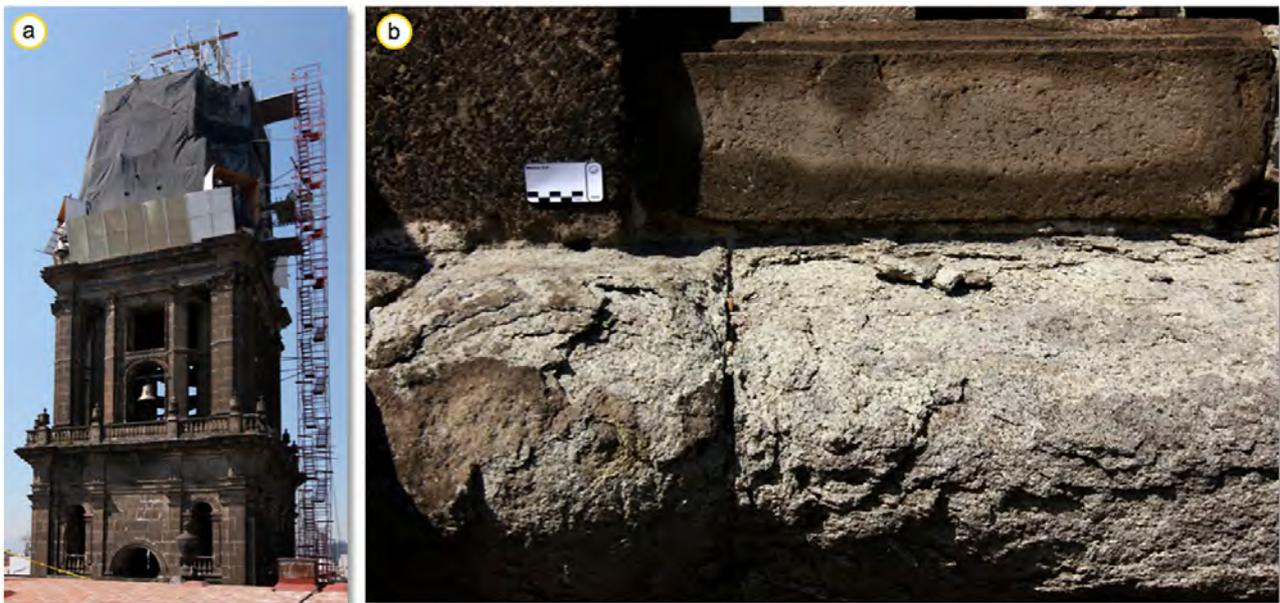
**Figure 49:** a) The left tower of the cathedral under restoration in 2009. b) Typical weathering forms consisting of gypsum crust formation, scaling and rounding of a sculpture at the Metropolitan Cathedral.

The deterioration of the Chiluca tuff starts with a rounding of the edges after the 15<sup>th</sup> cycle (Fig. 55). Later on, after the 45<sup>th</sup> cycle the splitting of a crust with a thickness of around 1.5 cm occurs. This starts at the upper area of the sample and leads to a stepwise reduction and rounding (Fig. 50). Similar weathering forms can be observed onsite at the cathedral and in several other palaces in Mexico City (Fig. 49).

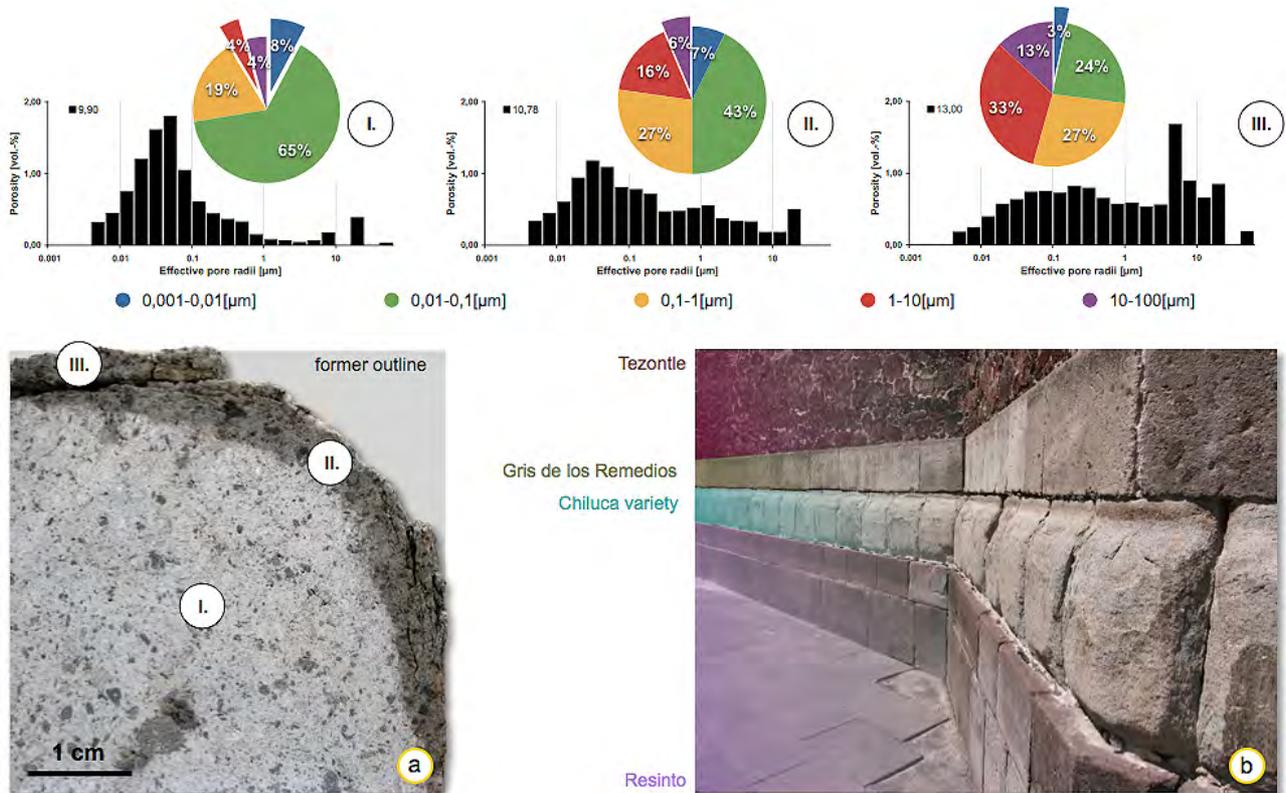
**Figure 50:** a) I, II and III depict changing pore radii distributions corresponding to the different zones of weathering. b) Truncated stone sample of pyroxene andesitic tuff from the Metropolitan Cathedral. c) Typical arrangement of the different rock types used in a historical building in Mexico City. Crust formation and rounding are visible in the Chiluca variety.

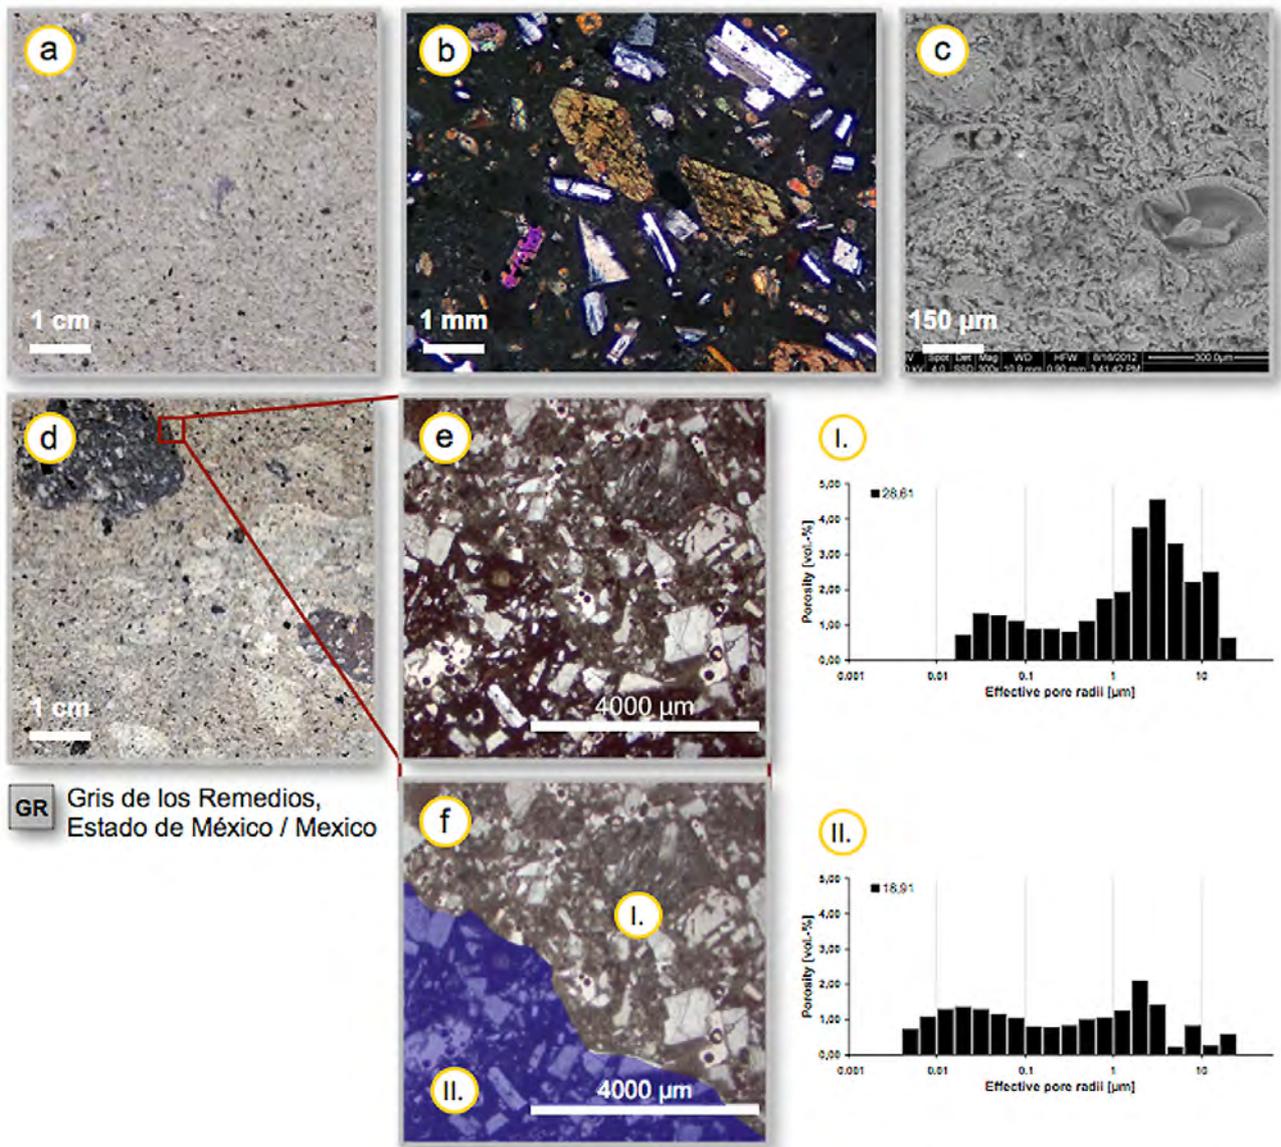
**Figure 53:** The Gris de los Remedios tuff: a) macroscopic view, b) thin section in polarized light shows altered minerals and compounds like crystalobalite, clays, sodium plagioclase and hornblende, c) SEM photograph shows the surface of the fabric, d) dark and light inclusions within the fine matrix, e) well welded matrix and inclusions (blue = dark inclusion) and f) I. pore size distribution of the matrix and II of a dark inclusion.

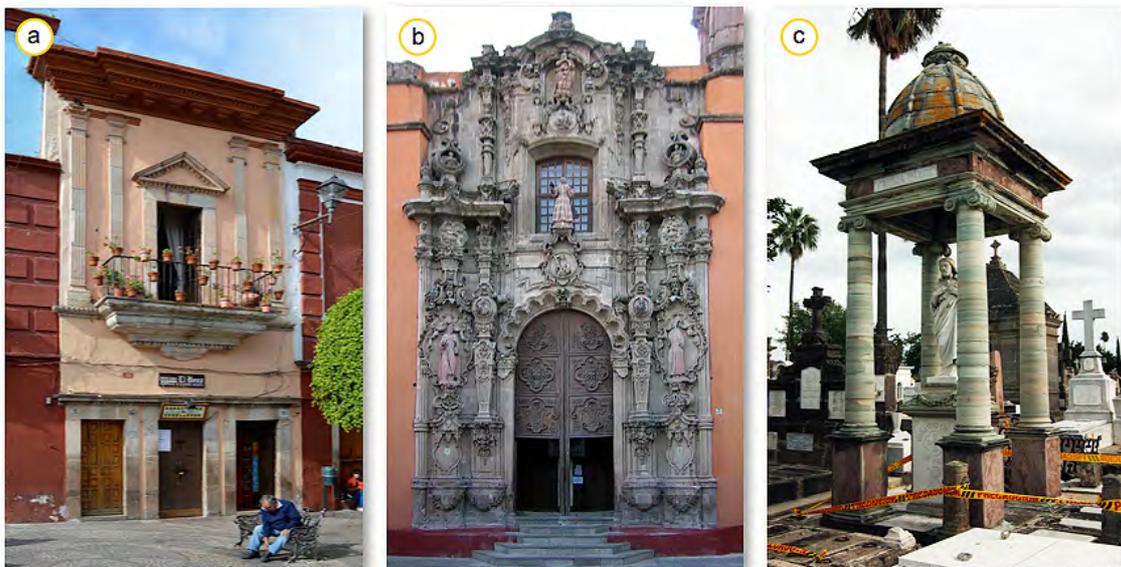
**Figure 58:** a) A 19<sup>th</sup> century house in the historical city of Guanajuato with decorative parts made from Loseros Tuff. b) The portal of the San Diego Church in Guanajuato mainly made from Bufa Tuff c) Monumental tomb at the Mazquitlan Cemetery in Guadalajara made from Loseros Tuff.

When the Loseros Tuff is cut along the lamination (X-axis), or it is finely reworked perpendicular to the lamination it is used as fine masonry for many important cultural, religious and governmental buildings as well as for decoration elements of ordinary houses (Fig. 58 a). In the nineteenth century and early twentieth century the Loseros Tuff was widely used as a popular material especially for tomb monuments in central Mexico. Examples can be found in Guadalajara (Fig. 58 c) as well as in Mexico City.

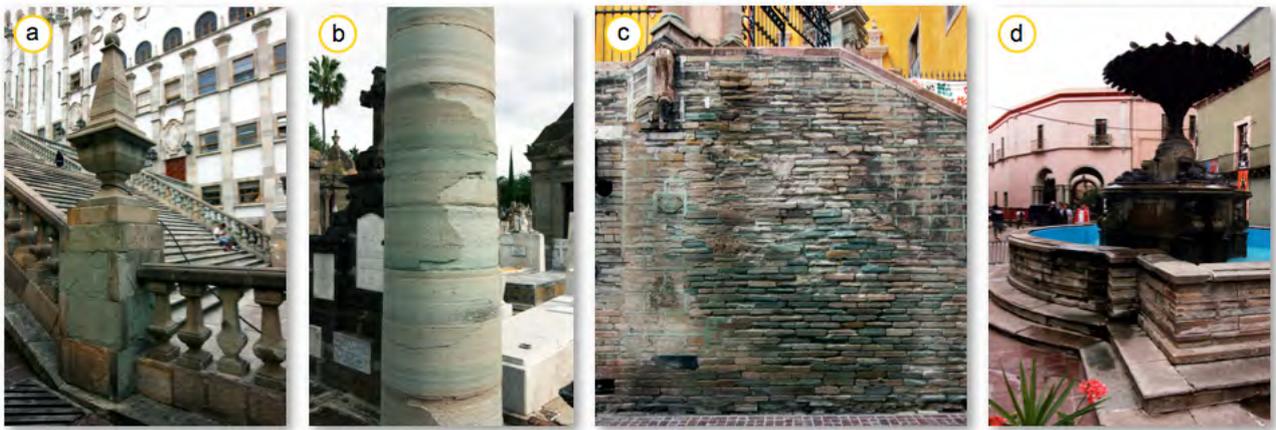
**Figure 59:** Appearance of the different damage and deterioration types observed in the Loseros Tuff. a) Delamination at the stairway of the main building of the university. b) Contour scaling perpendicular to the lamination at a column of a tomb in Guadalajara. c) Flaking and crumbling in the lower part of a wall affected by moisture infiltration and d) at a basin wall of a fountain in Guanajuato.

Although both volcanic rocks are widely used, they show significant deterioration and weathering effects, first of all by delamination (Fig. 59 a), contour scaling (Fig. 59 b), and crumbling (Fig. 59 c and d). These destructive phenomena are mostly found in areas of the building where moisture and water are permanently or temporarily present like in columns, fountains, balconies or external staircases.
