WEATHERING AND CONSERVATION OF MONUMENTS  
CONSTRUCTED FROM TUFF AND SANDSTONE  
IN DIFFERENT ENVIRONMENTAL CONDITIONS

Case Studies from Mexico, Germany, Jordan and Cambodia

Dissertation

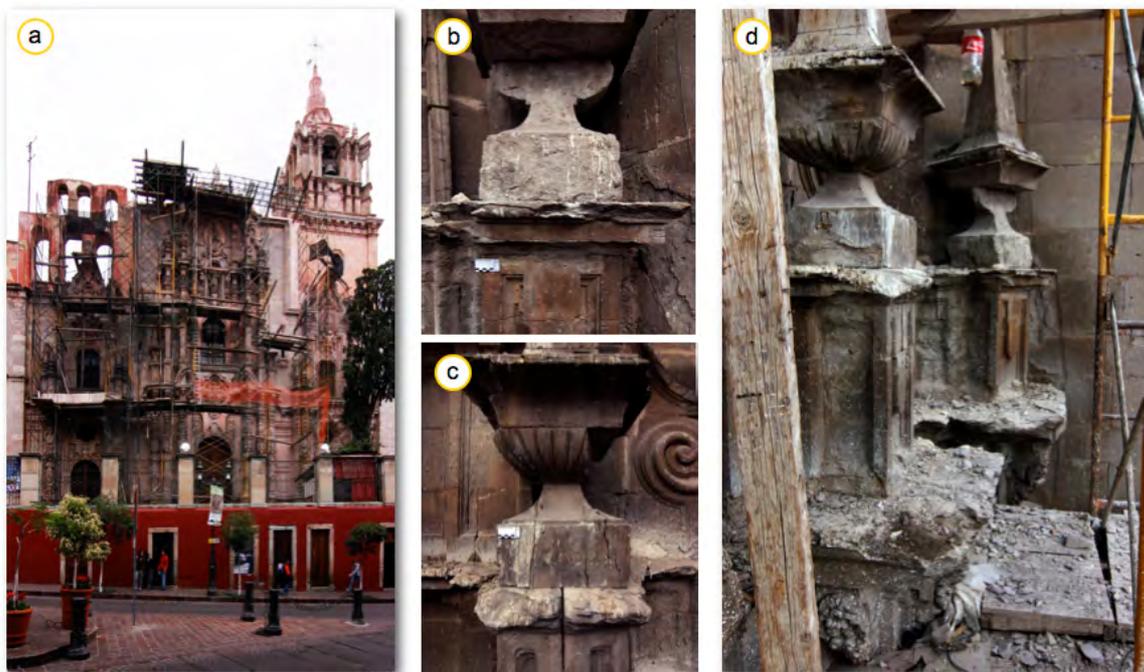
**Figure 59:** Appearance of the different damage and deterioration types observed in the Loseros Tuff. a) Delamination at the stairway of the main building of the university. b) Contour scaling perpendicular to the lamination at a column of a tomb in Guadalajara. c) Flaking and crumbling in the lower part of a wall affected by moisture infiltration and d) at a basin wall of a fountain in Guanajuato.

These weathering forms can be observed at some buildings in Guanajuato as well as in an extreme form in Guadalajara, where the stone was used for tomb monuments (Fig. 59 a and b).

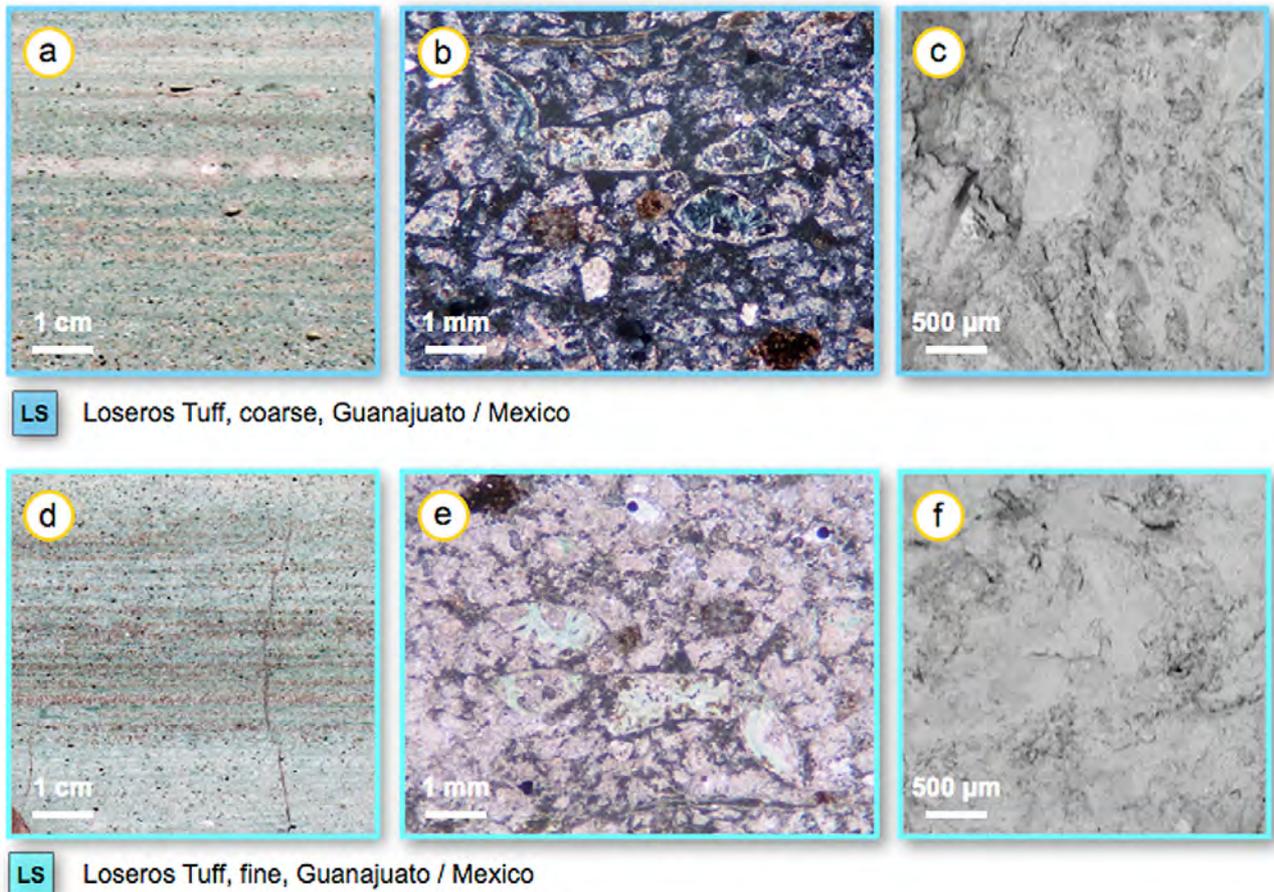
**Figure 62:** a) Macroscopic view of the coarse Loseros Tuff. b) Thin section in polarized light and c) overview under the SEM. d) Macroscopic view of the fine-grained Loseros Tuff. e) Thin section and f) overview under the SEM.

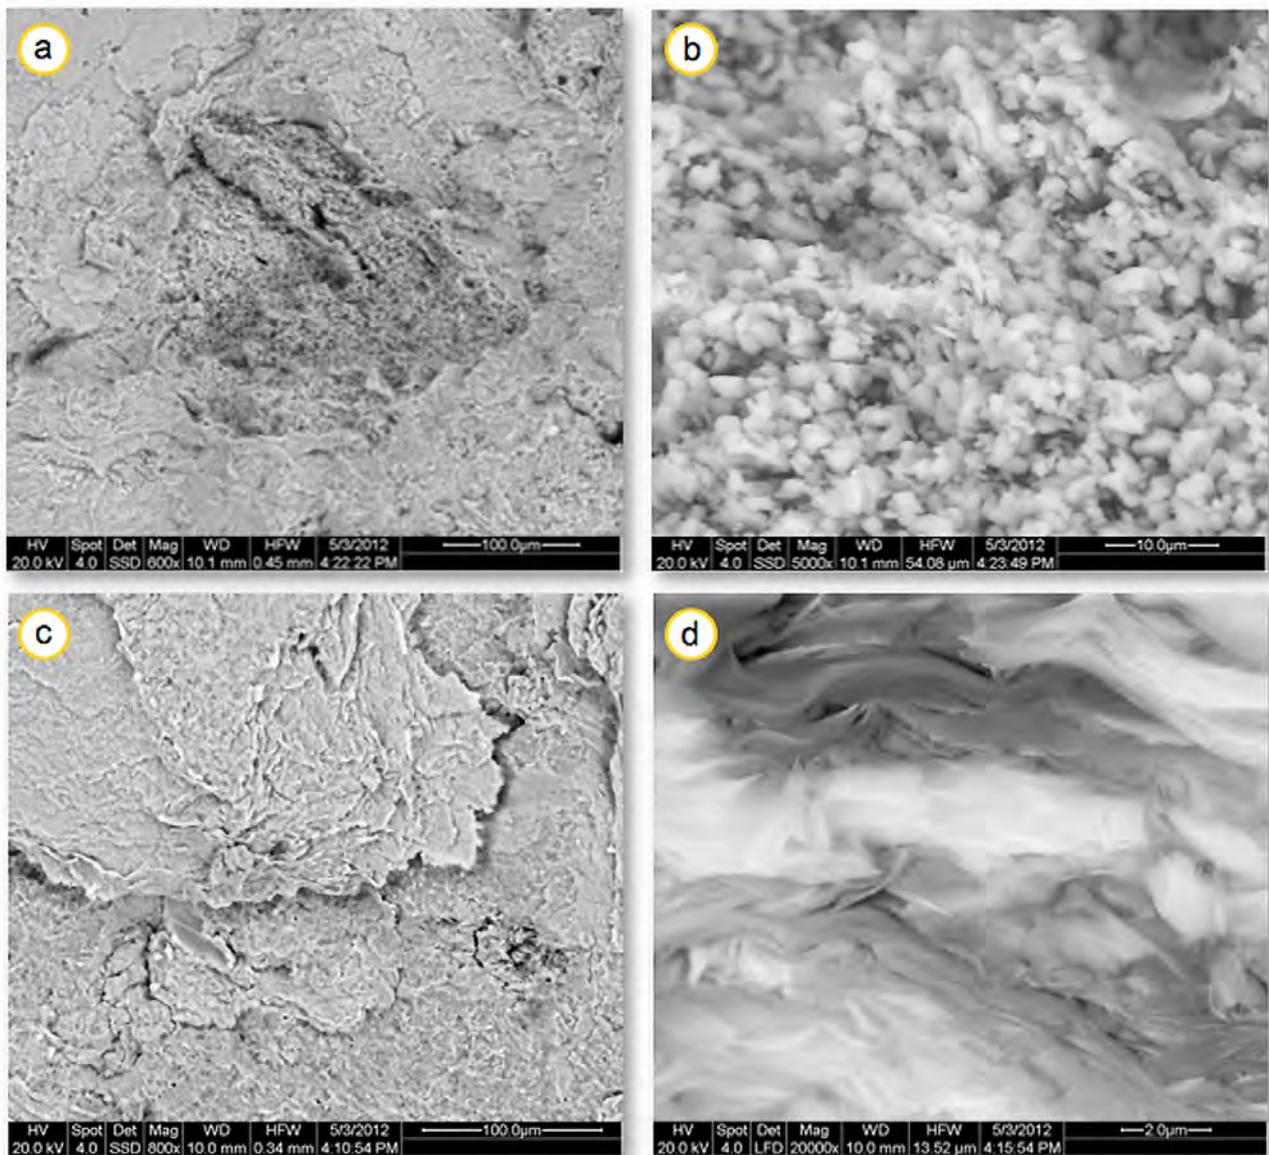
**Figure 64:** a) Typical large pore of relict crystals in the finer tuff embedded in a dense matrix as observed under SEM. b) Tenfold magnification of the central region indicates the presence of very fine-grained albite crystals. c) Clay minerals (illite–smectite) are densely packed and d) identified under high magnification.

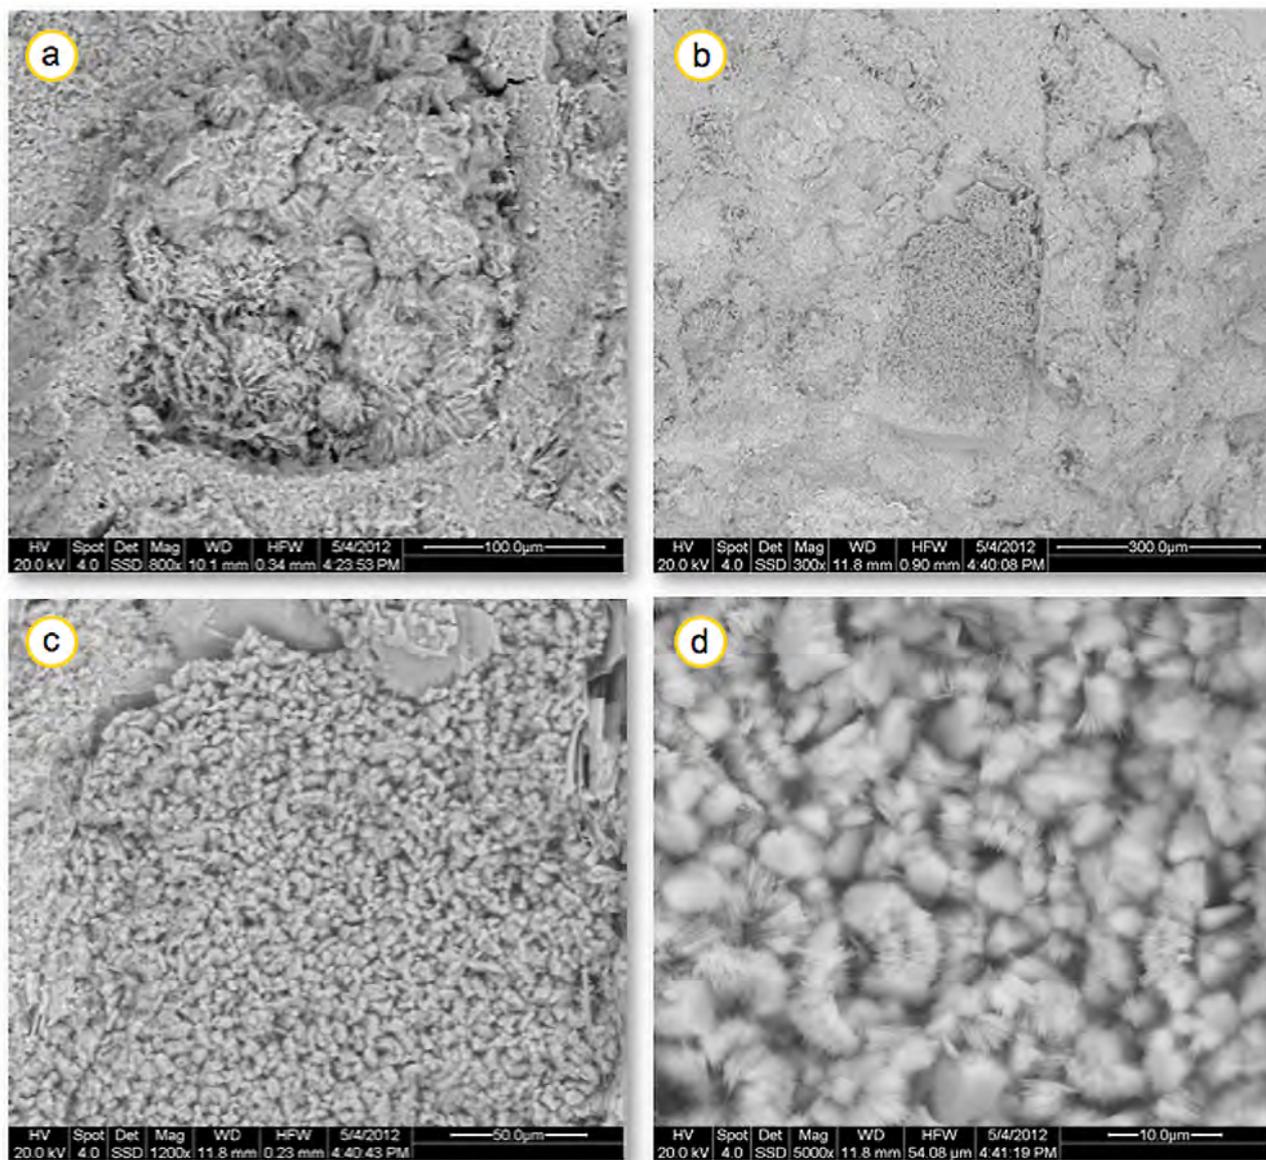
**Figure 65:** a) Larger pore with plenty of relict crystals or zeolites in the coarser tuff embedded in a dense matrix as observed under SEM. b) Feldspar crystal showing kaolinisation and c) the kaolinite booklets. d) Booklets in detail.

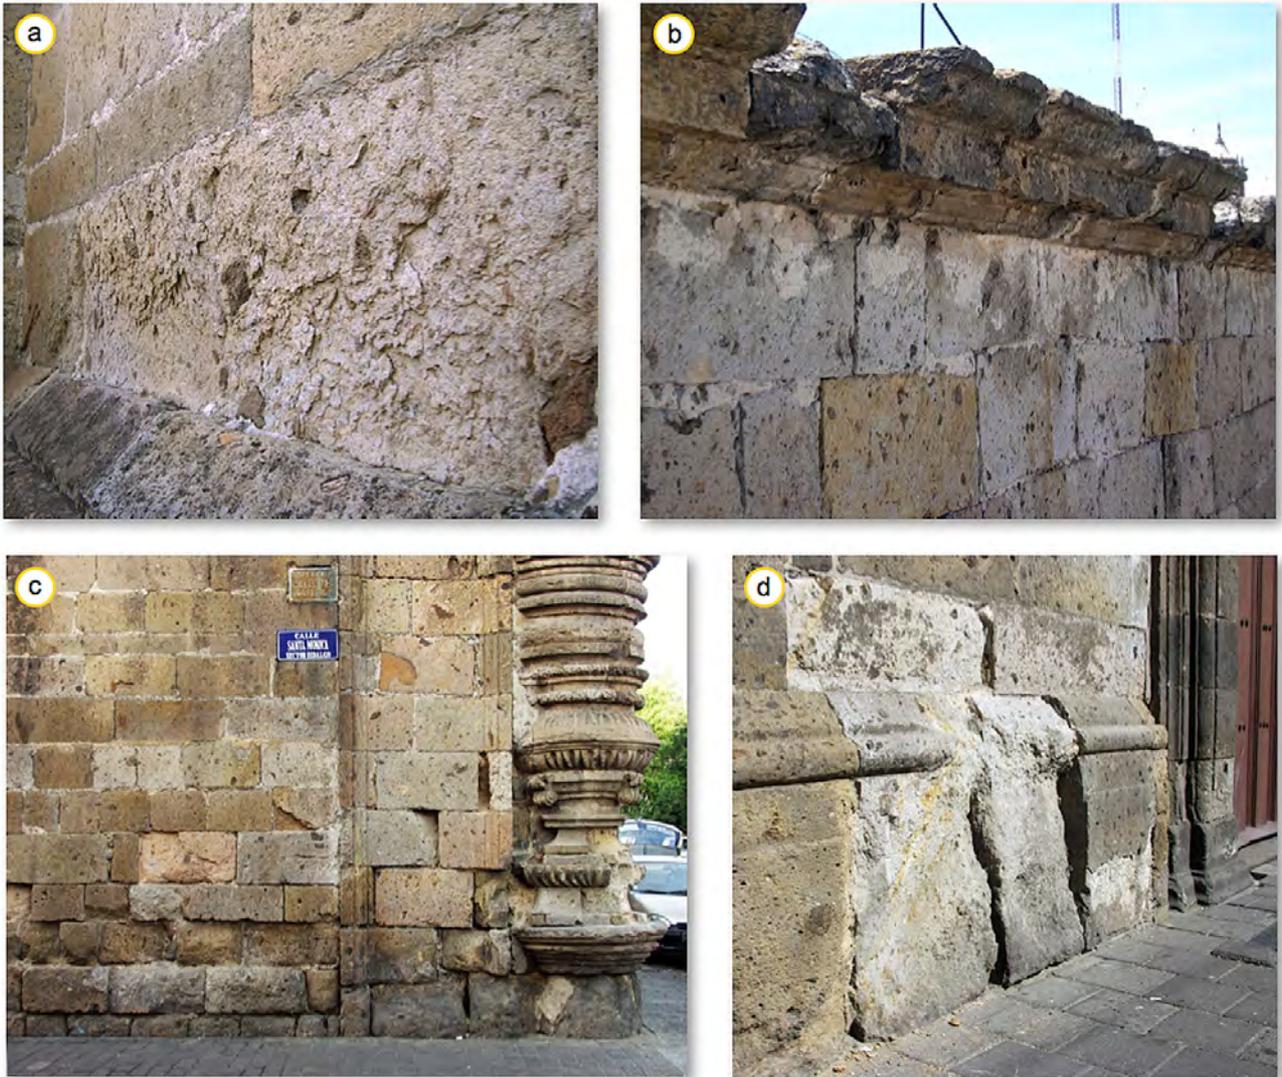
**Figure 77:** Typical weathering forms of the Cantera Amarilla Tuff, a) shows structural flaking and disaggregation, b) broken areas and crack formation, c) massive back-weathering at the foundation (Santa Mónica Church) and d) material loss due to crust formation and weathering (Museo Regional).

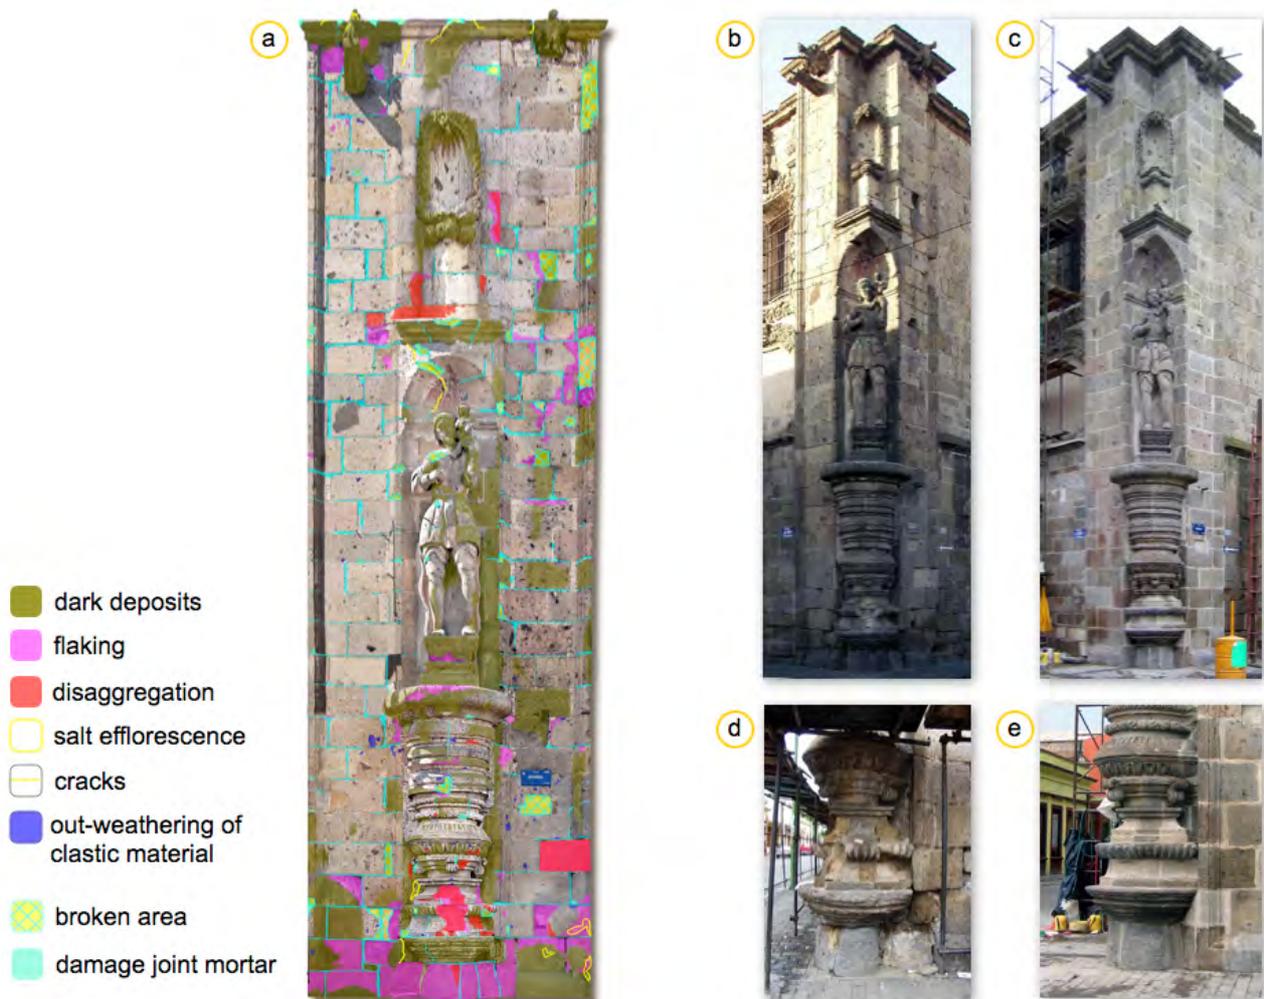
**Figure 78:** a) Mapping of the main pillar of the Santa Mónica Church. b) The pillar before and c) after restoration. d) Podium zone of the statue of St. Christopher before and e) after restoration.

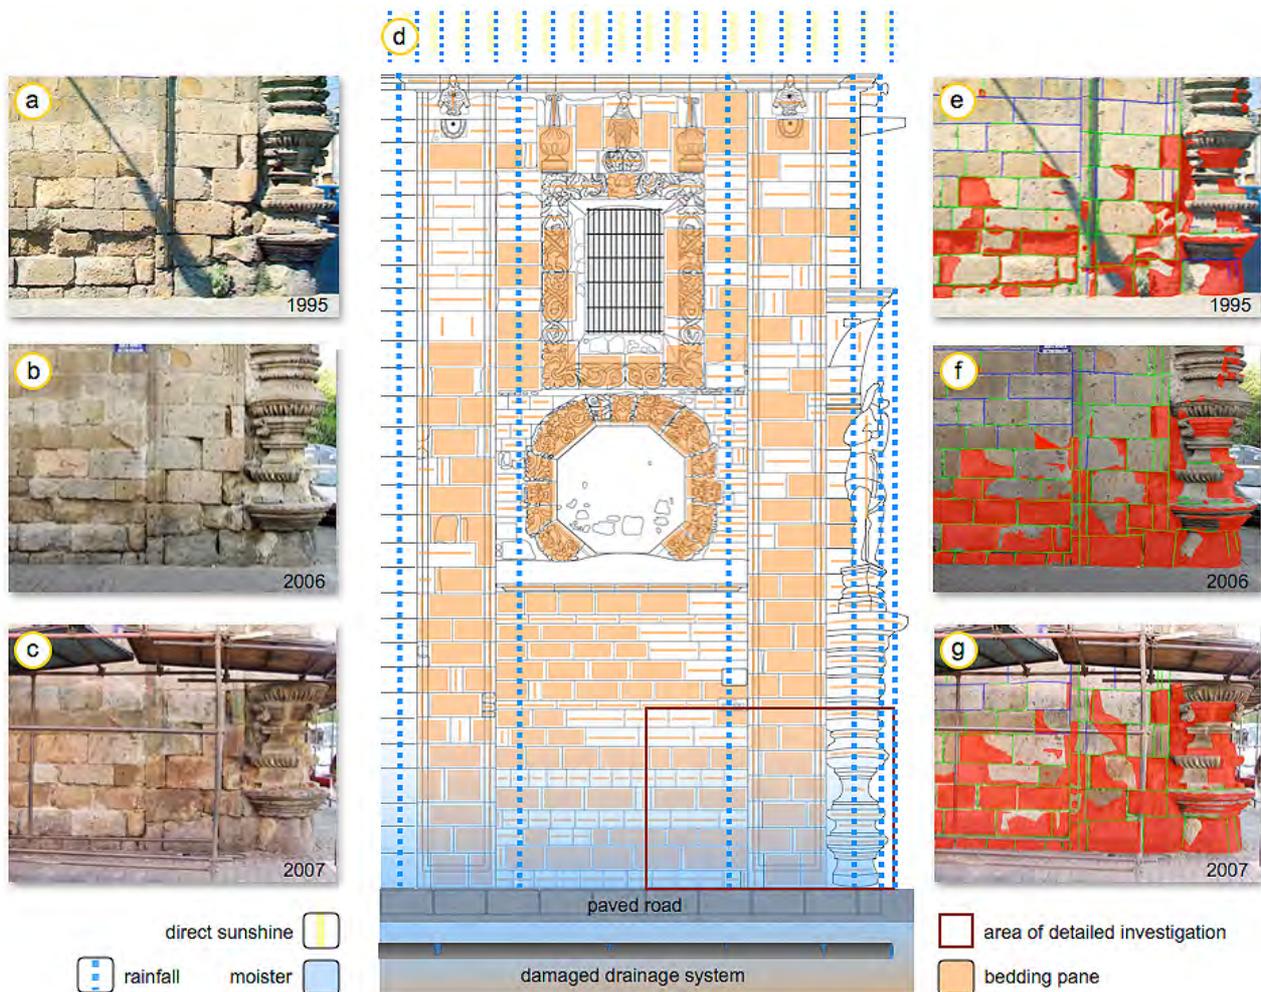
**Figure 79:** Weathering and weathering model of the Santa Mónica Church. a-c) The weathering situation at the edge of the building (lower part) from 1995 until 2007 before the restoration began. d) Weathering model of the building as defined by water infiltration coming from the damaged drainage system during the rainy season and direct sunshine. e - g) Depiction of the ongoing surface loss (red), lost joints (green) or damaged joints (blue).

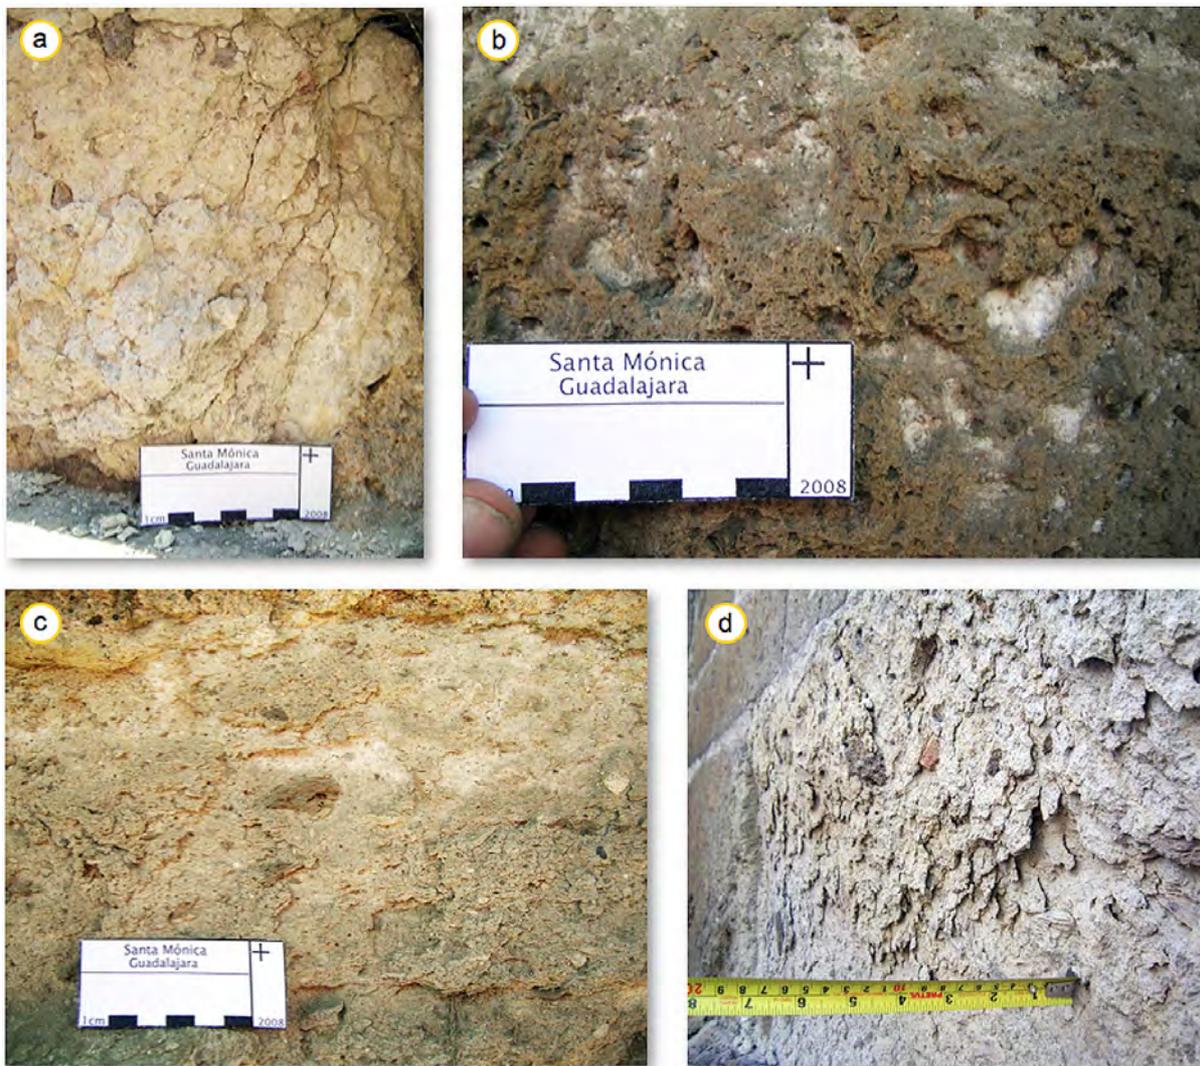
**Figure 80:** Close-ups of the typical weathering forms of the Cantera Amarilla Tuff show a) internal crack formation and crumbling, b) alveolar weathering clearly related to salt, c) flaking also related to salt accumulation as well as d) structural flaking.

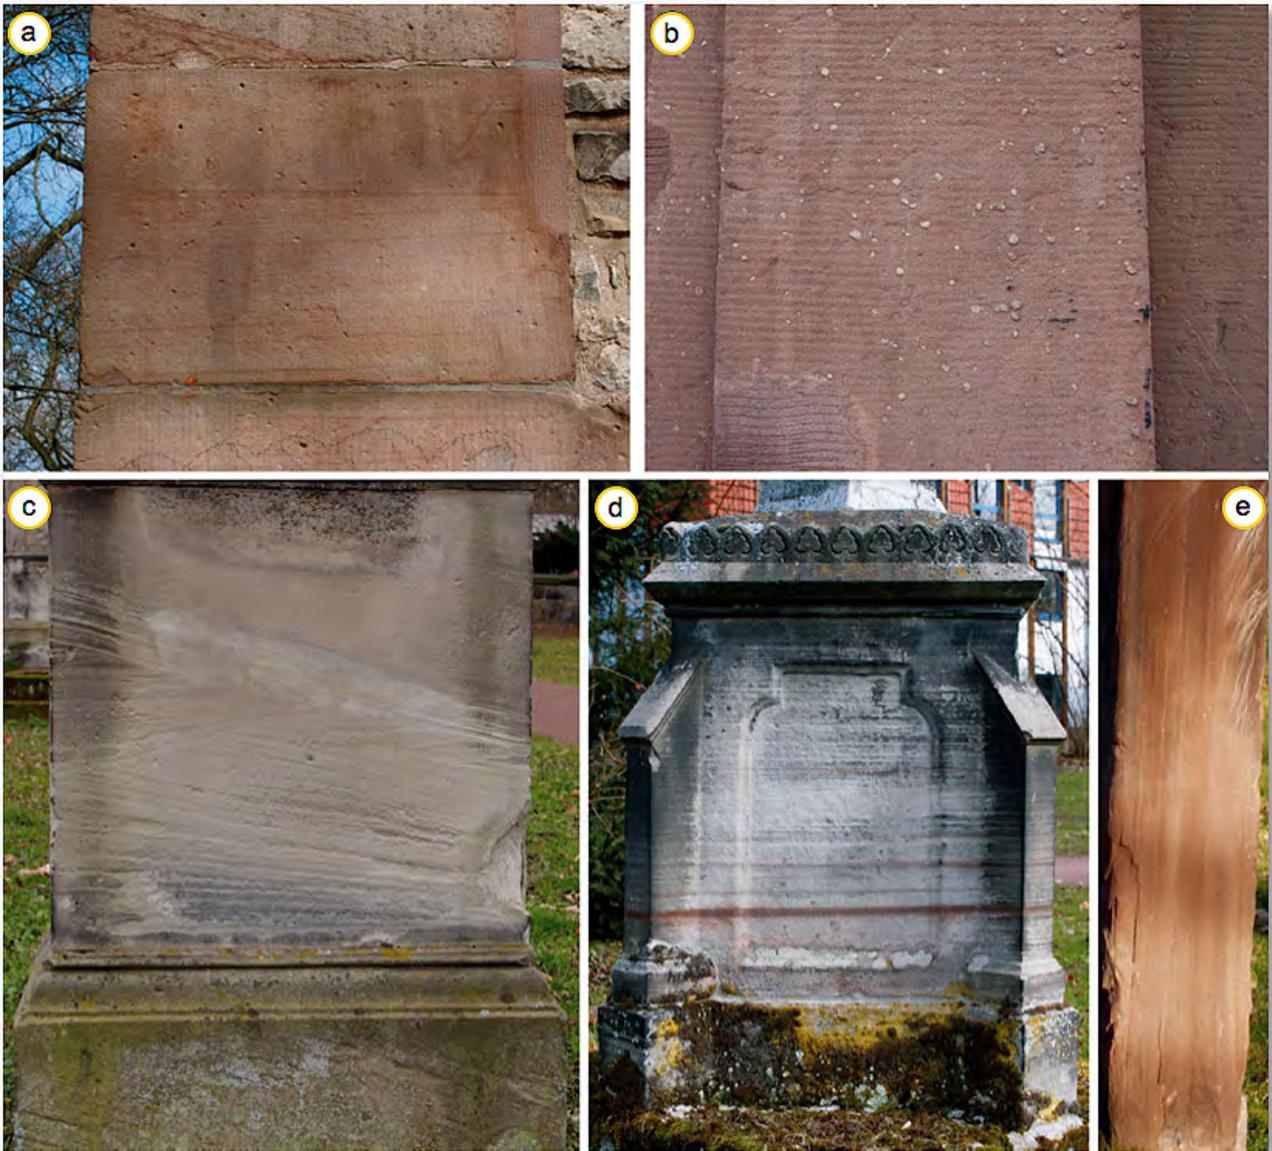
**Figure 90:** Characteristic sandstone materials of the Bartholomew Cemetery in Goettingen: a) coarsely bedded red sandstone, b) massive red sandstone with white nodules, c) massive gray sandstone with cross-bedding, d) finely bedded sandstone with red-gray interbedded strata and e) finely bedded red sandstone.

The construction material predominately used for the tombs at the Bartholomew Cemetery is the highly porous Bunt-sandstone (Fig. 90). Here, the rocks of the Solling Formation of the Middle Buntsandstein are especially significant. The Middle Bunt-sandstone is generally divided into four sequences: the Volpriehausen-, Detfurth-, Hardeggen- and Solling and consist of siliciclastic deposits originating from the Germanic Basin. Sedimentation of this deposit continued after the Variscan Orogeny in the Upper Carboniferous (Bachmann, Hoffmann 1997).

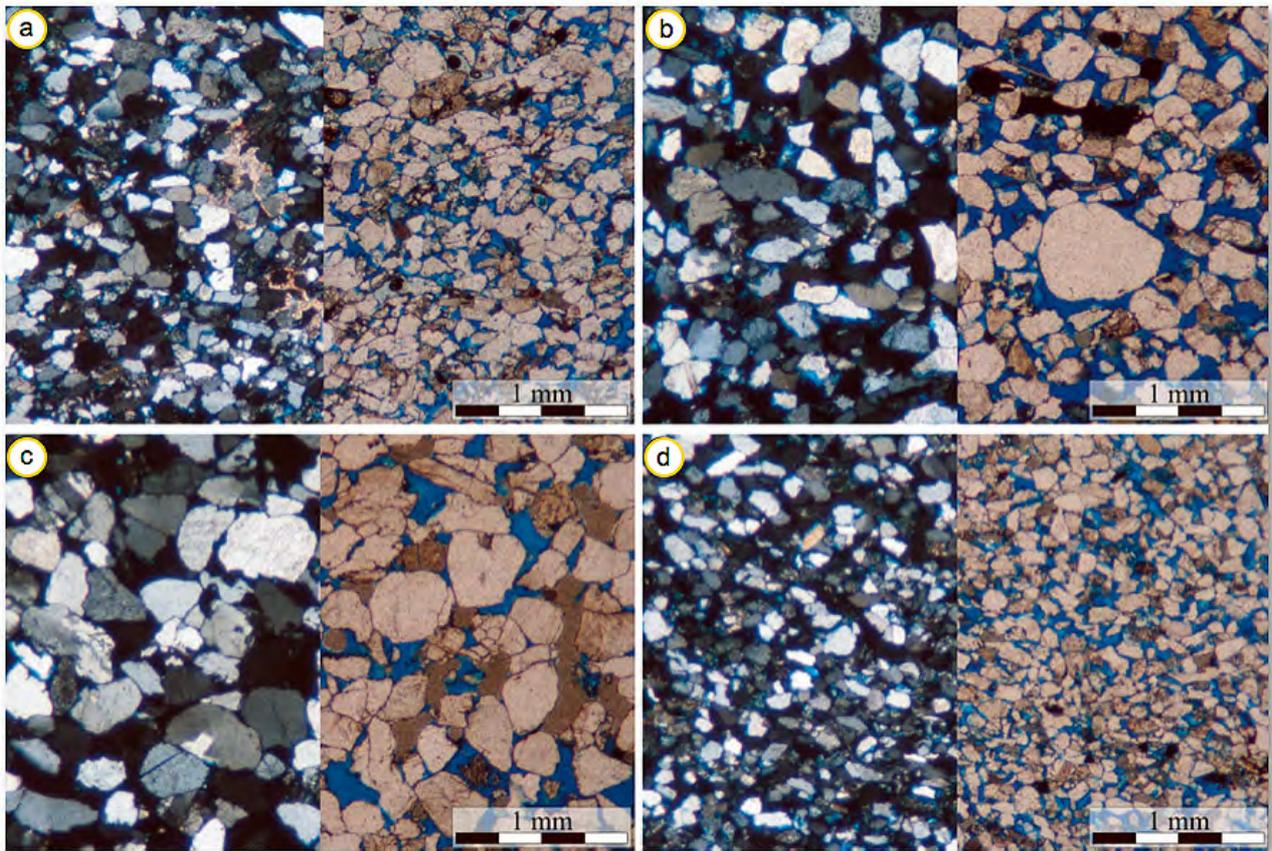
**Figure 91:** Microstructure of the sandstones under linear polarized (right) and crossed polarized conditions (left): a) sandstone of Arenshausen with relict carbonate cements (left); b) sandstone of Appenrode with partly non-uniform sorting and solidification; c) sandstone of the Johannis Church Goettingen showing tectonized quartz grains and a partly high content of lithoclasts (right); d) fine-grained sandstone of Reinhausen with alignment of grains parallel to the bedding and some relict carbonate cement.

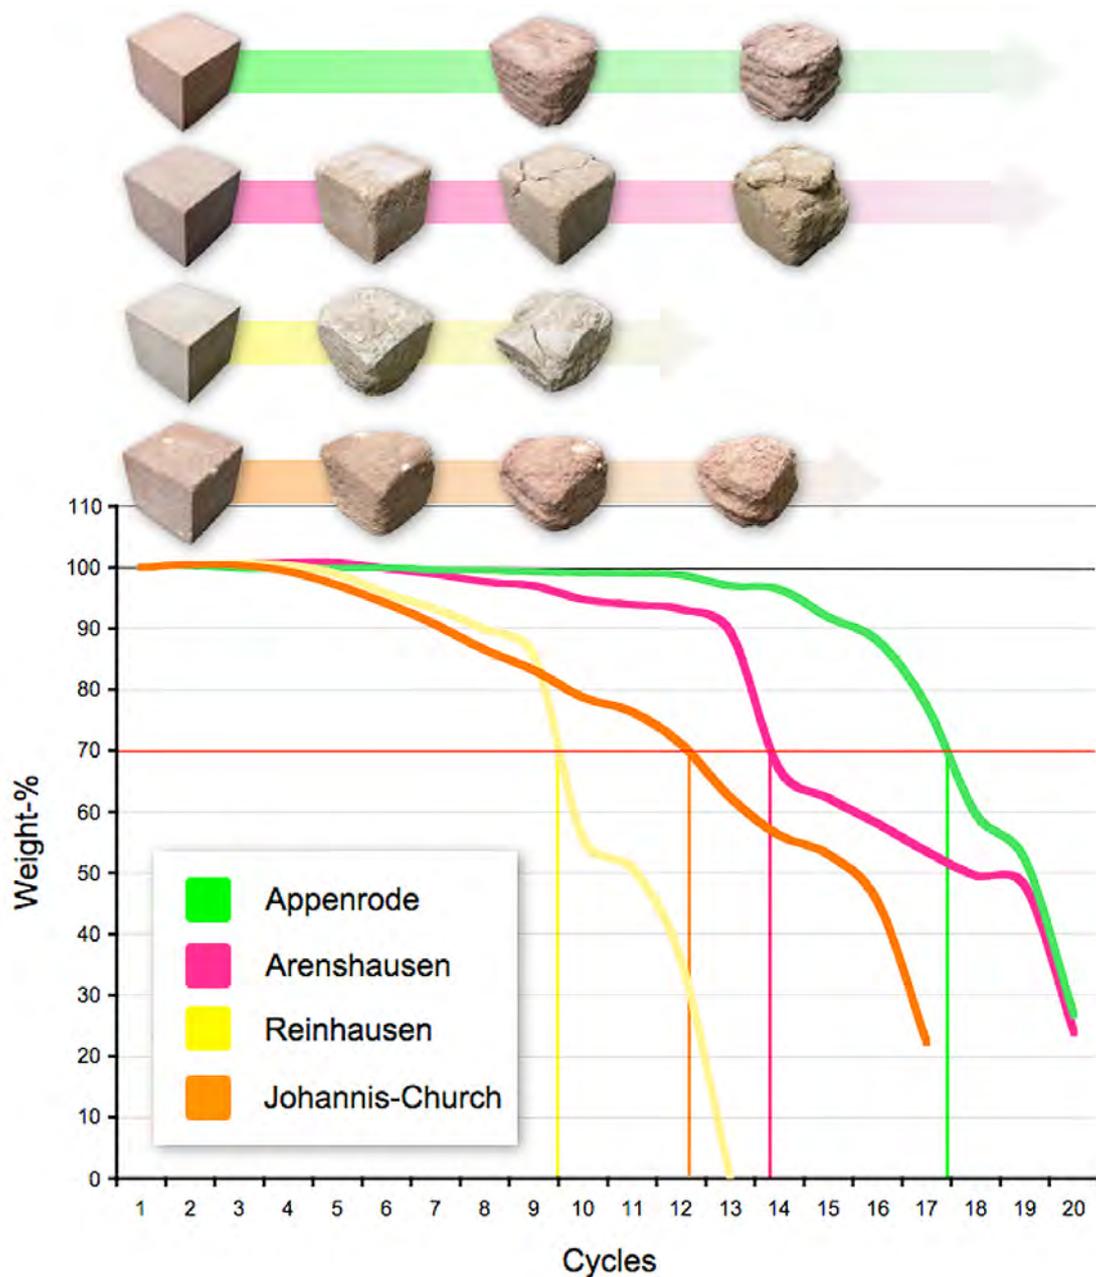
**Figure 92:** Salt bursting test of the Goettingen sandstones.

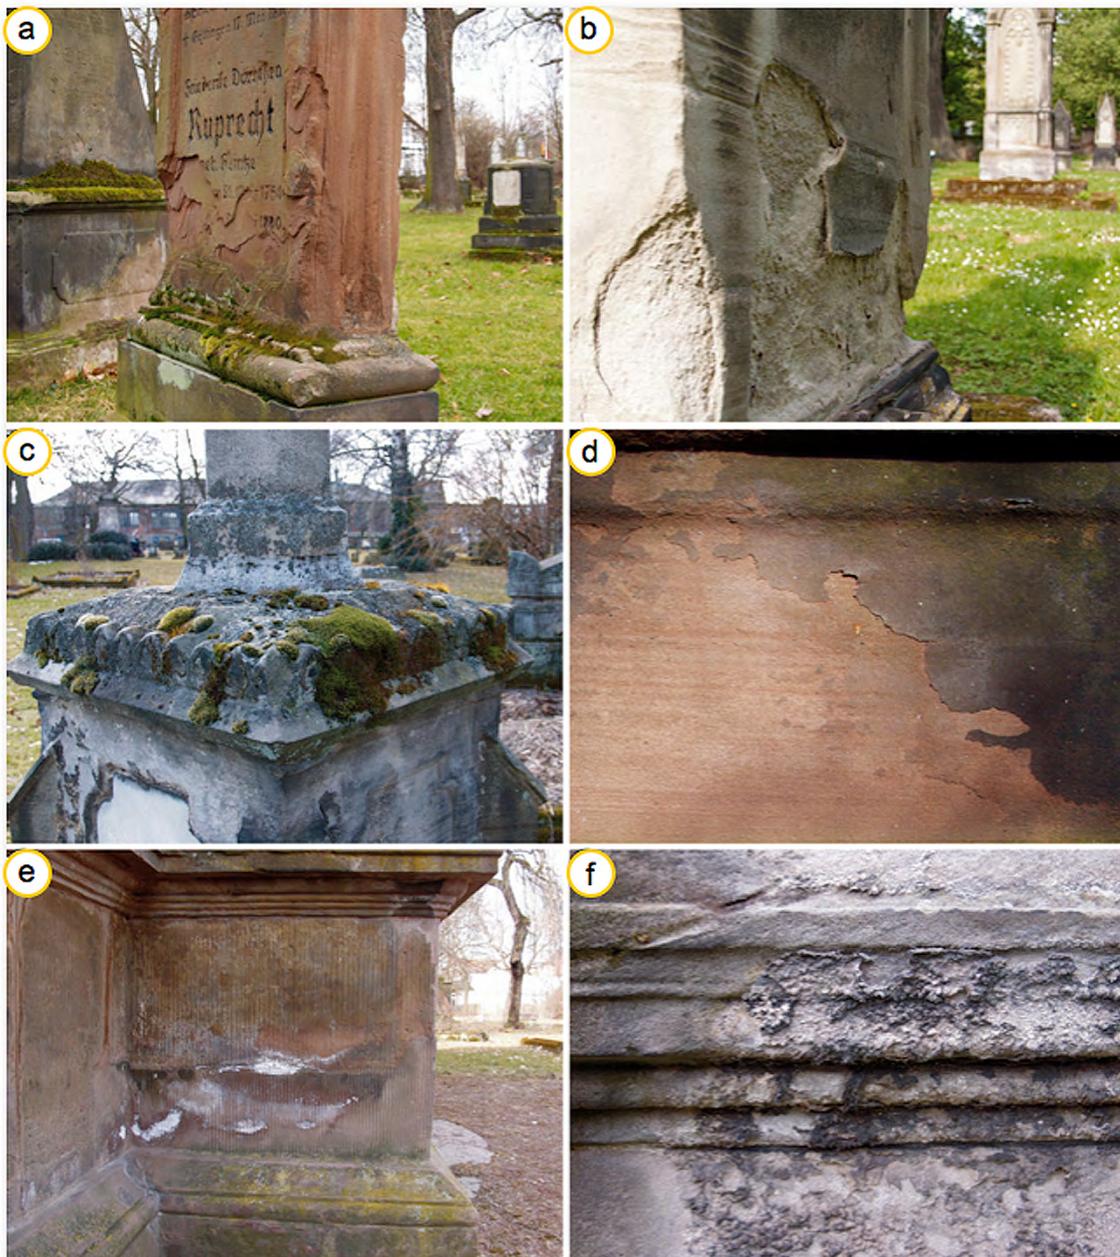
**Figure 93:** Typical weathering forms of the sandstones from the Bartholomew cemetery in Goettingen: a) scaling parallel to the bedding; b) contour scaling perpendicular to the bedding with secondary detachment of small flakes; c) biological colonization; d) flaking combined with black crusts; e) salt efflorescences; and f) formation of gypsum crusts.

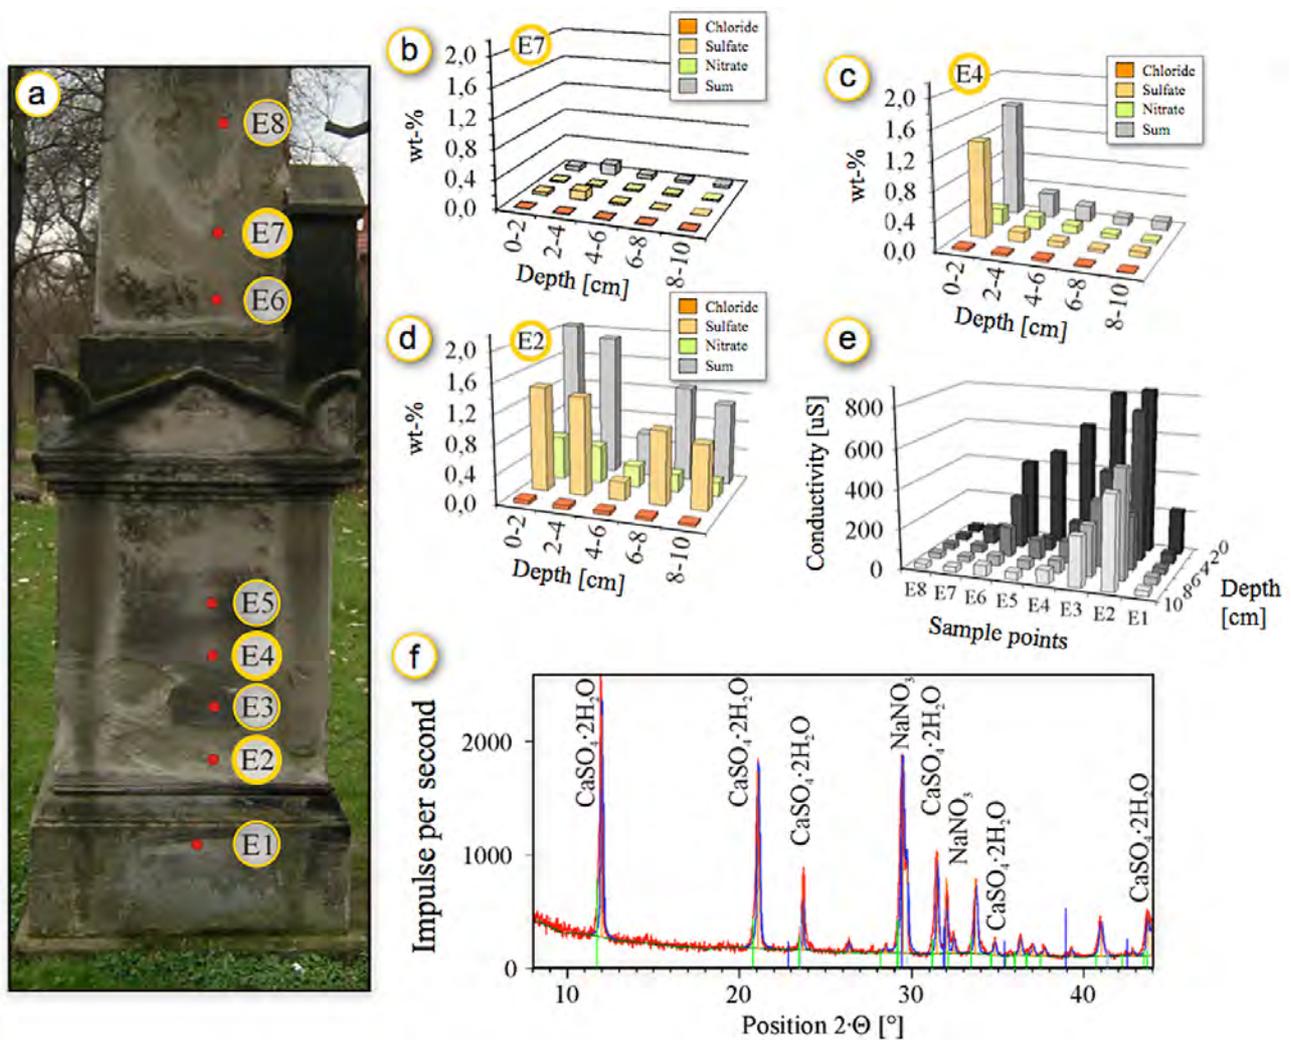
**Figure 94:** Salt-induced weathering on the Adolf Ellissen Tomb: a) sample points; b-d) ion chromatograph analyses; e) conductivity analyses and f) x-ray diffractometer analyses.

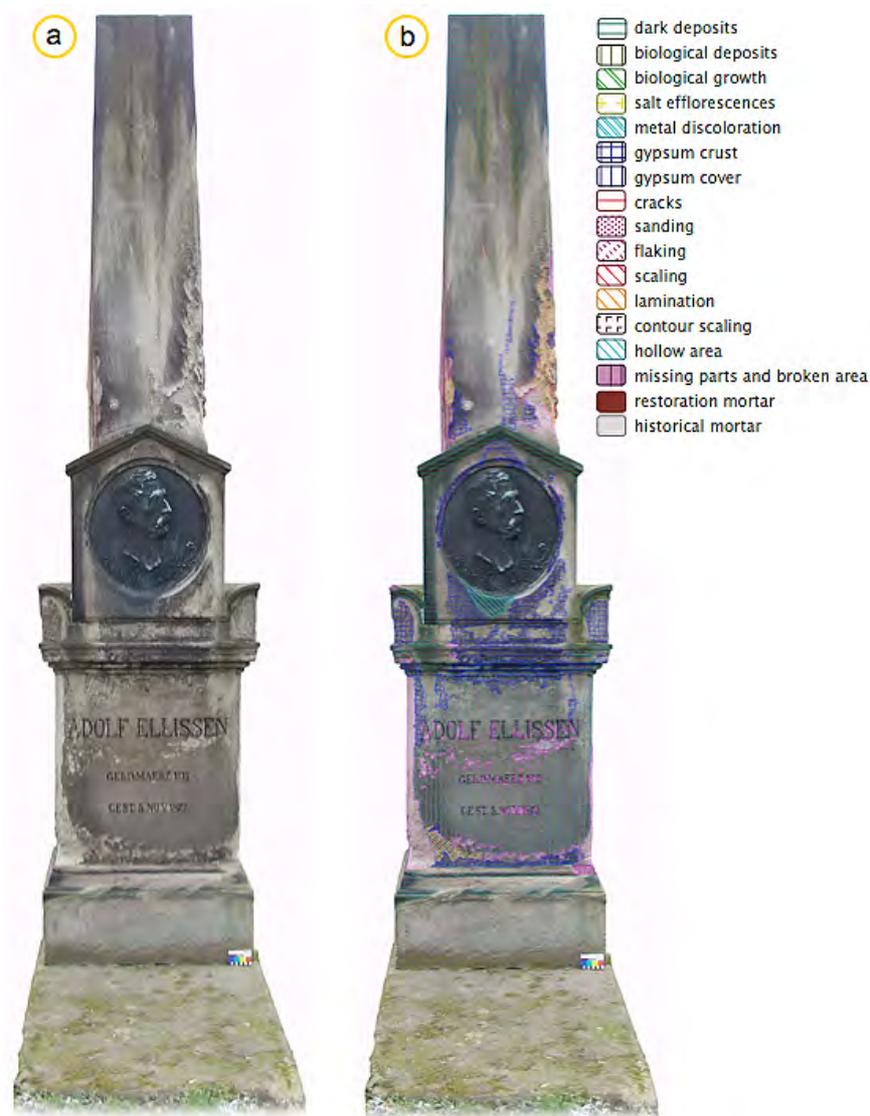
**Figure 95:** The Ellissen-Tomb. a) The tomb before conservation/restoration. b) Damage mapping of the tomb.

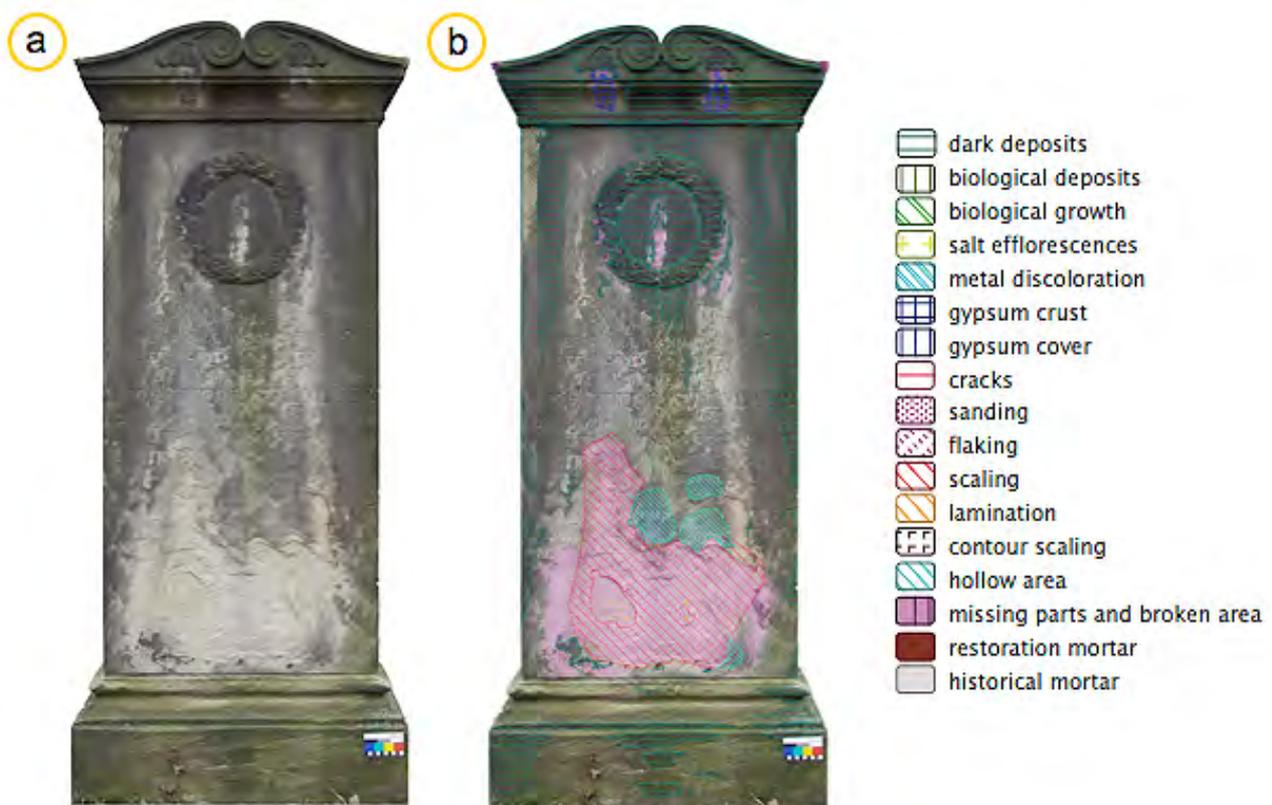
**Figure 96:** a) The Strohmeyer Tomb before conservation/restoration and b) damage mapping.

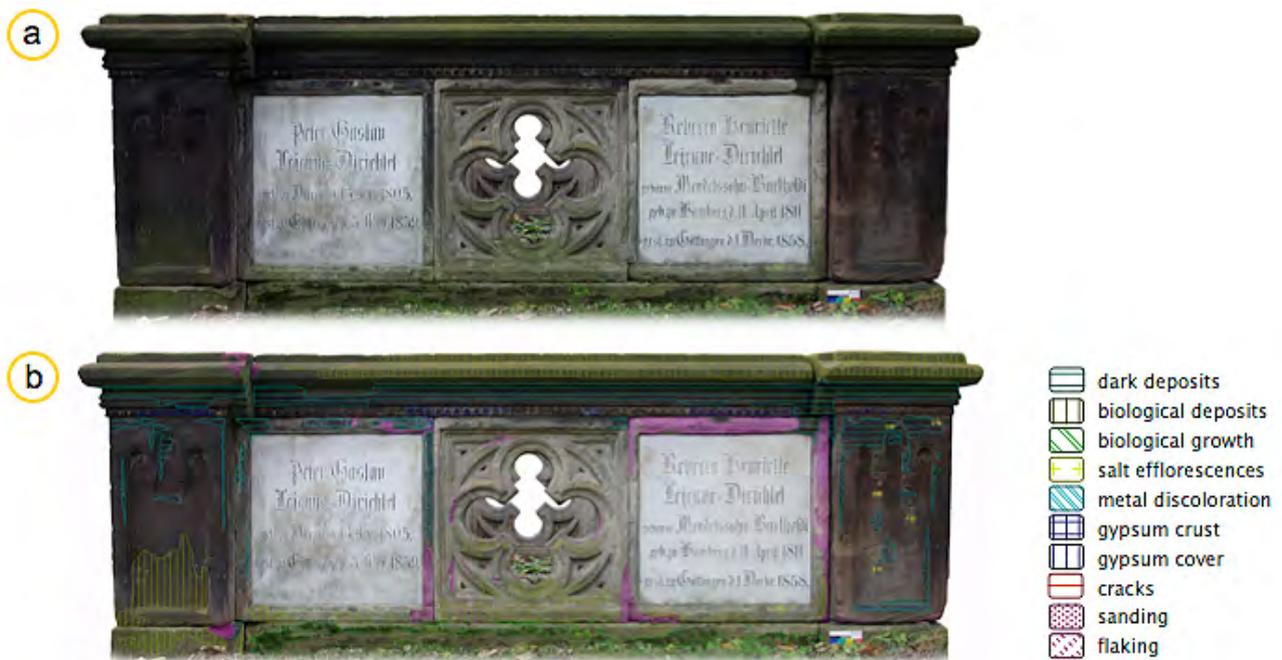
The Lejeune-Dirichlet Tomb is a balustrade tomb built using a rectangular floor plan with dimensions of 4 by 4 meters and a height of 1.20 m. It was erected after 1859 and built using a light sandstone similar to the Reinhausen variety and the red sandstone of Appenrode. The main weathering form found is sanding (Fig. 97).

**Figure 97:** a) The Lejeune-Dirichlet Tomb before conservation/restoration and b) damage mapping.

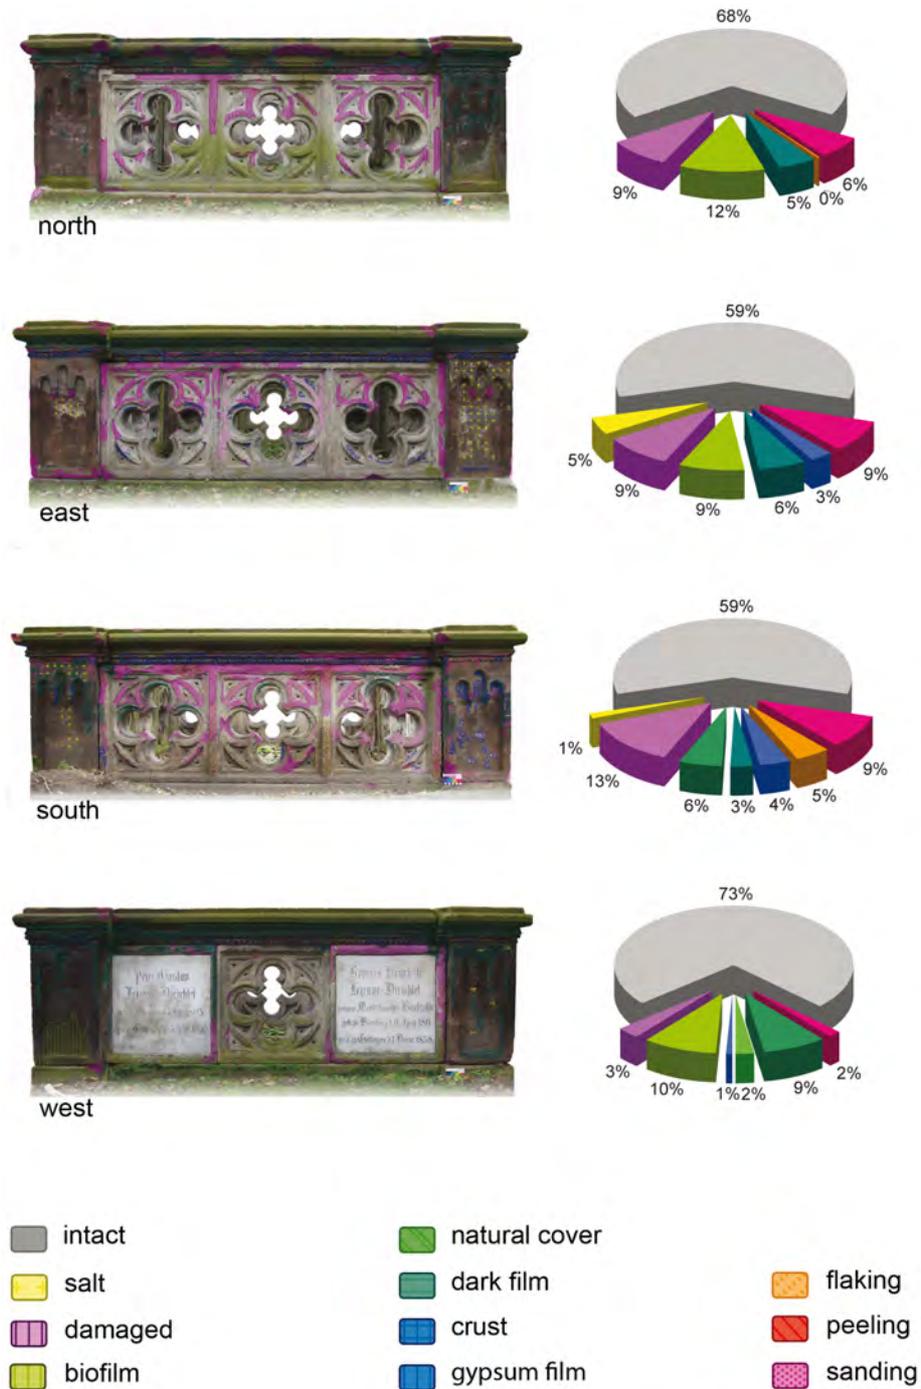
**Figure 101:** Quantitative mapping of all sites of the Lejeune-Dirichlet tomb.
