WEATHERING AND CONSERVATION OF MONUMENTS  
CONSTRUCTED FROM TUFF AND SANDSTONE  
IN DIFFERENT ENVIRONMENTAL CONDITIONS

Case Studies from Mexico, Germany, Jordan and Cambodia

Dissertation

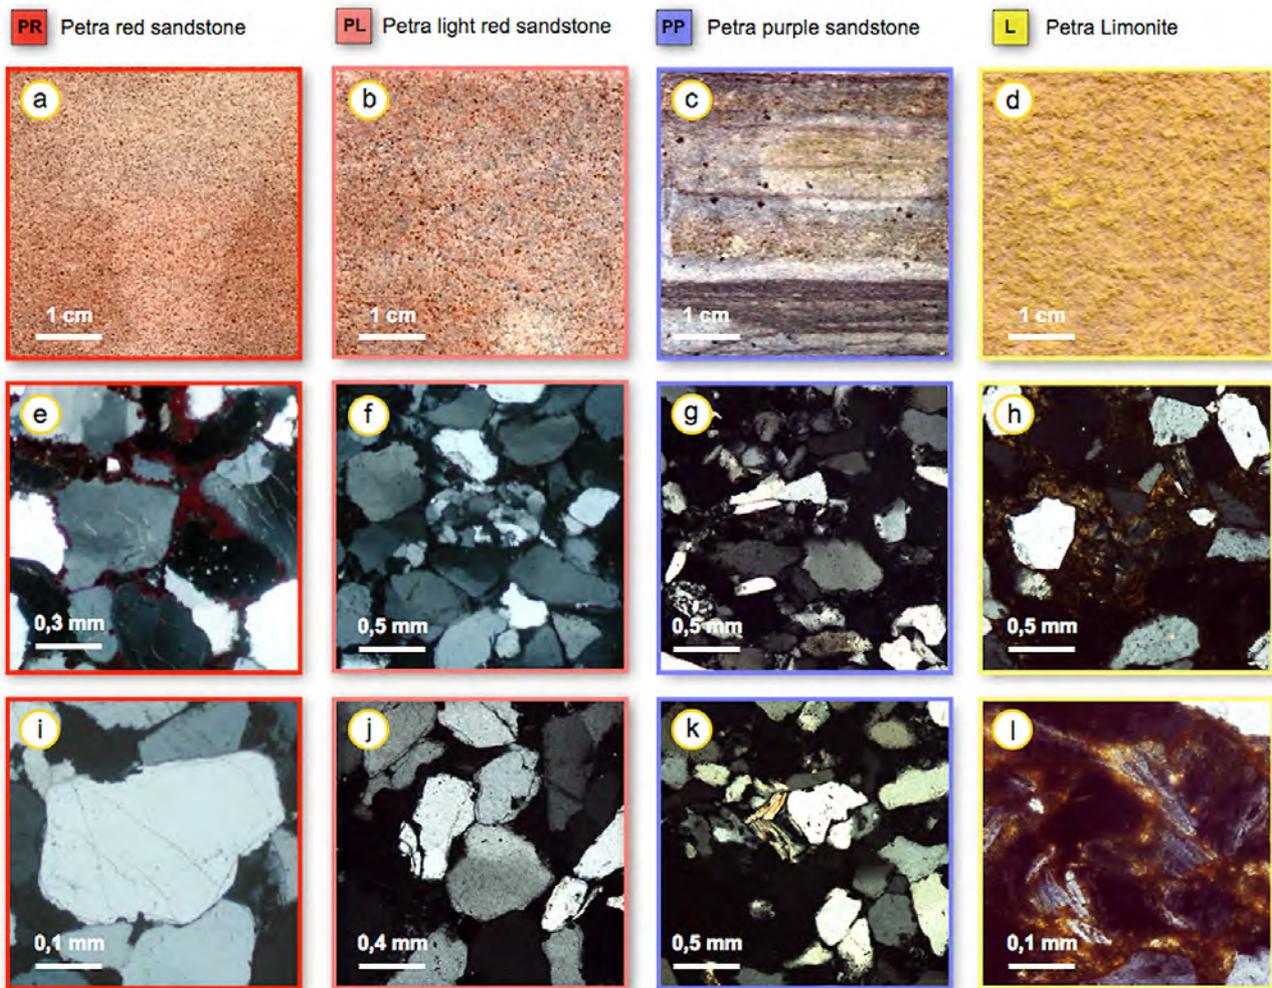
**Figure 106:** a) a-d) macroscopic images of the different sandstones, a) the PL Petra light red sandstone, b) the Petra red sandstone, c) the Petra purple sandstone and d) the Petra limonite. e-l) Thin sections images in polarized light. e & i) the PL sandstone, f & g) the PR sandstone, g & k) the PP sandstone and h & l) the L limonite.

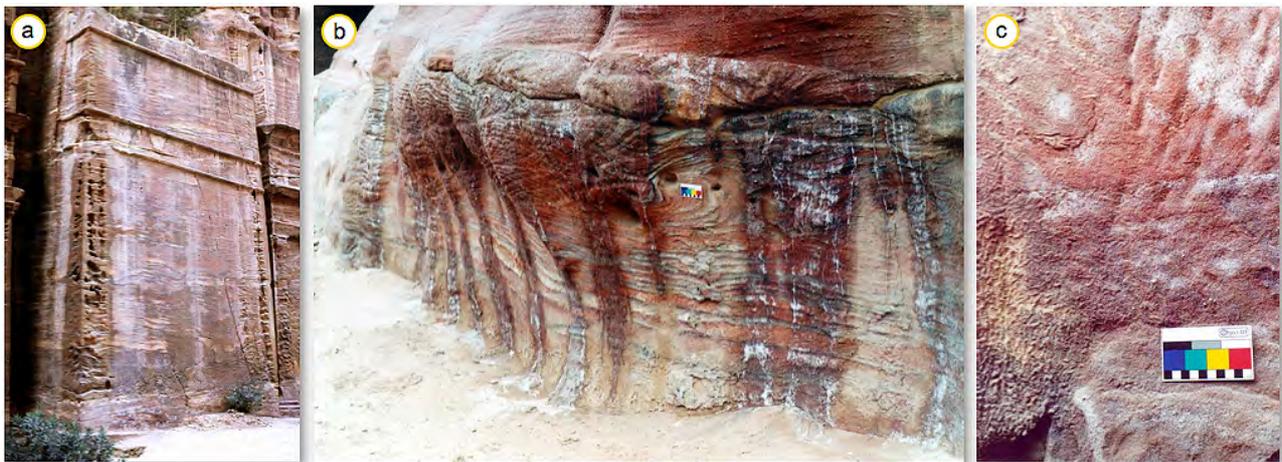
109: a) Wet area due to hygroscopic salts at one monument along the streets of the facades, b) water drainage and salt efflorescences and c) salt efflorescences at monument no. 826 after a heavy rainfall.

After the winter rainfalls, the salt becomes observable by whitish efflorescences (Fig. 109 b and c). A higher salt load on the surface during the winter was also measured by Bala'awi *et al.*, (2012). The rock salt of Petra consists of halite (NaCl). Fitzner and Heinrichs (2000) identified the solid salt crust as halite. In areas behind the crusts poorly soluble calcium sulfate ( $\text{CaSO}_4$ ), but also highly soluble potassium, nitrates, and magnesium sulfate were also found. Al-Naddaf (2002) also examined the destructive salt of Petra with similar findings. In addition to NaCl and  $\text{CaSO}_4$ , he also found traces of  $\text{KHCO}_3$ ,  $\text{CaCO}_3$ ,  $\text{KNO}_3$ , and KCl. Various authors mention, in addition to the above-mentioned salts: magnesium chloride ( $\text{MgCl}_2$ ), thenardite ( $\text{Na}_2\text{SO}_4$ ), potassium sulphate ( $\text{K}_2\text{SO}_4$ ), sodium carbonate ( $\text{NaCO}_3$ ), magnesite ( $\text{MgCO}_3$ ), kalicinite ( $\text{KHCO}_3$ ) and potassium carbonate ( $\text{KCO}_3$ ) (Al-Saad, Abdel-Halim 2001; Wedekind, Ruedrich 2006; Bala'awi 2008; Eklund 2008; Heinrichs 2008). Gomez-Heras *et al.*, (2011) presented a study of the „Silk Tomb“ where a wide variety of salts such as halite (NaCl), sylvite (KCl), niter ( $\text{KNO}_3$ ), gypsum ( $\text{CaSO}_4 \cdot 2\text{H}_2\text{O}$ ), syngenite ( $\text{K}_2\text{Ca}(\text{SO}_4)_2 \cdot (\text{H}_2\text{O})$ ), polyhalite ( $\text{K}_2\text{Ca}_2\text{Mg}(\text{SO}_4)_4 \cdot 2(\text{H}_2\text{O})$ ) and apthitalite ( $(\text{K},\text{Na})_3 \text{Na}(\text{SO}_4)_2$ ) can be found. These samples were taken from the lower part of the monument.

Horizontal alveolars usually run below and markedly above the limonite layers that often run through the rock massif towards the sedimentation. The limonite has a low porosity and consists mainly of micropores (Tab. 21, Fig. 109 b). In contrast to the surrounding sandstone, this clay-silicic limonite layer is very soft in the first few millimeters. On the surface they deteriorate faster than sandstone, which is probably due to their high hygric expansion in the XY-direction (Tab. 21). However, drill resistance measurements have shown that at depth these limonite layers have a high hardness and a higher density than sandstone. They are mechanically stronger than feldspar or arkosic sandstones. Apparently, the limonite layers act as water-retarding layers. During evaporation salts accumulate at the surface, which was observed on many examples at Petra after rainfalls (Fig. Fig. 109 c). During precipitation events rainfall infiltrates the sandstone until it reaches the limonite water-retarding layer and flows towards the surface and down the rock face (Fig. 109 b).

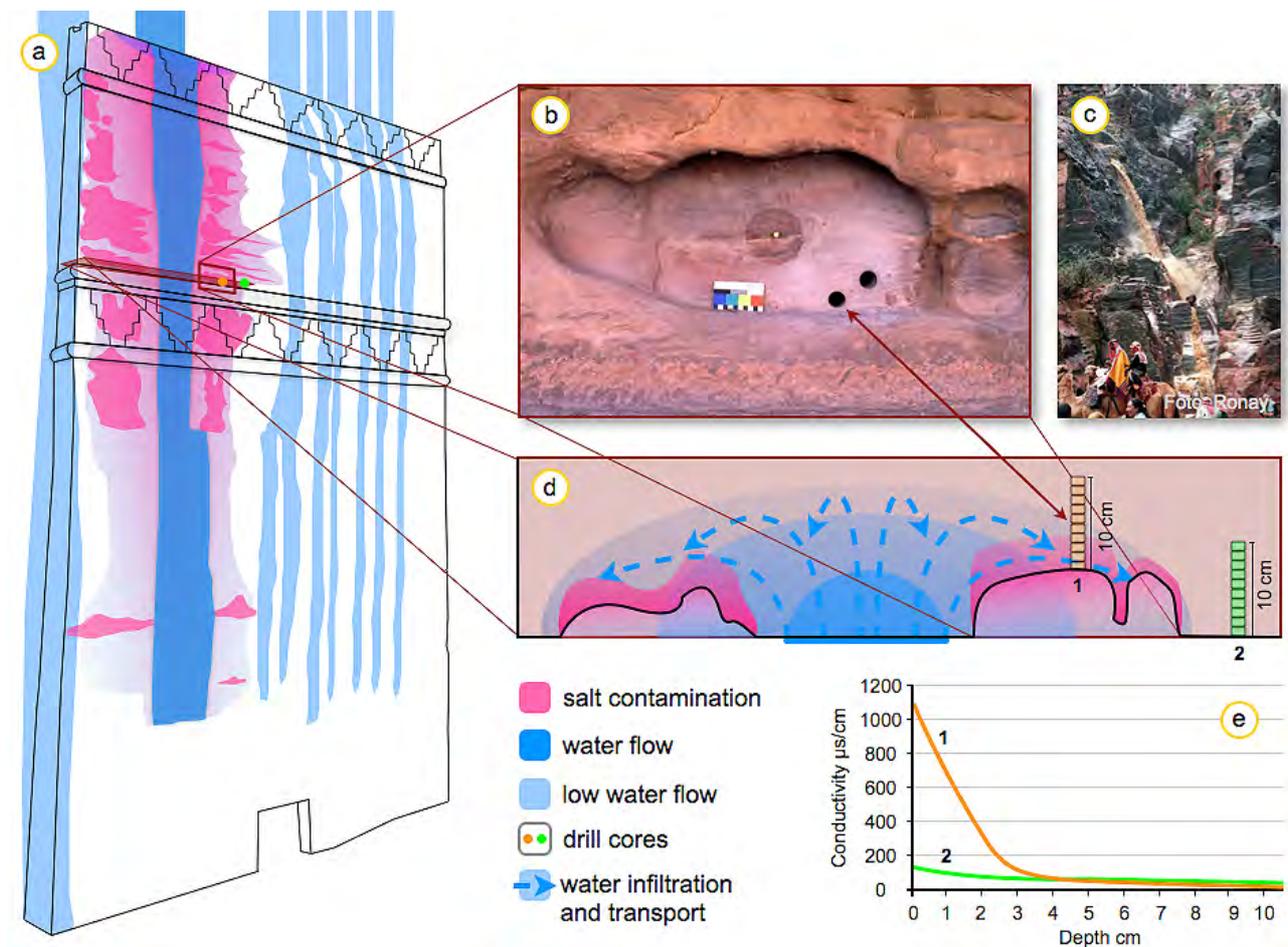
**Figure 111:** a) Distribution of alveolar weathering and traces where the rainwater drains at façade no. 826. b) Tafoni 3 with sampling points and drill core holes. c) Cascade-like water stains after a rainfall. d) Idealized cross section of the sampling area. e) Contribution of the electrical conductivity of the drill core samples with depth.

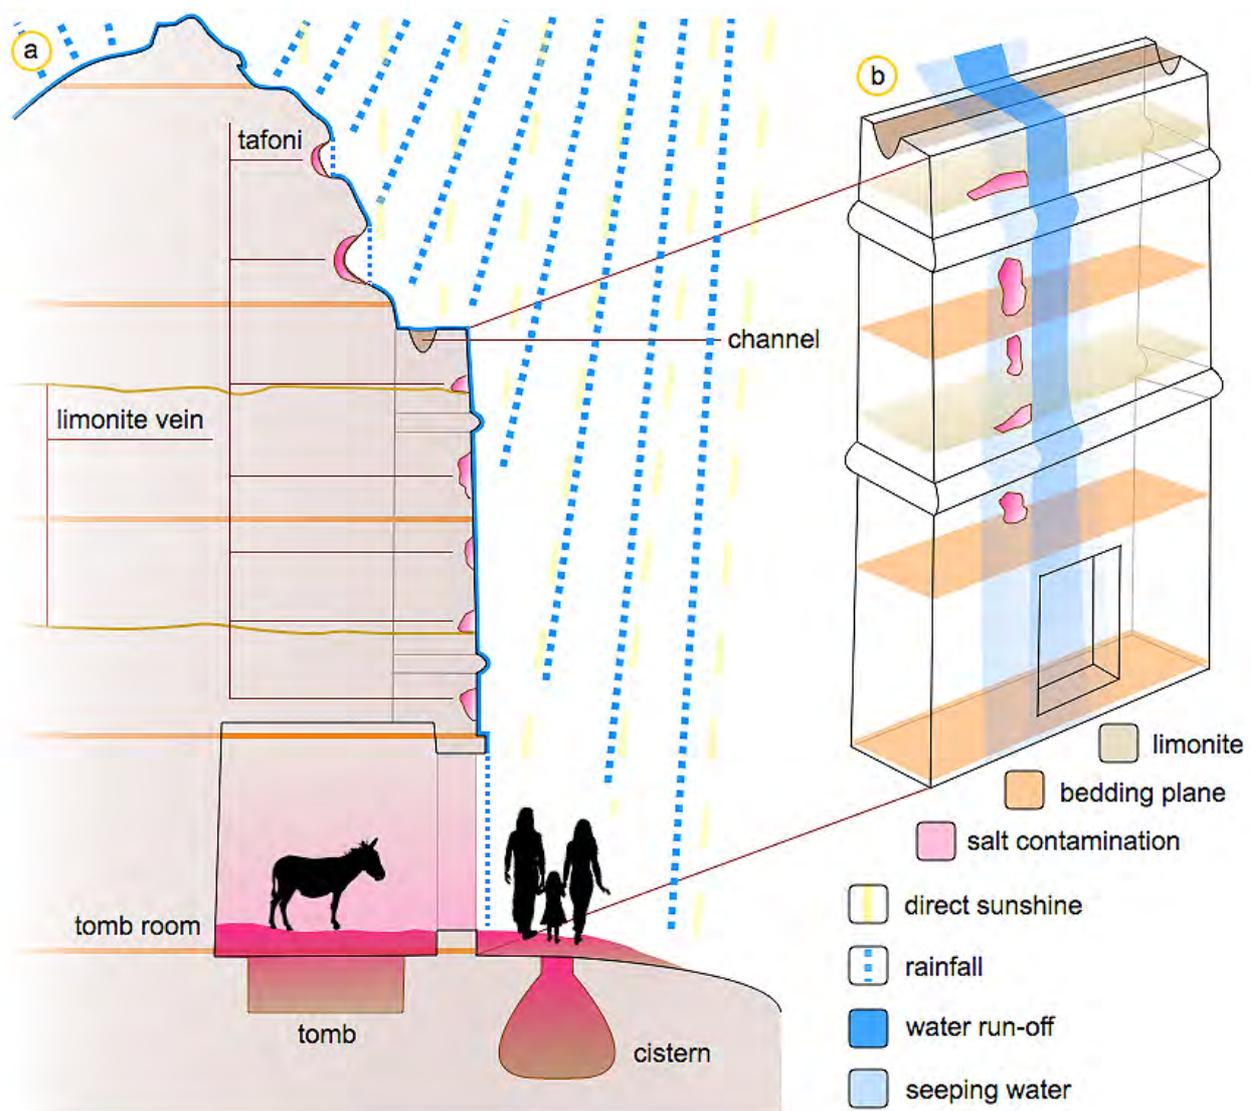
**Figure 112:** Weathering model of the rock cut monuments in Petra.

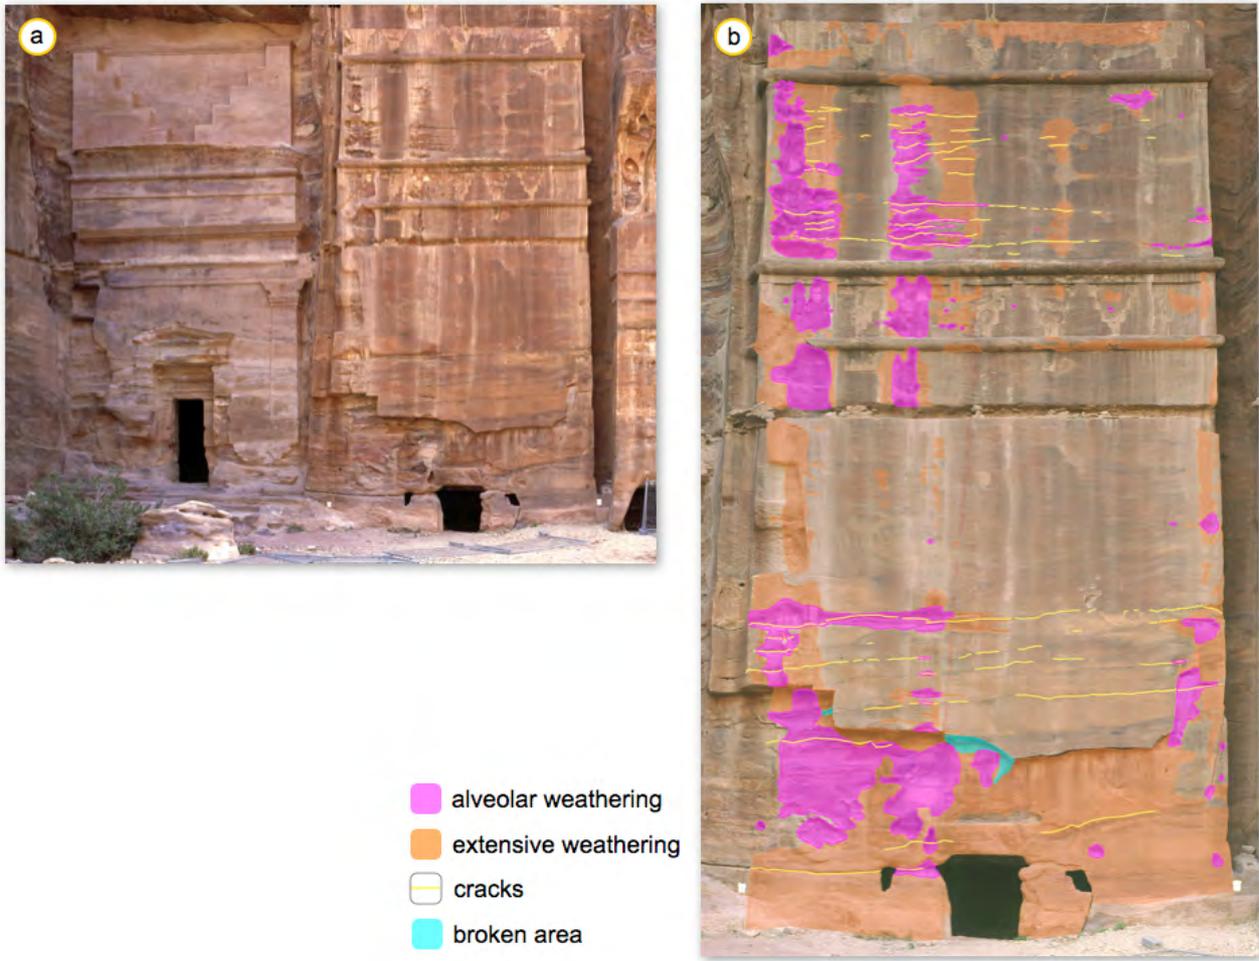
(left) and tomb no. 826 before restoration. b) Quantified mapping of monument no. 826.

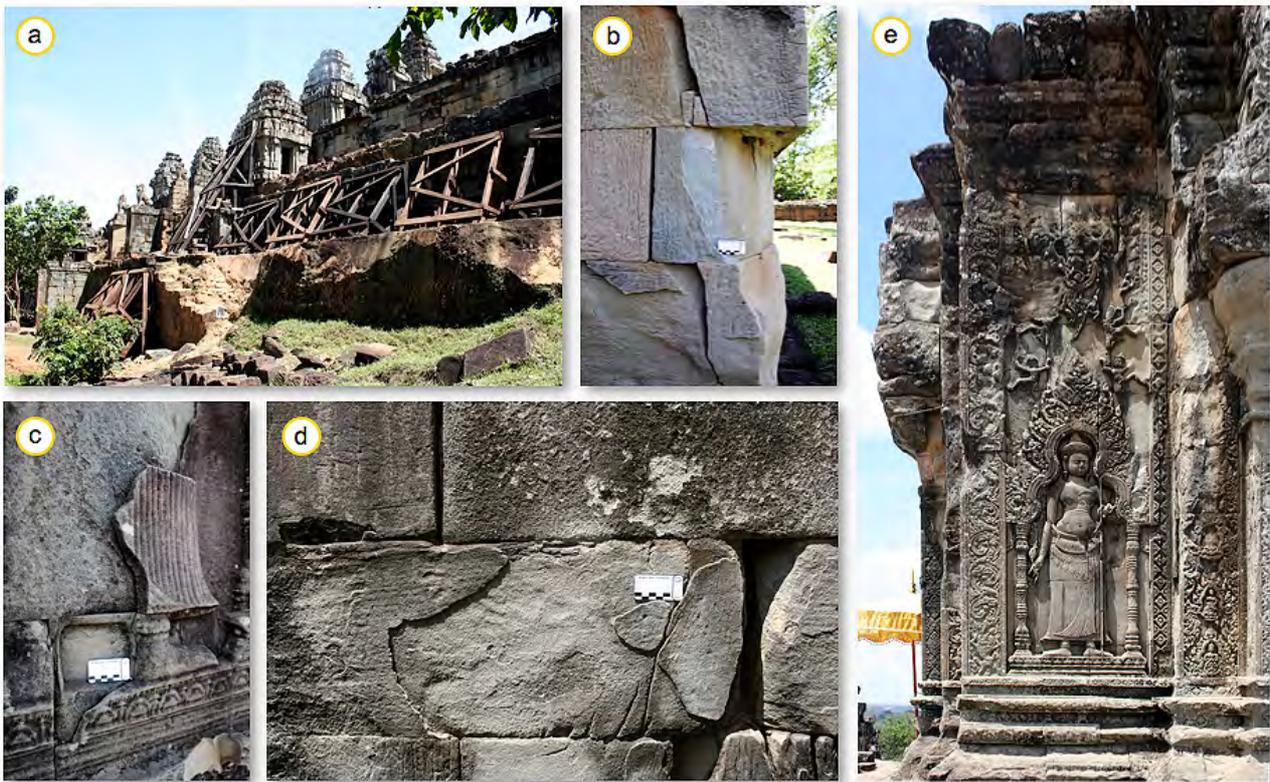
**Figure 117:** Damages at the Phnom Bakheng Temple: a) wooden protection constructions at the pyramid walls, b) structural cracks, c and d) contour scaling and e) back-weathering at the upper relief zone.

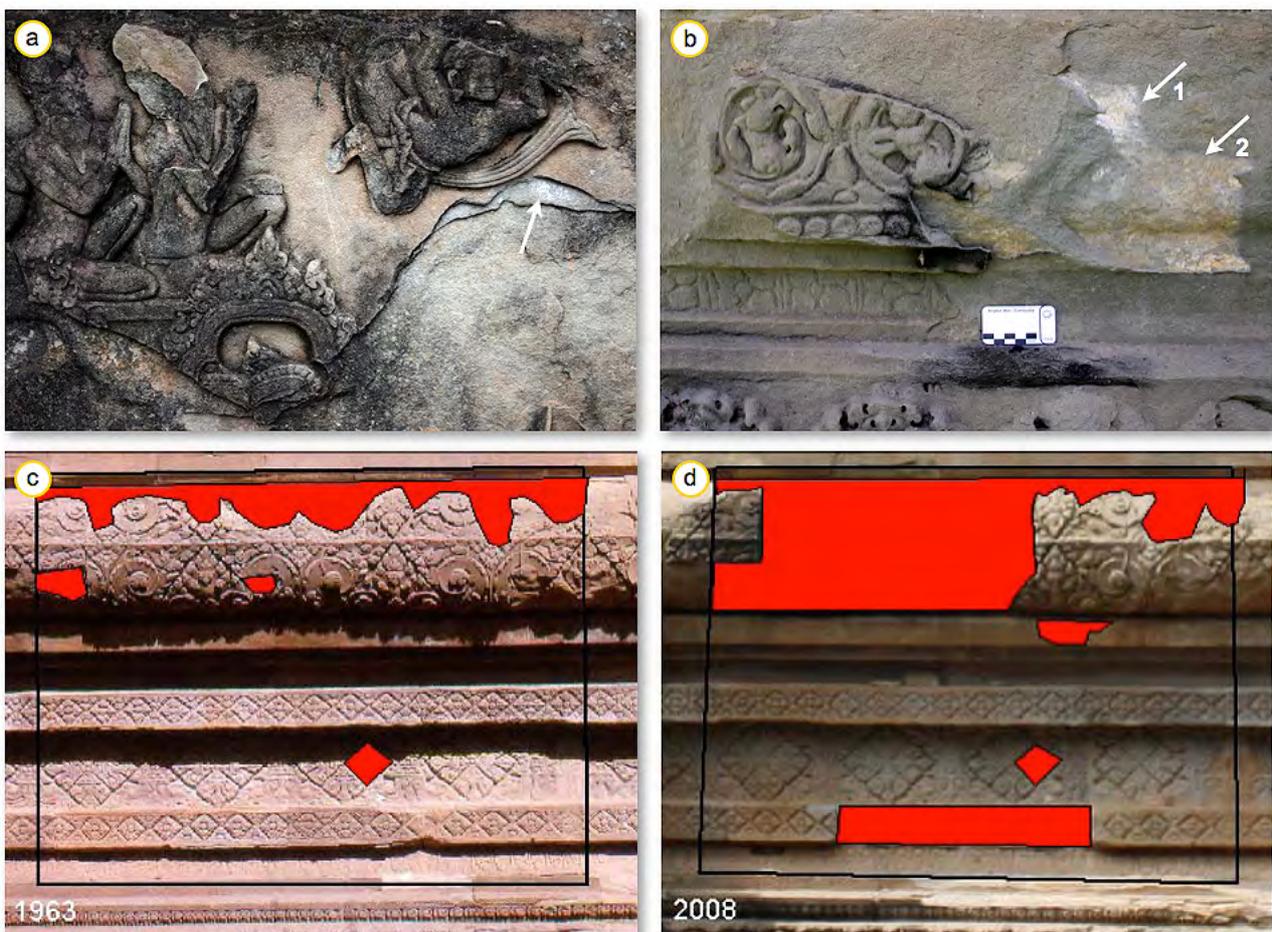
**Figure 119:** a) Layered contour scaling with calcite precipitation underneath a recently lost scale (arrow). b) Calcite precipitation (arrow 1) and calcite as well as iron precipitation (arrow 2) between a recently lost scale. c) Mapping of a detailed area based on a photograph from 1963 and d) in 2008 (source: André *et al.*, 2012).

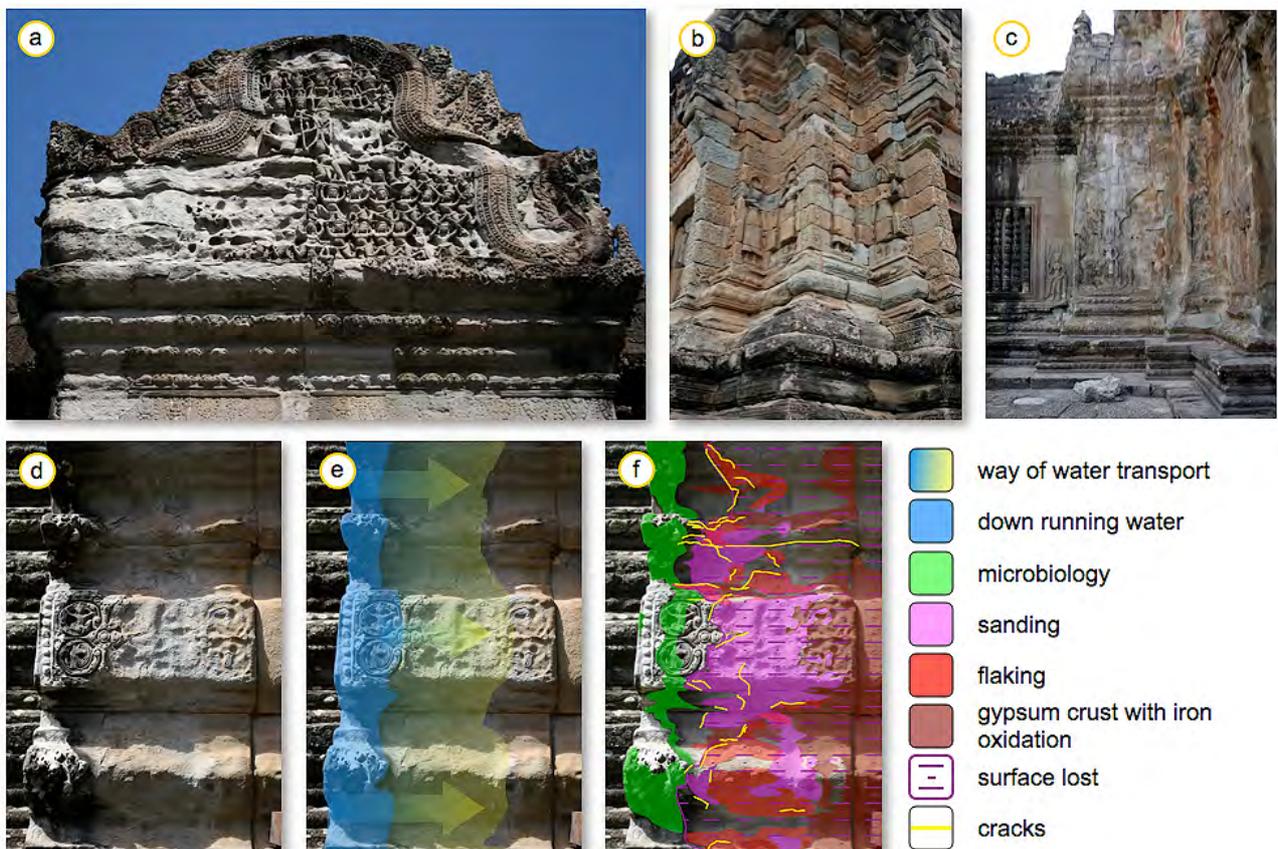
**Figure: 120:** a) Different weathering intensities observable on different building stone varieties at the Angkor Wat Temple. b) Different weathering intensities as well as the development of an iron-rich oxidation crust by chemical weathering. c) Intense iron discolorations at the Angkor Wat Temple. d) Alveolar-like weathering at the Angkor Wat Temple. e) During a rainfall, water runs down leading to infiltration and the accumulation of soluble materials nearby. f) This leads to different weathering forms like sanding, flaking and the formation of an oxidation crust.

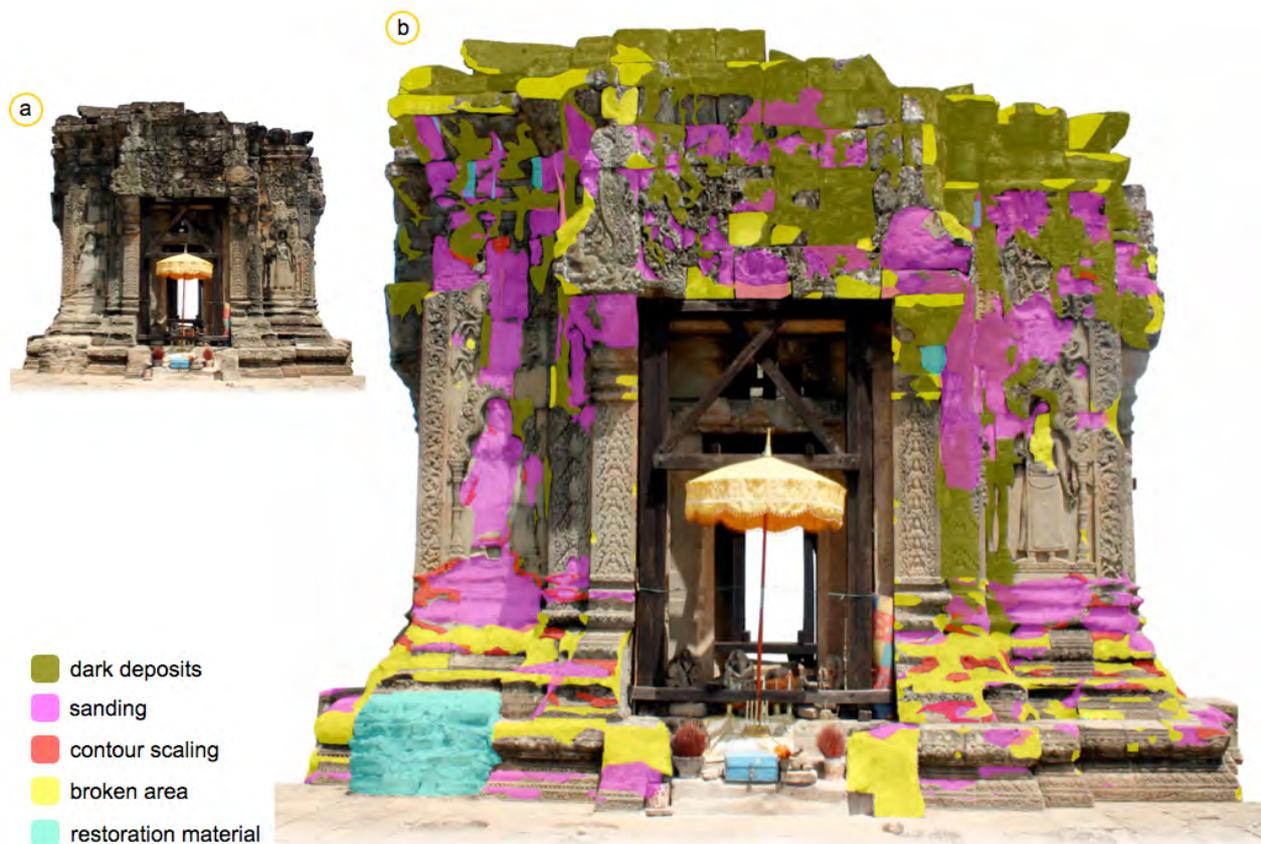
**Figure 121:** Quantified mapping of the south facade of the main sanctuarium of the Phnom Bakheng Temple. a) The conservation state of the facade and b) quantified mapping.

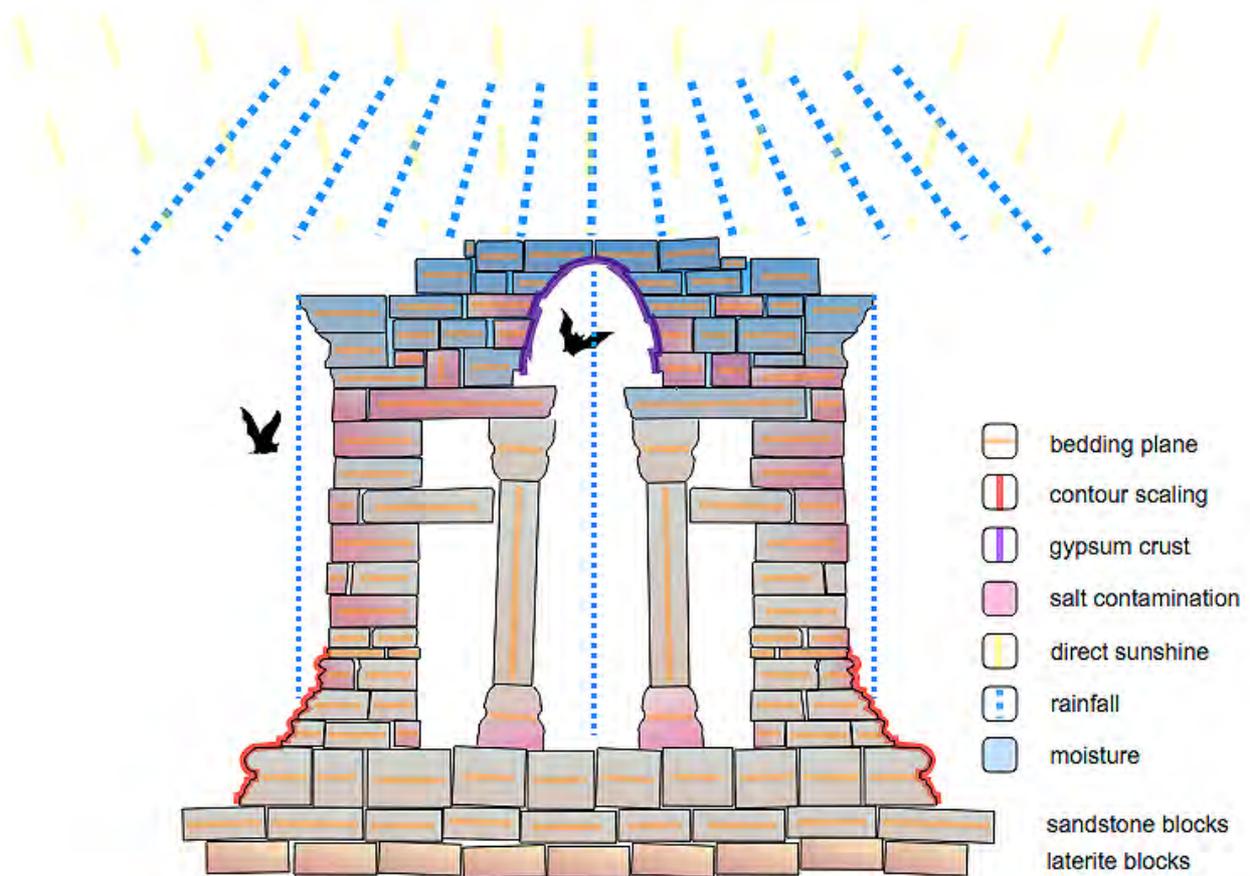
**Figure 122:** Cross section illustrating the weathering model of the main sanctuary at the Phnom Bakheng Temple.

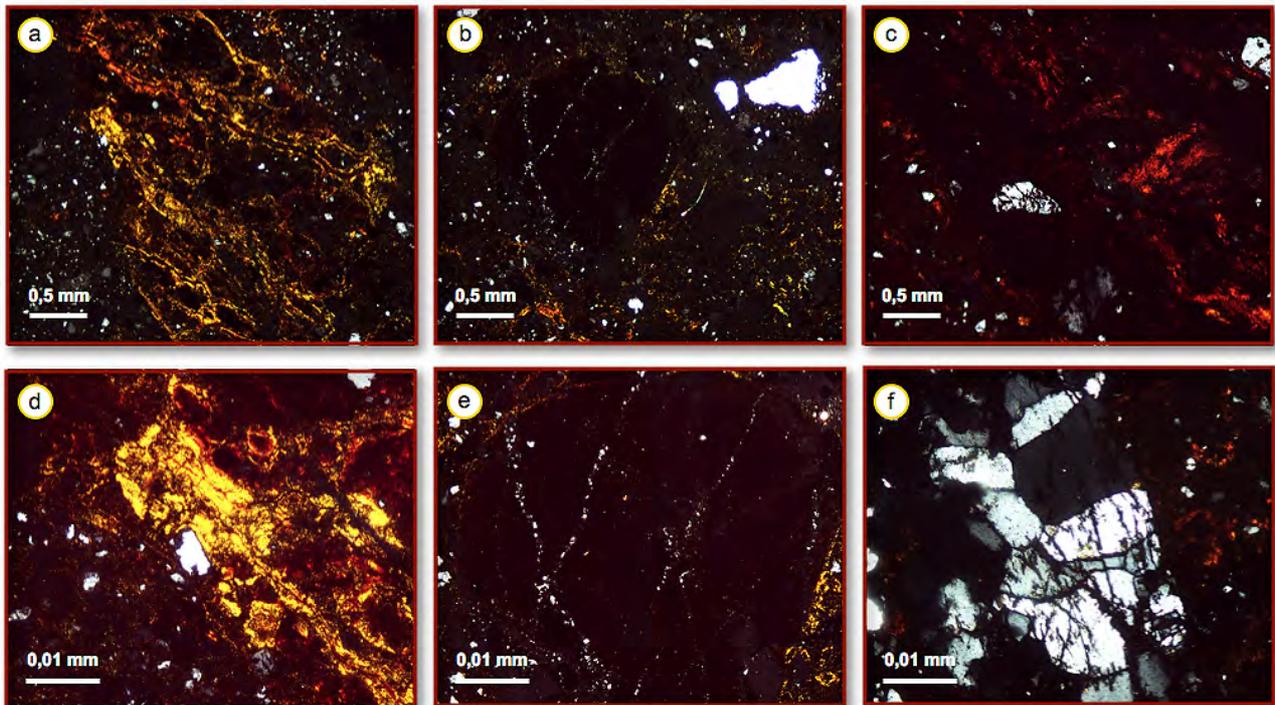
**Figure 126:** a) Yellow amorphous structures and b) red accumulation and single quartz grains within a microcrystalline matrix. c) Single quartz grains within a reddish amorphous matrix. d) The yellow amorphous structure show flow structures. e) Within drying cracks small quartz grains are visible. f) Bigger quartz grains shows alteration.

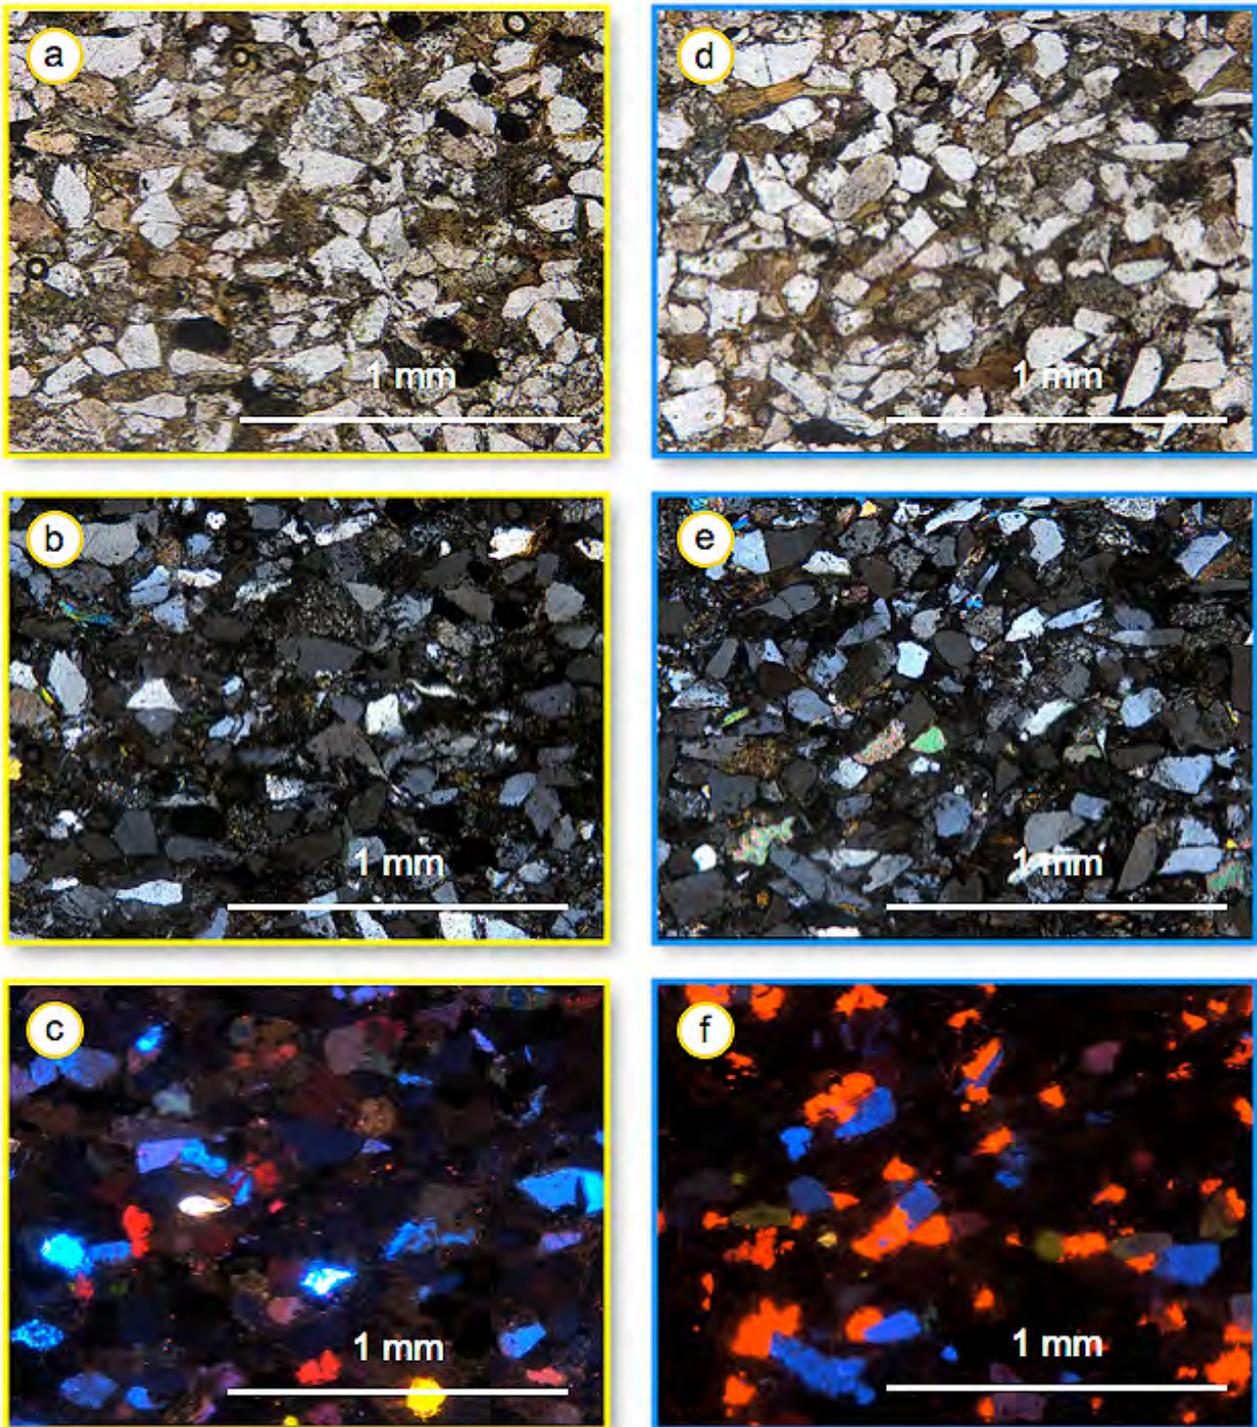
**Figure 127:** a - c) Thin section of the Phnom Bakheng sandstone (PB) and d - f) of the restoration material (PBr).  
 a) and d) Samples under transmitted light. b) and e) Samples under polarized light and c) and f) under cathodoluminescence.

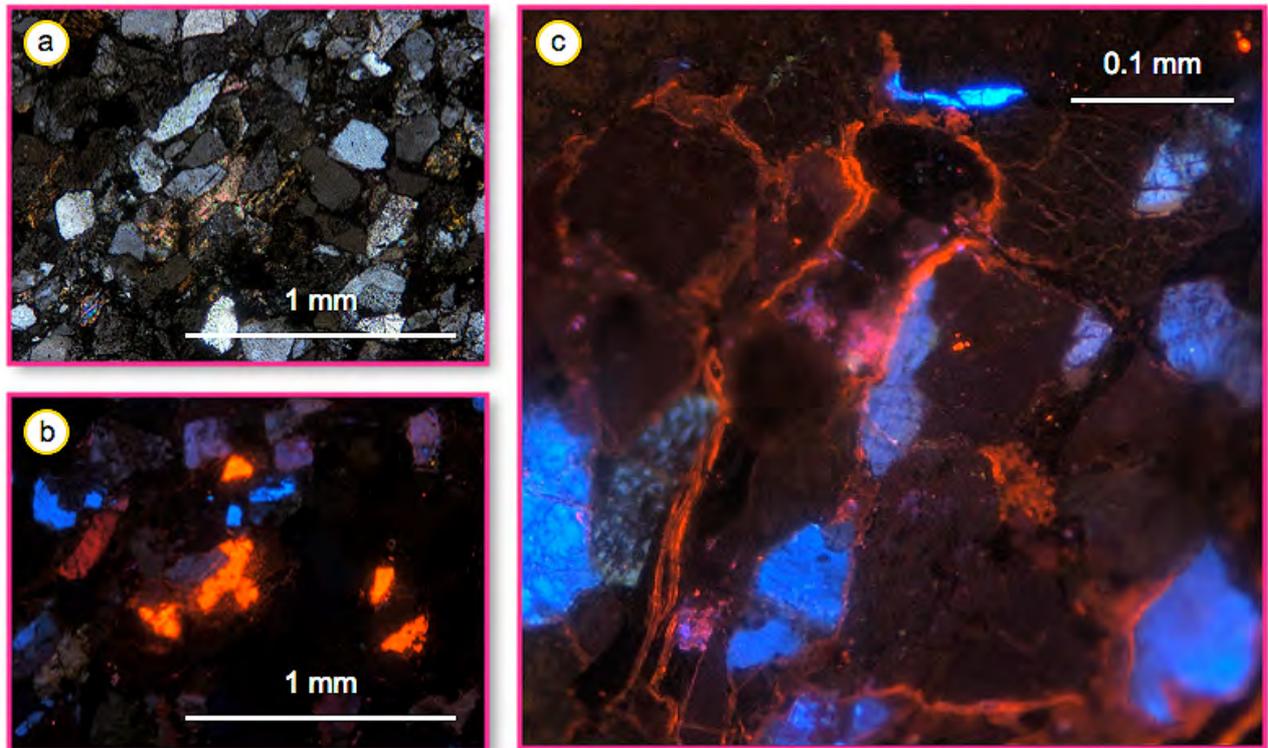
**Figure 128:** a) - c) Thin section of the weathering crust from the Phnom Bakheng sandstone. a) Samples under transmitted light. b) Sample under cathodoluminescence. c) Detail of the sample under CL showing the finely precipitated calcite within cracks and along the grain boundaries between grains of quartz (very low luminescence) and feldspar (blue).

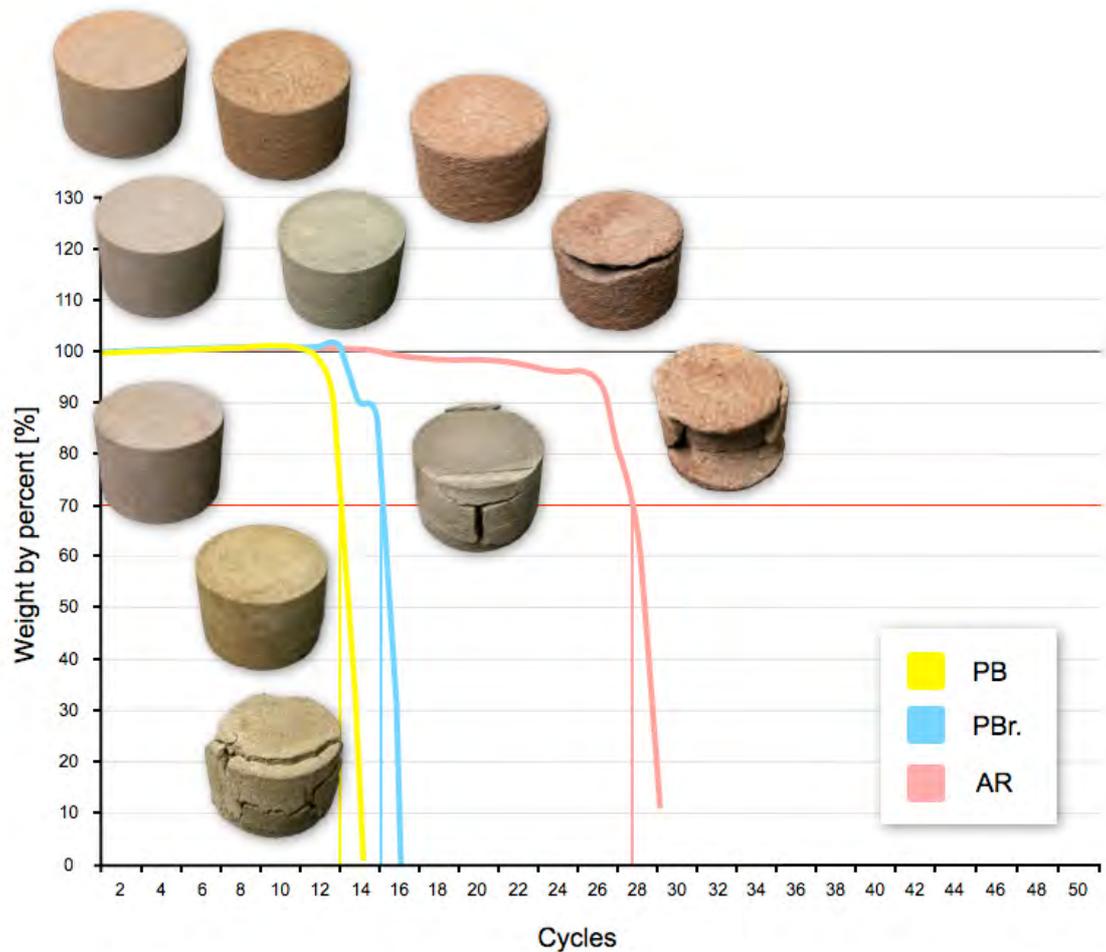
Figure 129: Salt resistance test for the investigated sandstones of Angkor.

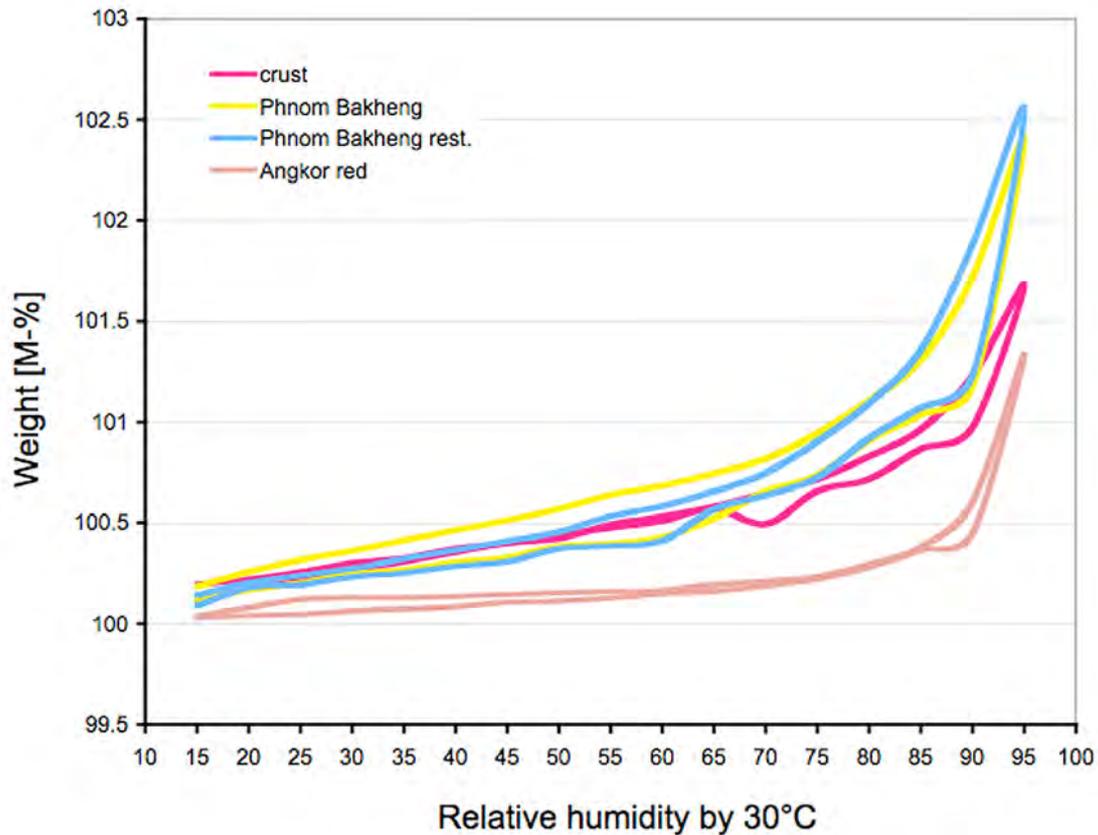
**Figure 132:** Sorption and desorption as a function of weight-% related to relative humidity of the investigated Angkor sandstones.

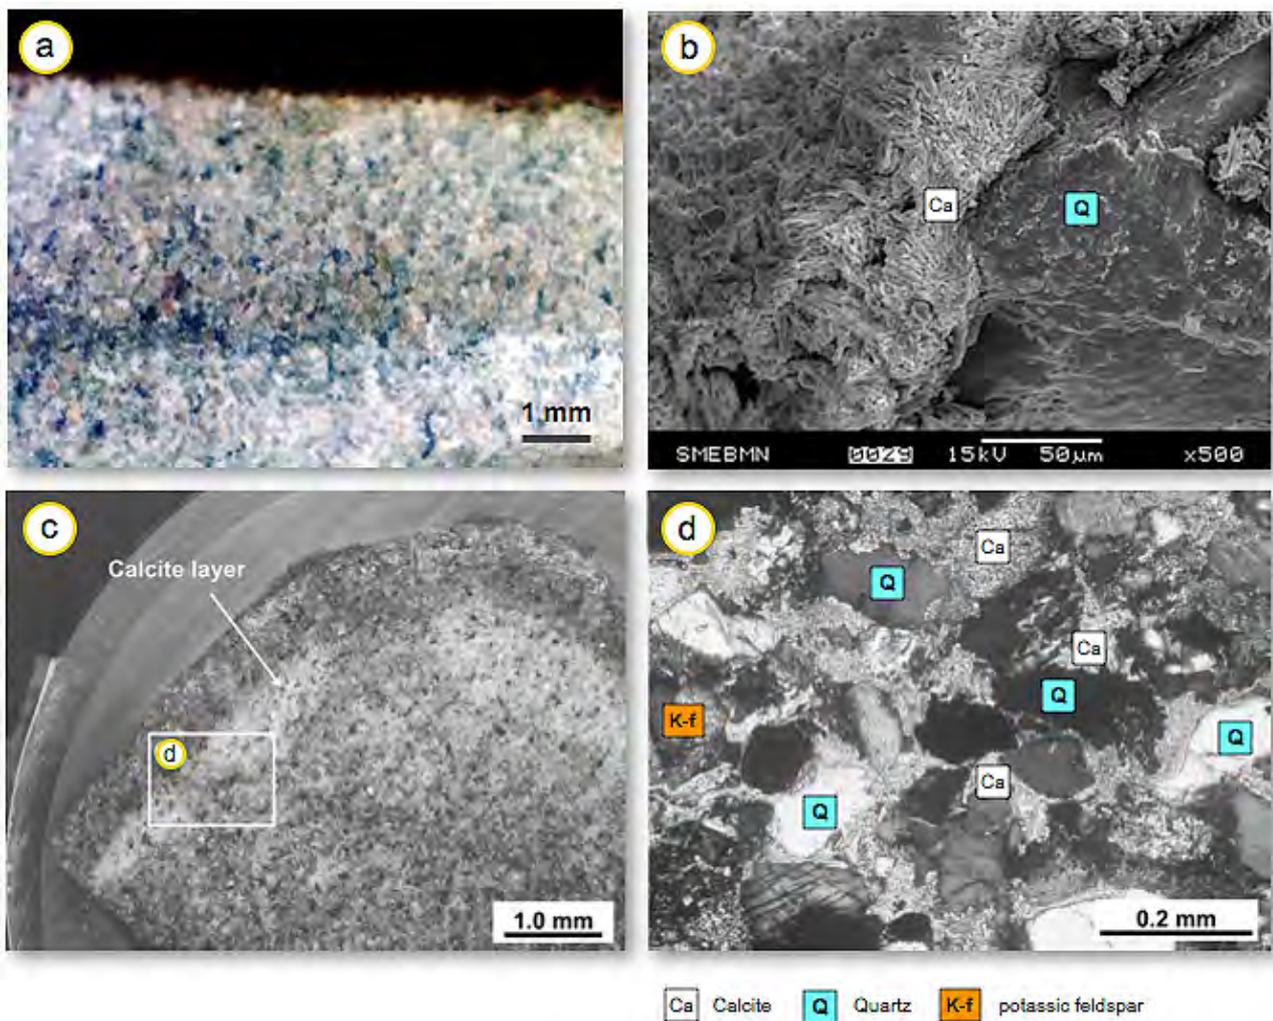
**Figure 133:** a) Cross section of the crust showing a distinct zoning - a brownish zone at the surface and a whitish one beneath. b) Within the lamination zone a compact layer of calcite occurs (SEM-photograph: André *et al.*, 2008). c) Underneath the crust an extensive calcite accumulation parallel to the surface develops (photograph: Hosono *et al.*, 2006). d) Thin section image showing the pore space completely filled with calcite (photograph: Hosono *et al.*, 2006).

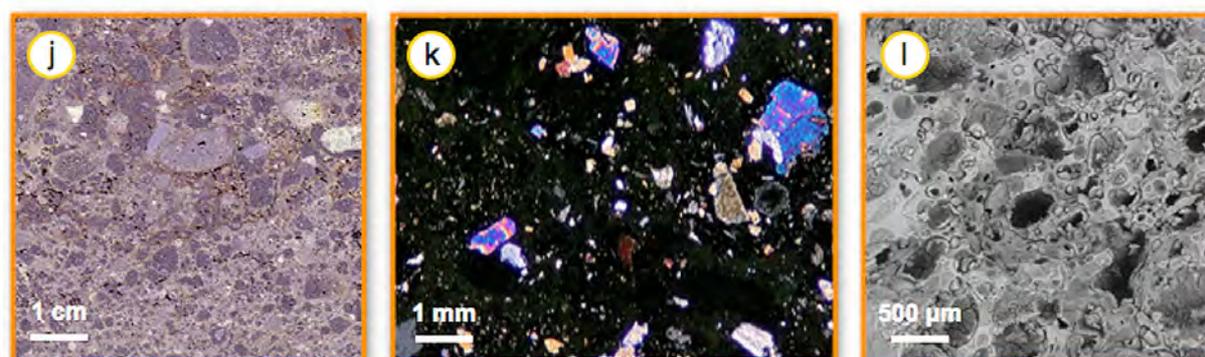
**HD** Hilbersdorf Tuff, Saxony / Germany

**Figure 138:** Illustration of the German volcanic rock samples. From top to bottom: Weibern Tuff, Rochlitz Porphyry Tuff, Hilbersdorf Tuff, Habichtswald Tuff, a, d, g, j, m) polished section, b, e, h, k, n) thin section under polarized light and c, f, i, l, o) SEM micrograph.

*Hilbersdorf Tuff (HD)* shows different varieties of grain size and colour. It can be pale pink to brick red, light or dark purple or greenish, and often shows a peculiar alteration with light pink or greenish speckles, spots or strips (Fig. 138 g). In the fine-grained matrix of the tuff (around 60 to 70 % of the rock), lapilli inclusions were observed; however, the average grain size varied from 0.5 to (rarely) coarser than 2 mm. Larger cavities from several mm to cm, mostly amygdaloid-type, were partially filled with clay minerals. It consists of mono- and polycrystalline quartz, alkali feldspar

and seldom lithic grains of metamorphic rocks (sericite-rich), quartzite and gneiss-like xenoliths in a hypocrySTALLINE to eutaxitic texture (Fig. 138 h). In addition to quartz and feldspar, XRD proved the presence of approximately 20 wt% muscovite/illite. Scanning electron microscope (SEM) images of the Hilbersdorf Tuff matrix (Fig. 138 i), additionally demonstrated the presence of dickite, a clay mineral that belongs to the kaolinite group (see also Fischer 1990 and Siedel 1995, 2006).

The fabric of a rock affects the petrophysical properties (Siegesmund, Duerrast 2011). One key factor is the pore-size distribution, which affects the stone's durability (Punuru *et al.*, 1990; Fitzner, Basten 1994; Benavente *et al.*, 2004). Ruedrich *et al.*, (2011 a) found that the effect of the disjoining pressure is relevant in rocks with a high amount of micropores. In fact, tuffs like HW, HD, BT, LS, TY and BP have a significant portion of micropores (50 % or more). These samples also show the highest values of hydric dilatation, especially on the Z-axis (Fig. 142). Especially HD, which has a very low CEC value, shows an important dilatation. In this case, the dilatation is controlled exclusively by the microporosity and its dense and complex pore network that is associated to the layering of the tuff. This observation points to the disjoining pressure as a major factor affecting moisture expansion (Fig. 138, Hilbersdorf Tuff, i).

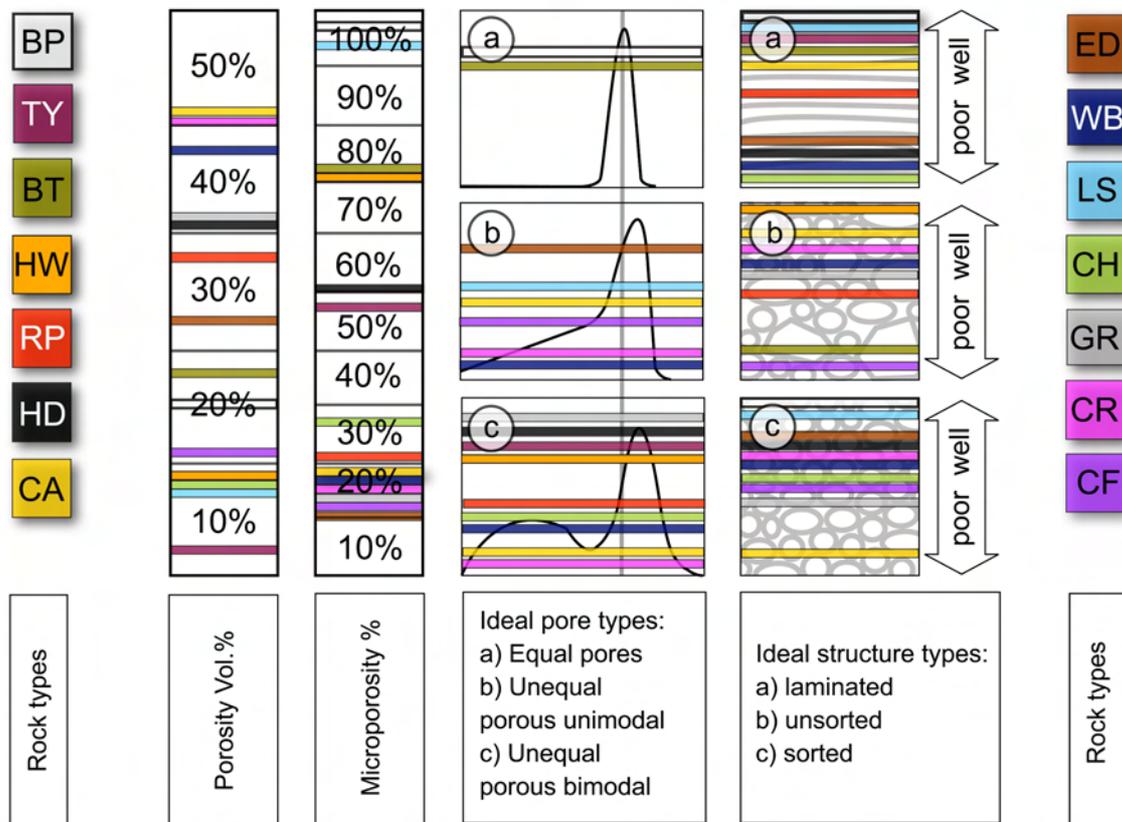
**Figure 140:** Overview diagram of the main pore space properties and structural characteristics measured by hydrostatic weighting and MIP.

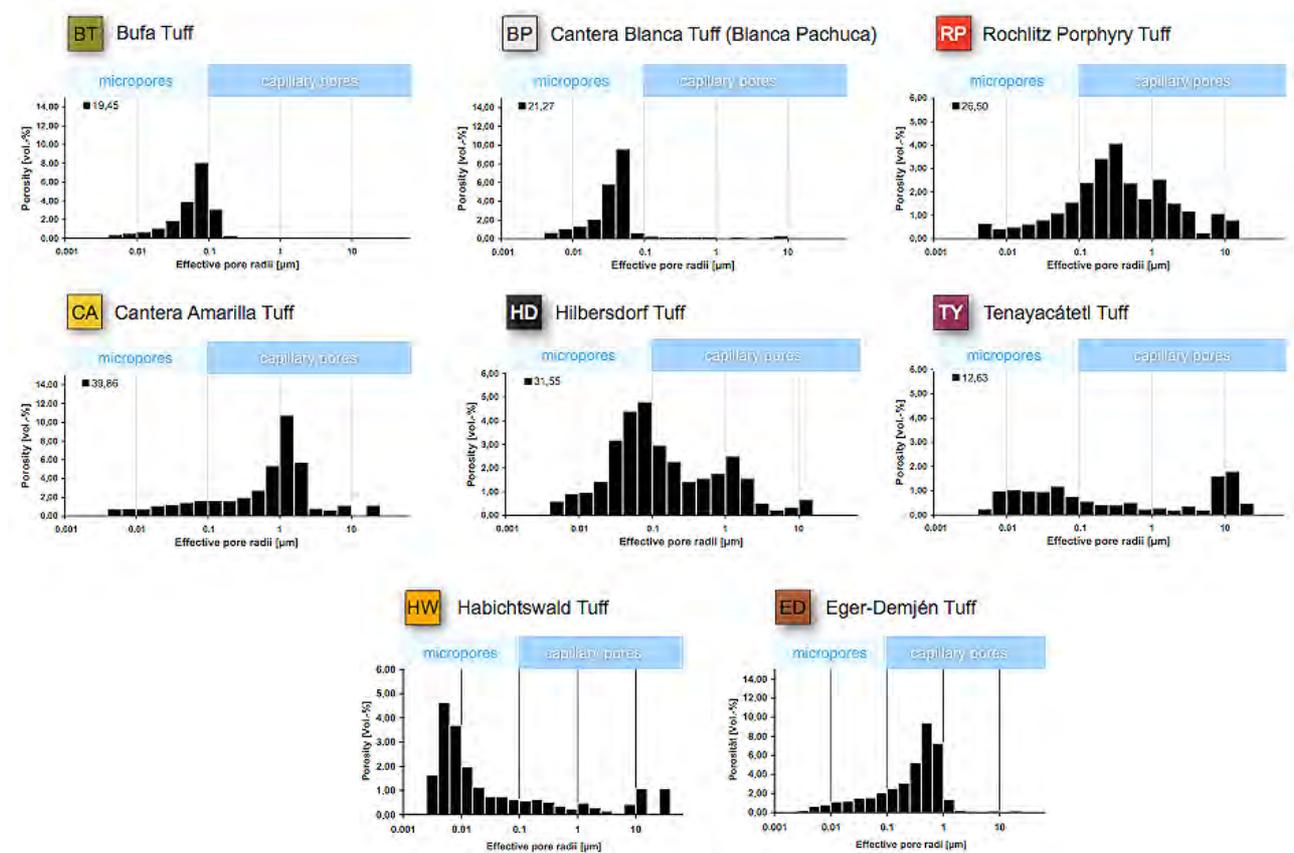
**Figure 141:** Pore size distribution of the eight investigated tuffs and measured by hydrostatic and MIP.
