WEATHERING AND CONSERVATION OF MONUMENTS  
CONSTRUCTED FROM TUFF AND SANDSTONE  
IN DIFFERENT ENVIRONMENTAL CONDITIONS

Case Studies from Mexico, Germany, Jordan and Cambodia

Dissertation

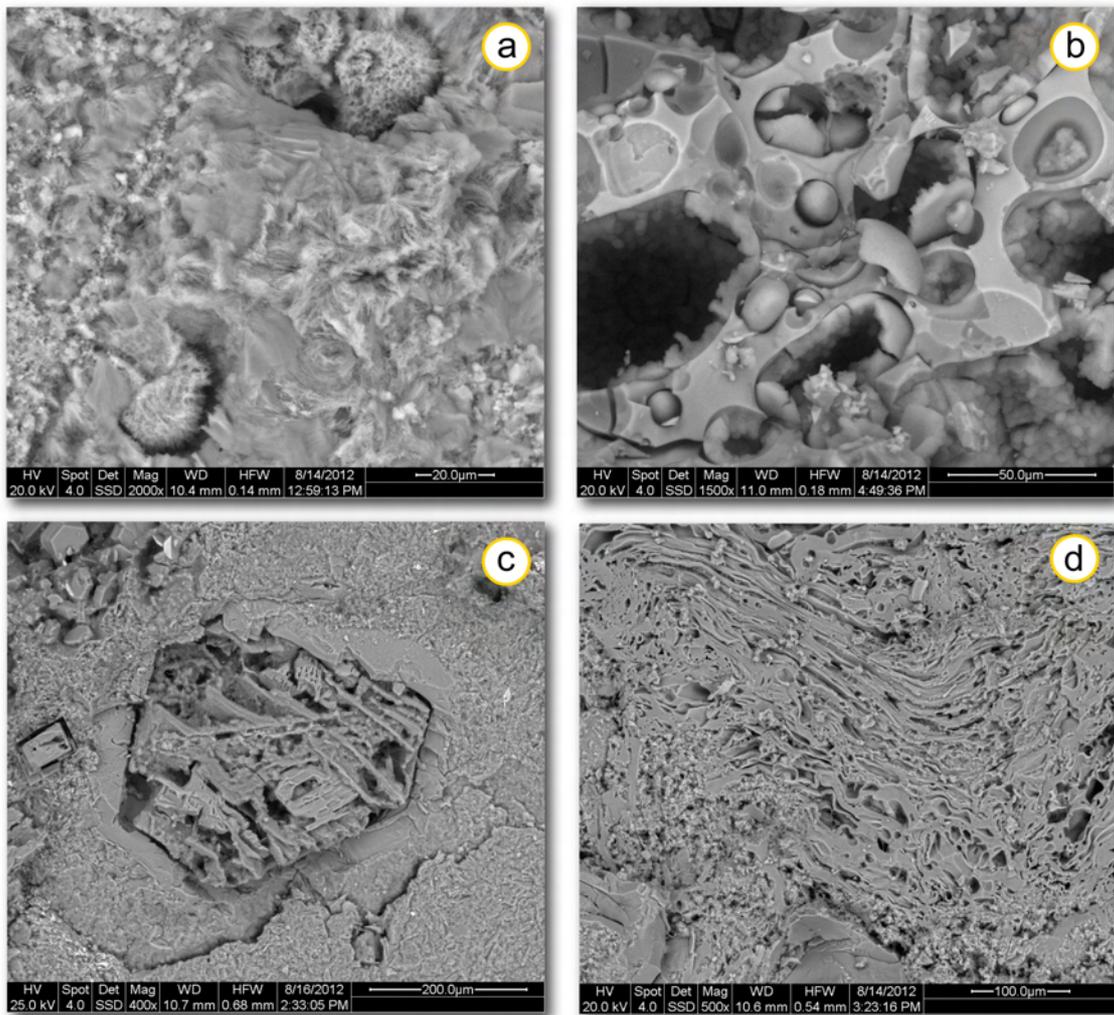
**Figure 151:** a) SEM images of Blanca Pachuca Tuff (BP) with partly filled pores. b) The Habichtswald Tuff (HW), with a clay-rich pore space coating consisting of smectite. c) Inner structure of the Tenayocátetl Tuff (TY) shows altered minerals covered with a fine coating of smectite (plagioclase in the middle). d) Eger-DEMjén Tuff (ED) with long drawn-out pores.

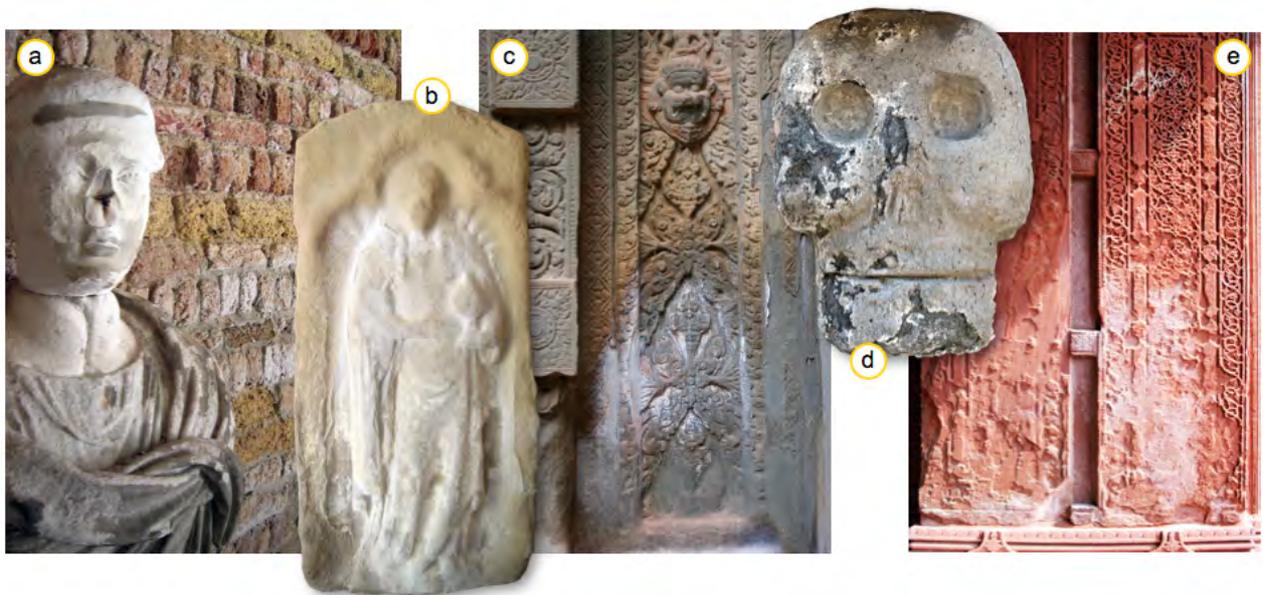
**Figure 153:** Salt weathering is a main weathering form that occurs on historical monuments worldwide and the contamination can have various sources. a) Weathering of marble and brickstone due to marine salt contamination in Venice/Italy, b) a salt contaminated tomb plate due to magnesium sulphate salts created by the binding material of the sandstone and industrial pollution, c) salt weathering at a temple of Angkor/Cambodia due to bat guano, d) salt weathering of a skull at the Templo Mayor in Mexico City due to salt contamination within the groundwater and rising dampness and e) salt weathering due to contamination by pigeons at the Fatipur Sikri Temple/India.

Damages on historical structures built from natural building stones are in many cases due to the impact of salt crystallization (Fig. 153). The fundamental prerequisite is the reduction of the stresses created by salinization. The damage processes may be stopped or slowed down by preservation measures, which would guarantee a sustainable protection of the object under consideration.

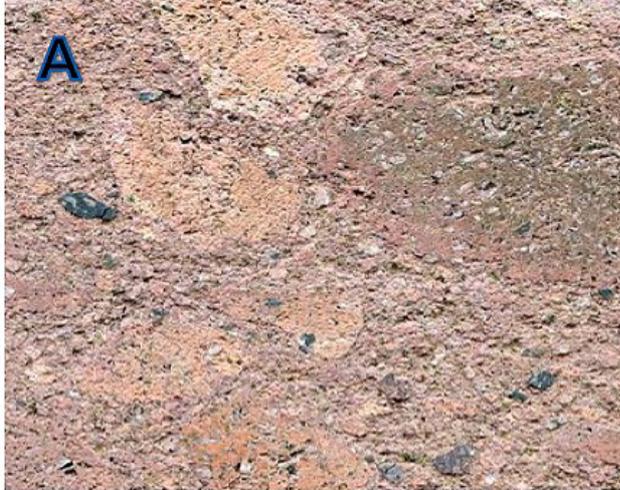
Red Tuff from San Miguel de Allende (RG)

**Table 154:** Tuff rocks from San Miguel de Allende. A, C and E) Macroscopic fabric in hand specimen (all samples are 6.5 cm in length). B, D and F) Thin section of the tuff rocks from San Miguel de Allende (all microphotographs are 5 mm in length and taken with a 5X objective), B and F) parallel nicols, D crossed nicols. Red Tuff of San Miguel de Allende (RG).

In thin section the RG shows a dark reddish, relatively coarse matrix with yellowish, whitish, grayish and orange unoriented and non-altered clasts in different sizes and textures (Fig. 154 A). The main mineral is plagioclase, recognized by its typical interference color, twinning and zoning. Idiomorphic olivine und fine-grained quartz crystals are also embedded in the matrix. The texture of this tuff is cryptocrystalline to glassy and a smooth flow texture is also observable (Fig. 154 B). The percentage of matrix and clasts is about 60 % - 40 %, respectively.

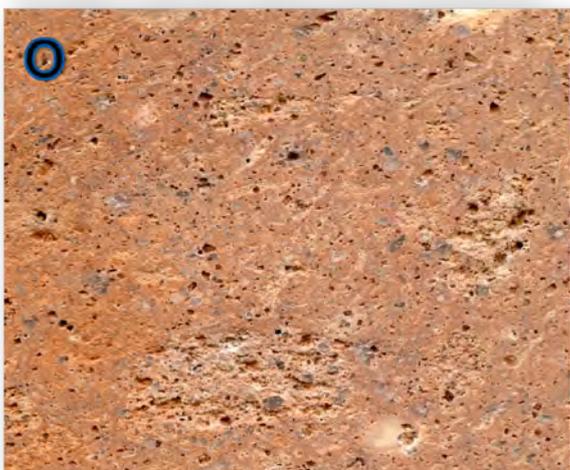
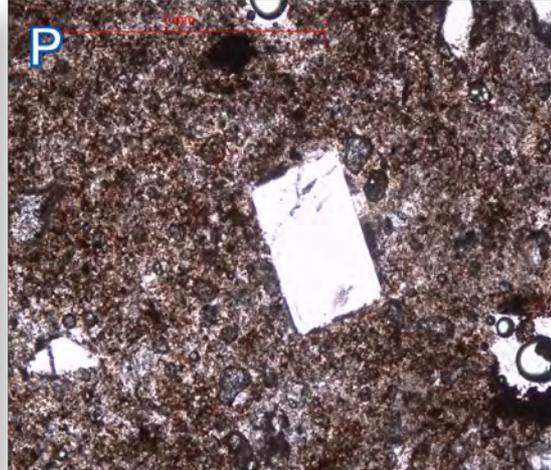
El Salto Tuff (El Salto) from Zacatecas

**Figure 156:** Tuff rocks from Zacatecas. K, M and O, Macroscopic fabric in hand specimen (all samples are a 6.5 cm in length). L, N and P, Thin section of the tuff rocks from Zacatecas (all microphotographs are 5 mm in length and taken with a 5X objective and parallel nicols).

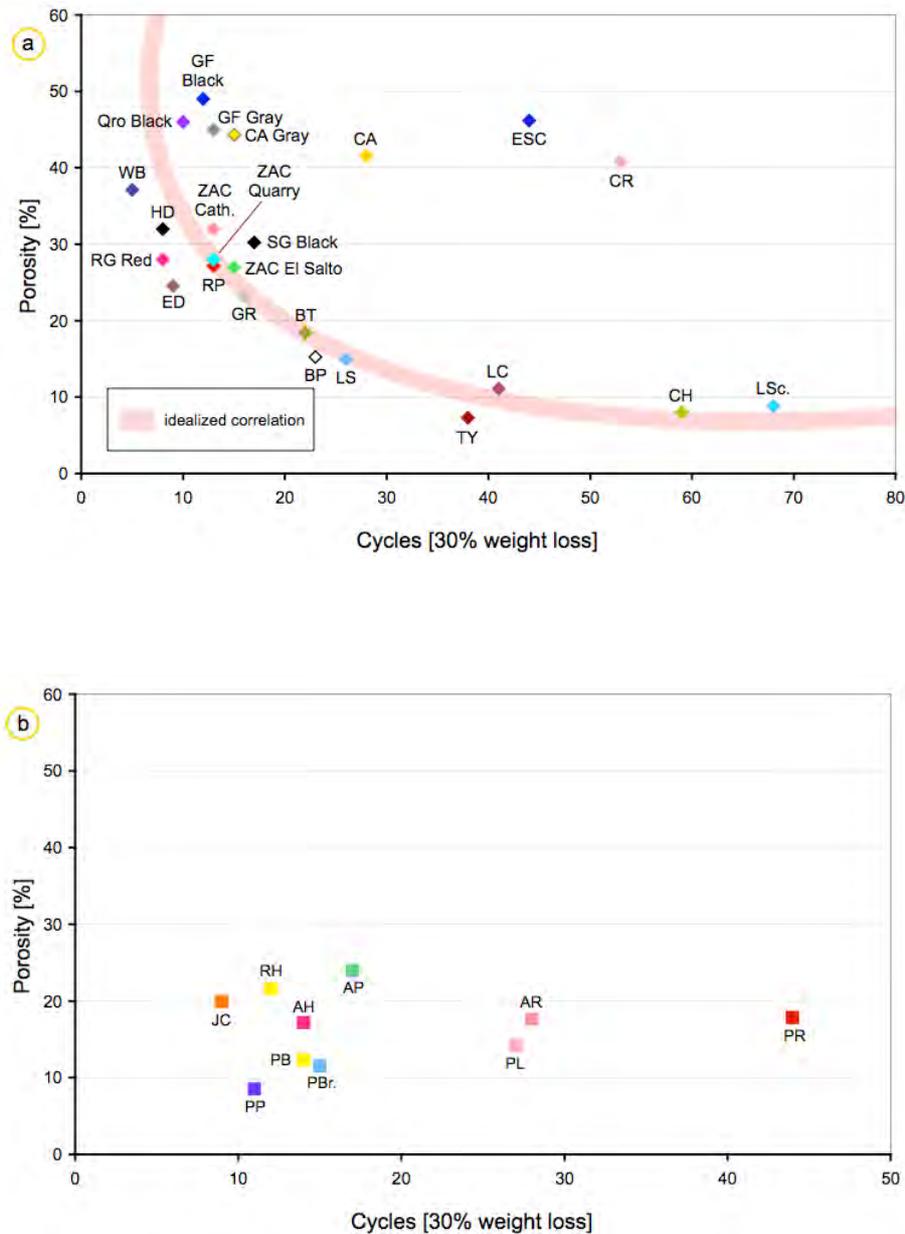
**Figure 157.** Correlation of the porosity versus the number of cycles a) of the tuffstones and b) of the sandstones.

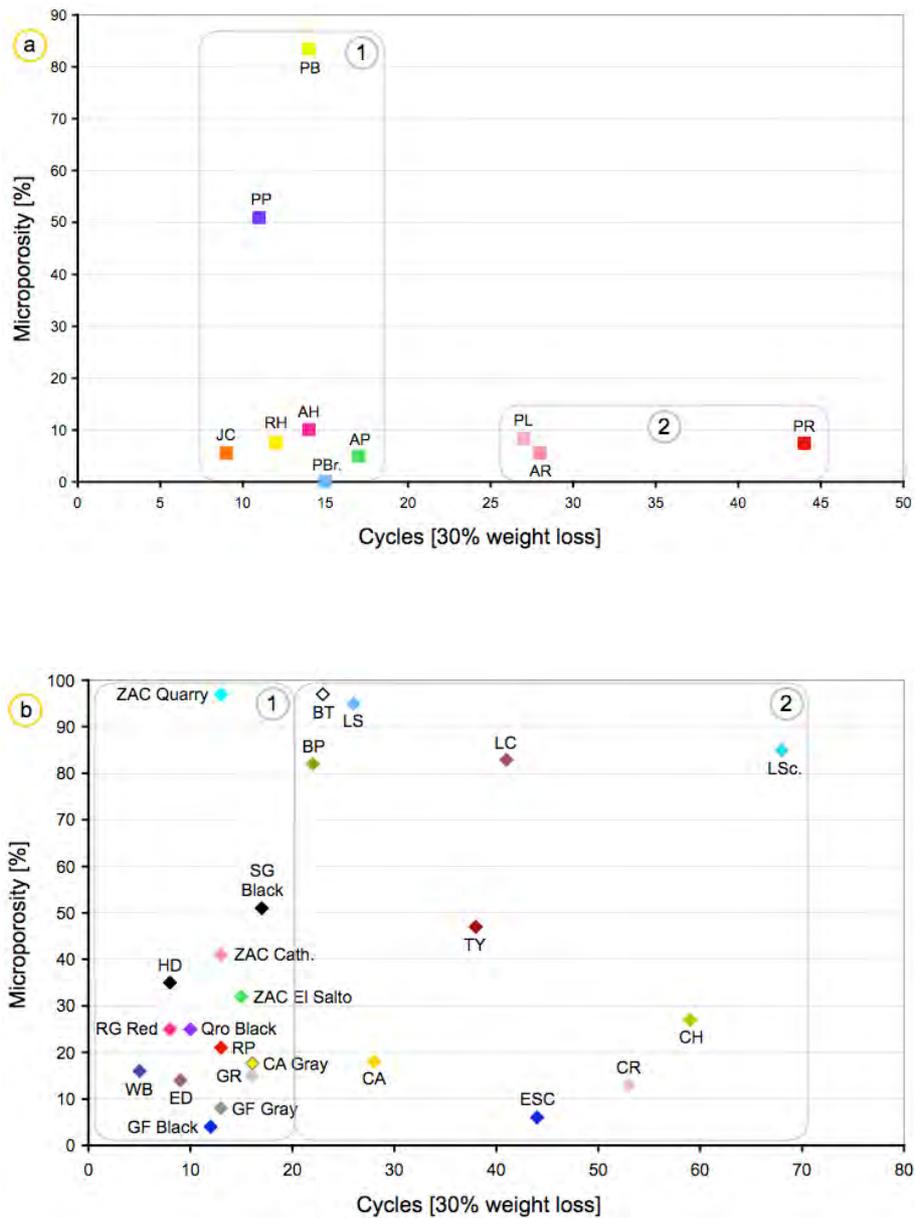
**Figure 158:** Correlation of the microporosity versus the number of cycles a) of the sandstones and b) of the tuffstones.

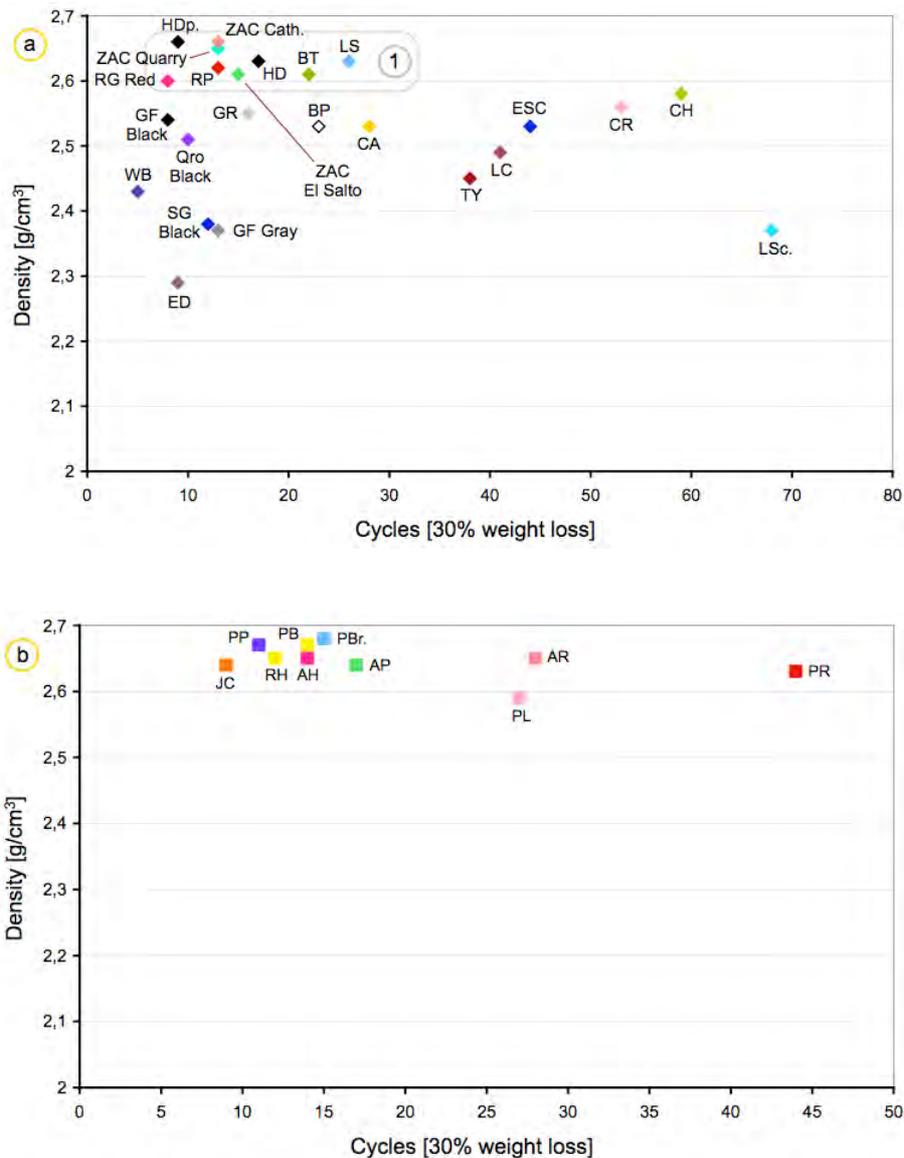
**Figure 159:** Correlation of the density versus the number of cycles.

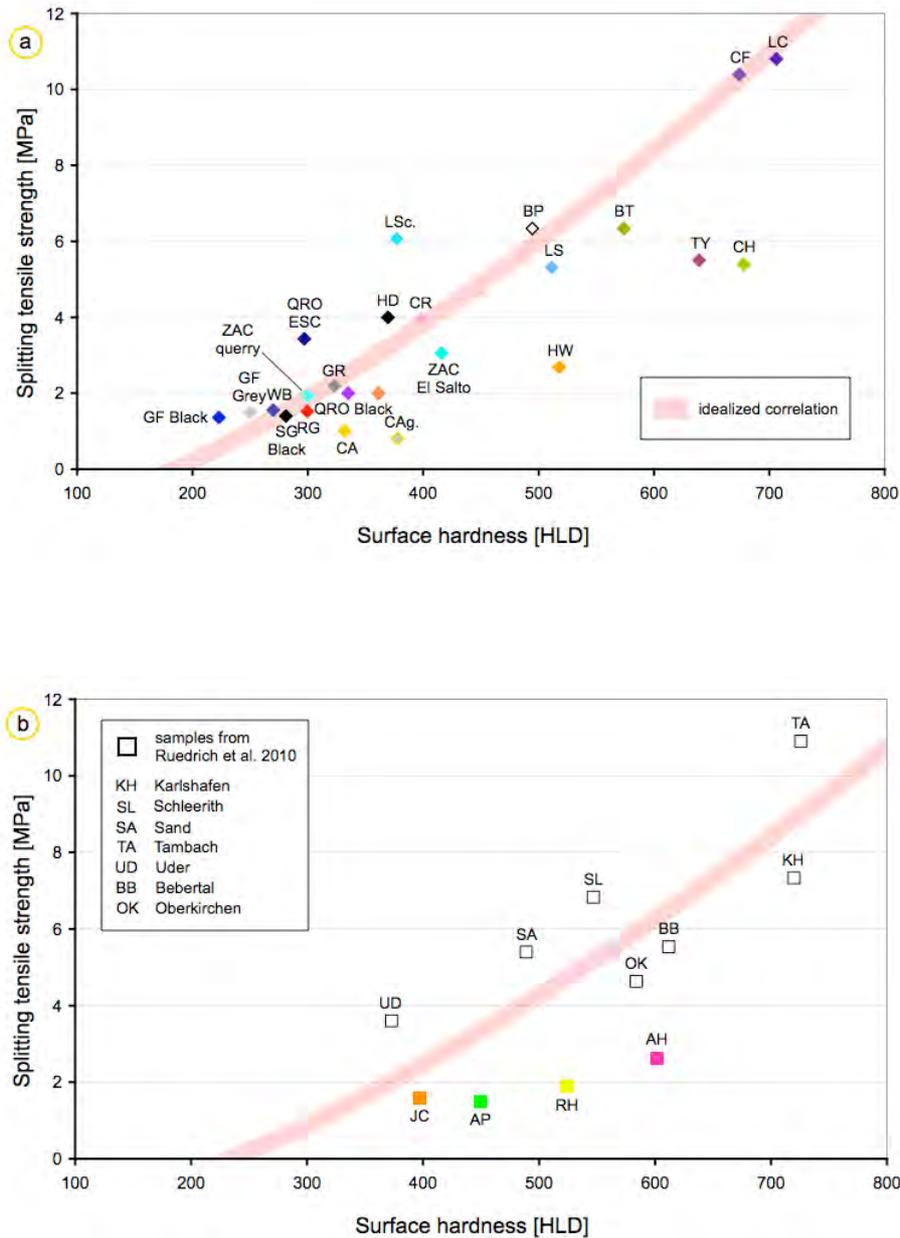
**Figure 162:** a) Correlation of the splitting tensile and surface hardness of the tuffs and b) of the sandstones.

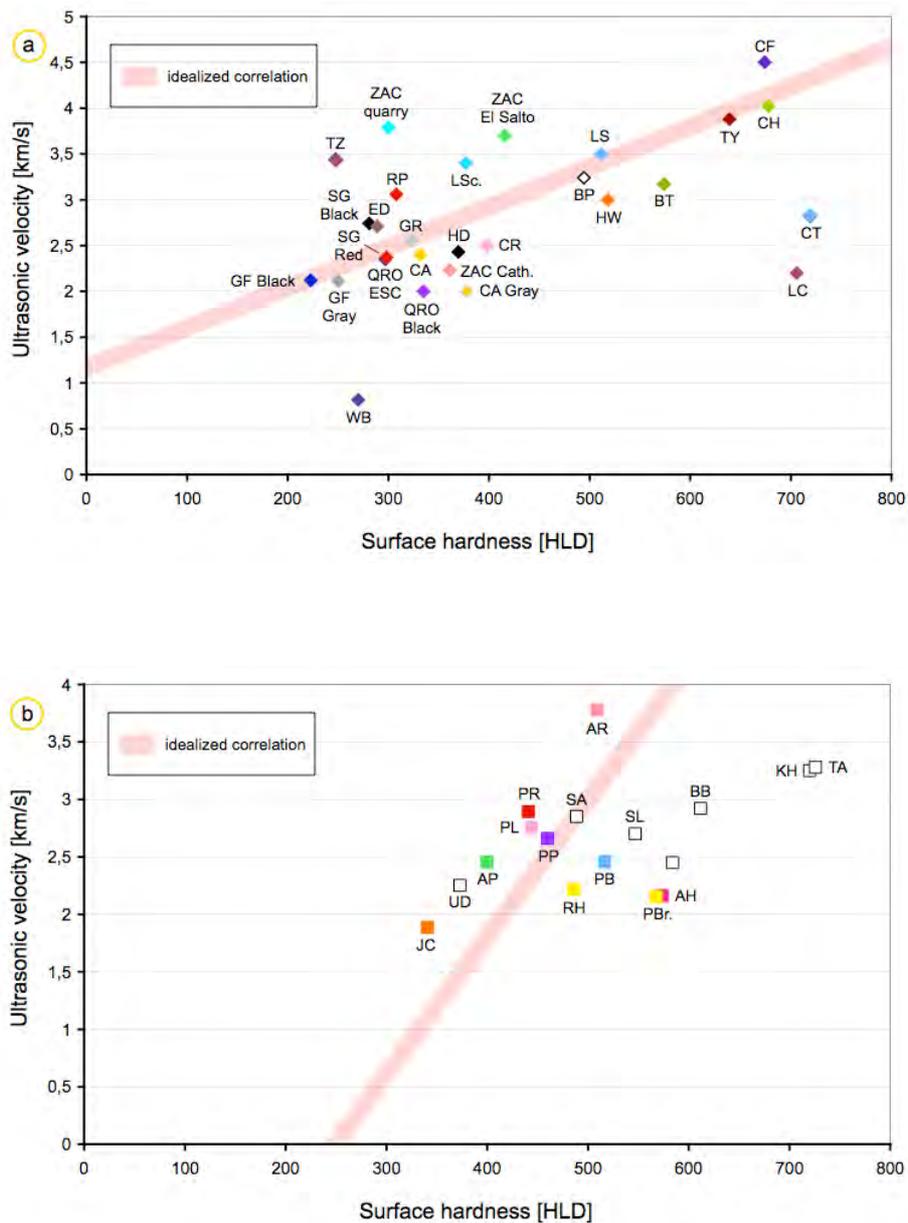
**Figure 164:** Correlation of the surface hardness versus the ultrasonic velocity, a) for the tuffstones and b) for the sandstones.

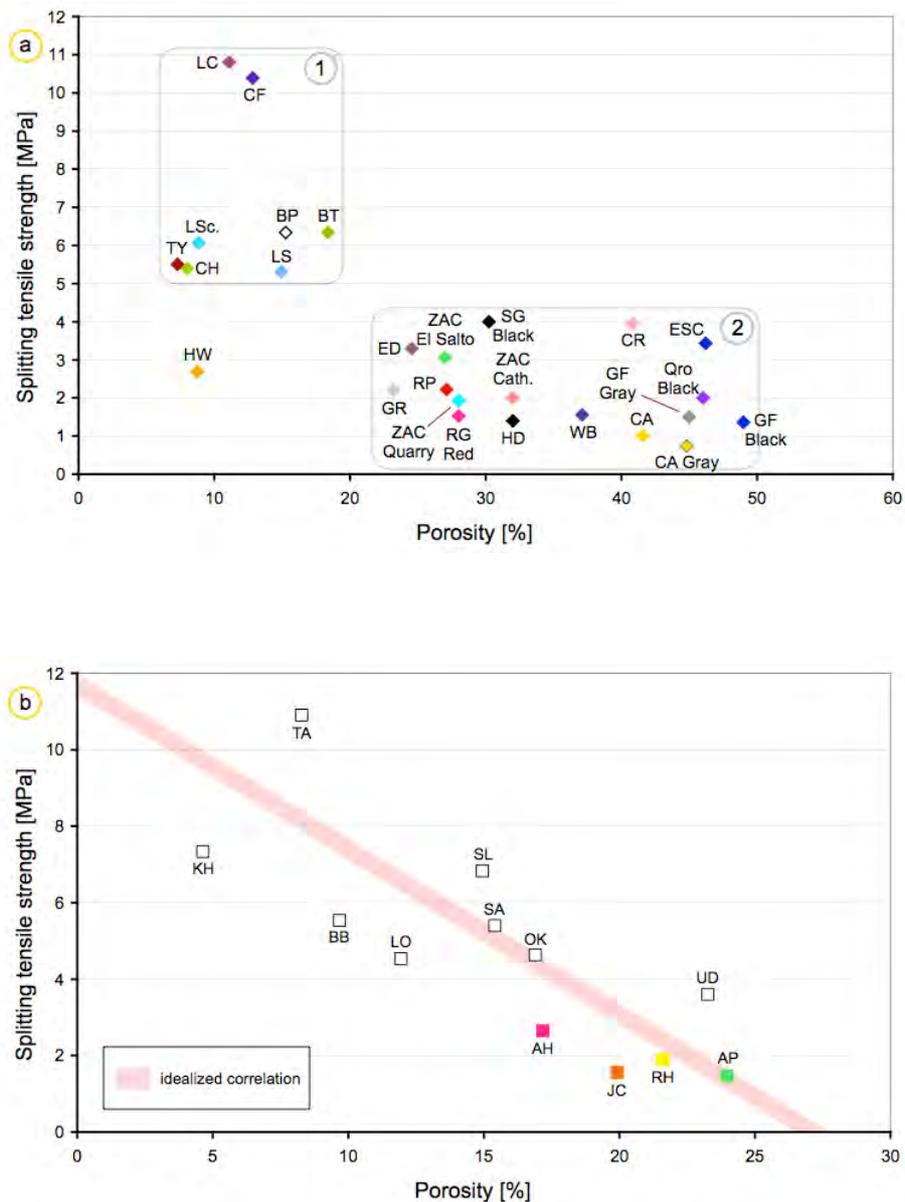
**Figure 165:** Correlation of the tensile strength versus the porosity. a) Two groups of samples can be identified in the case of the tuffs (1 and 2) and b) a nearly linear correlation of strength and porosity is evident in the case of the sandstones.

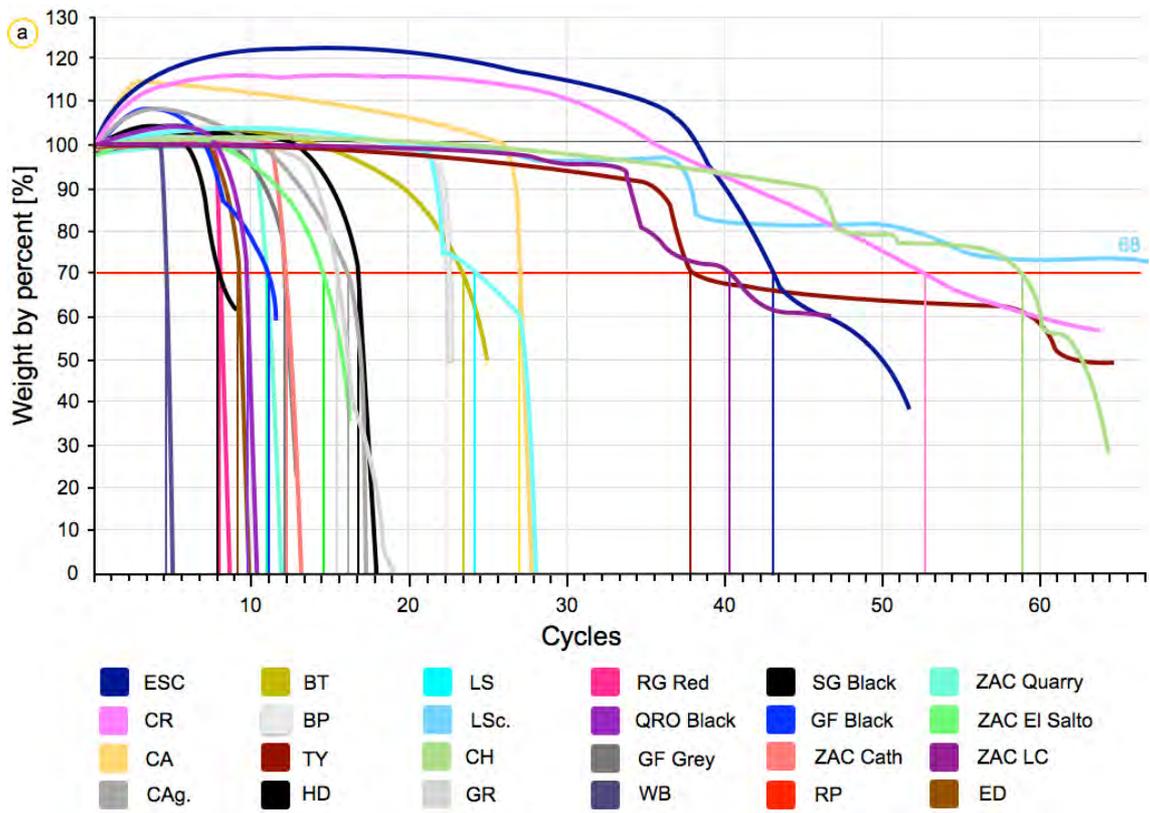
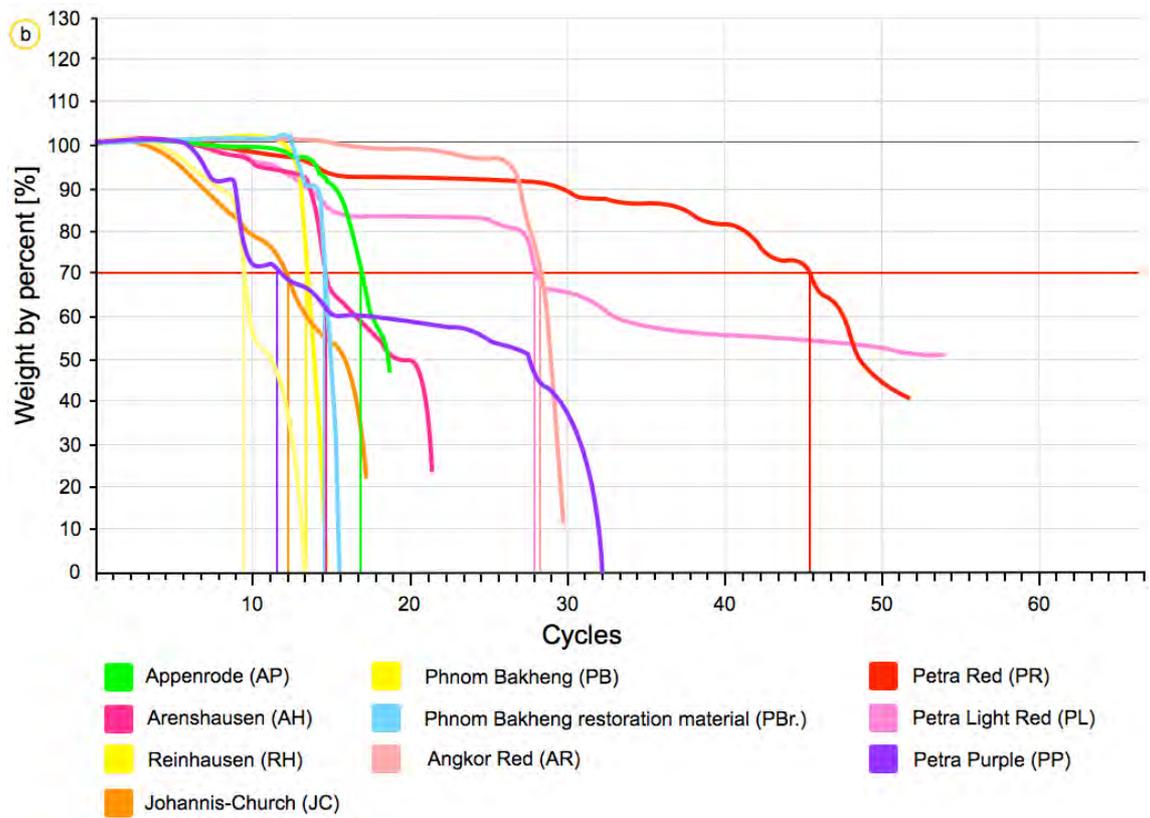
**Figure 168:** Correlation of the weight versus the number of testing cycles, a) of the tuffstones and b) for the sandstones.

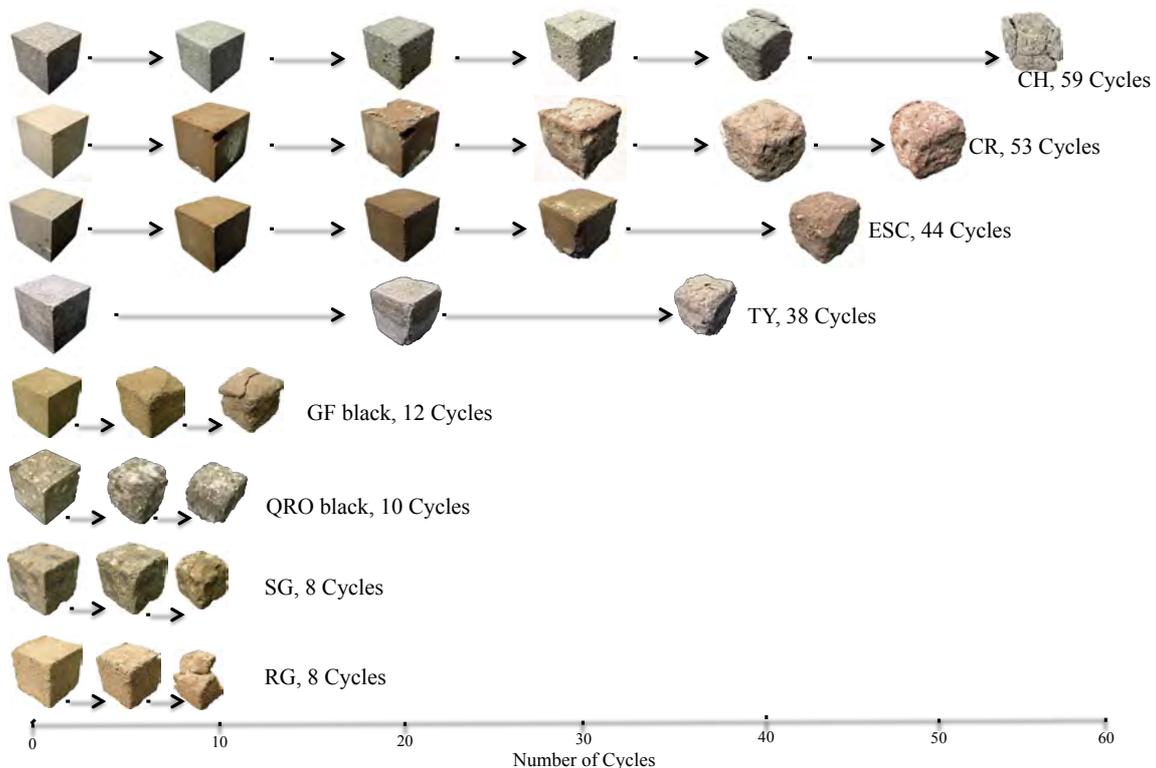
**Figure 169:** Photographic documentation of the salt bursting test of the four most resistant and the four less resistant investigated tuffs.

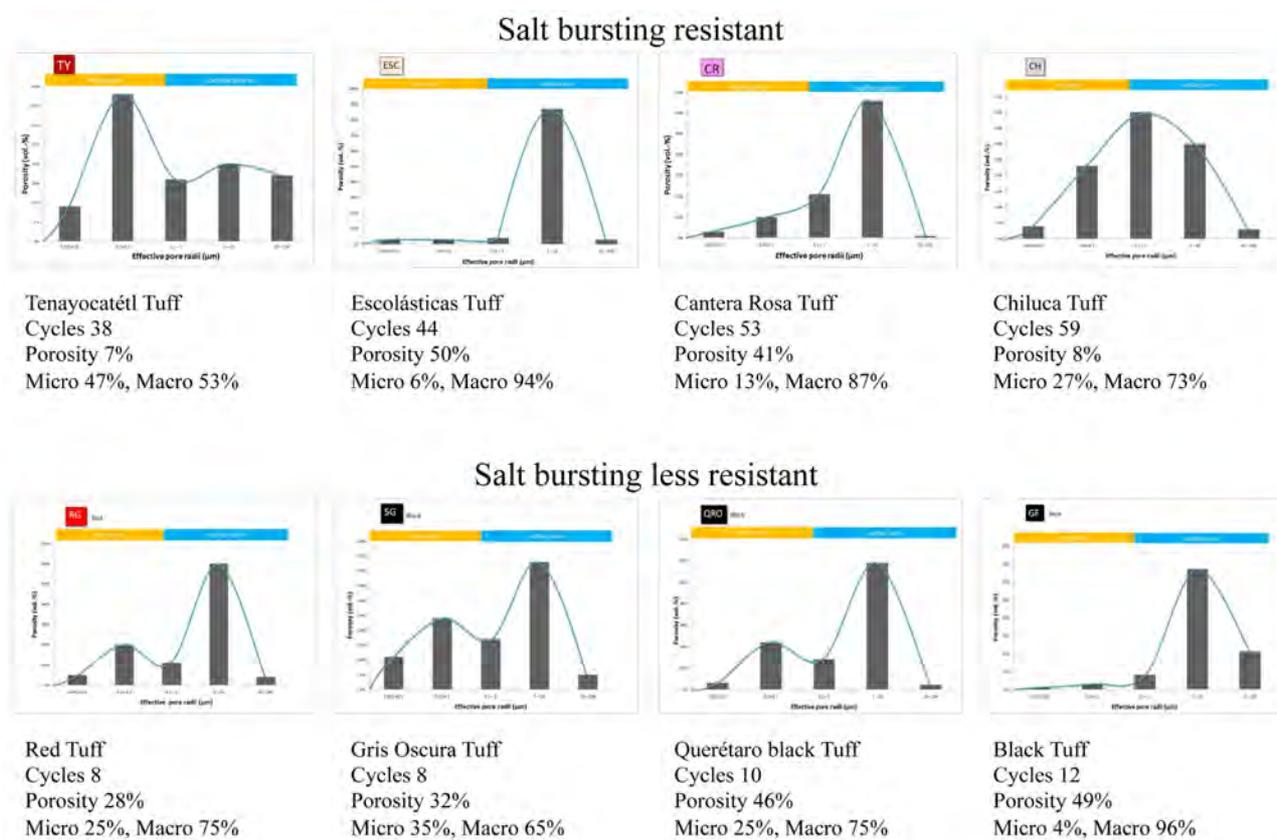
**Figure 170:** Comparison of the different pore radii distributions between the four resistant (above) and the non-resistant tuffs (below) against salt bursting.

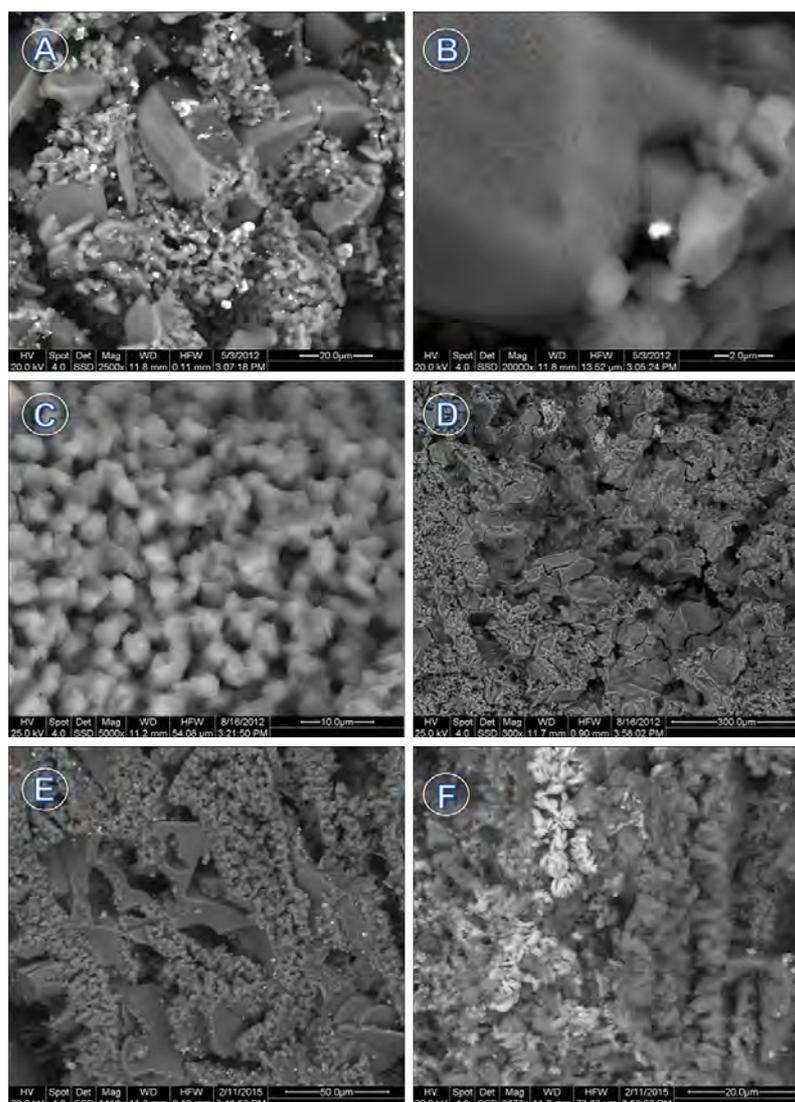
**Figure 171:** Scanning electron microscopy (SEM) images of the ESC, CA and CR-tuffs. a) Crystalobalite crystals overlain by a fibrous mineralogical structure within the pore space of ESC. b) The fine fibrous structure in detail. c) Kaolinite and amicitite crystals forming a complex pore network in the matrix of the CA tuff. d) Amicitite-phillipsite zeolite and probably kaolinite produced by the alteration of feldspar and located within larger pores of the same sample. e) Quartz in the center surrounded by very fine-grained K-feldspar. f) Mn-Ba mineralization (probably hausmannite/psilomelane) in the CR-tuff, together with fine-grained chlorite needles.

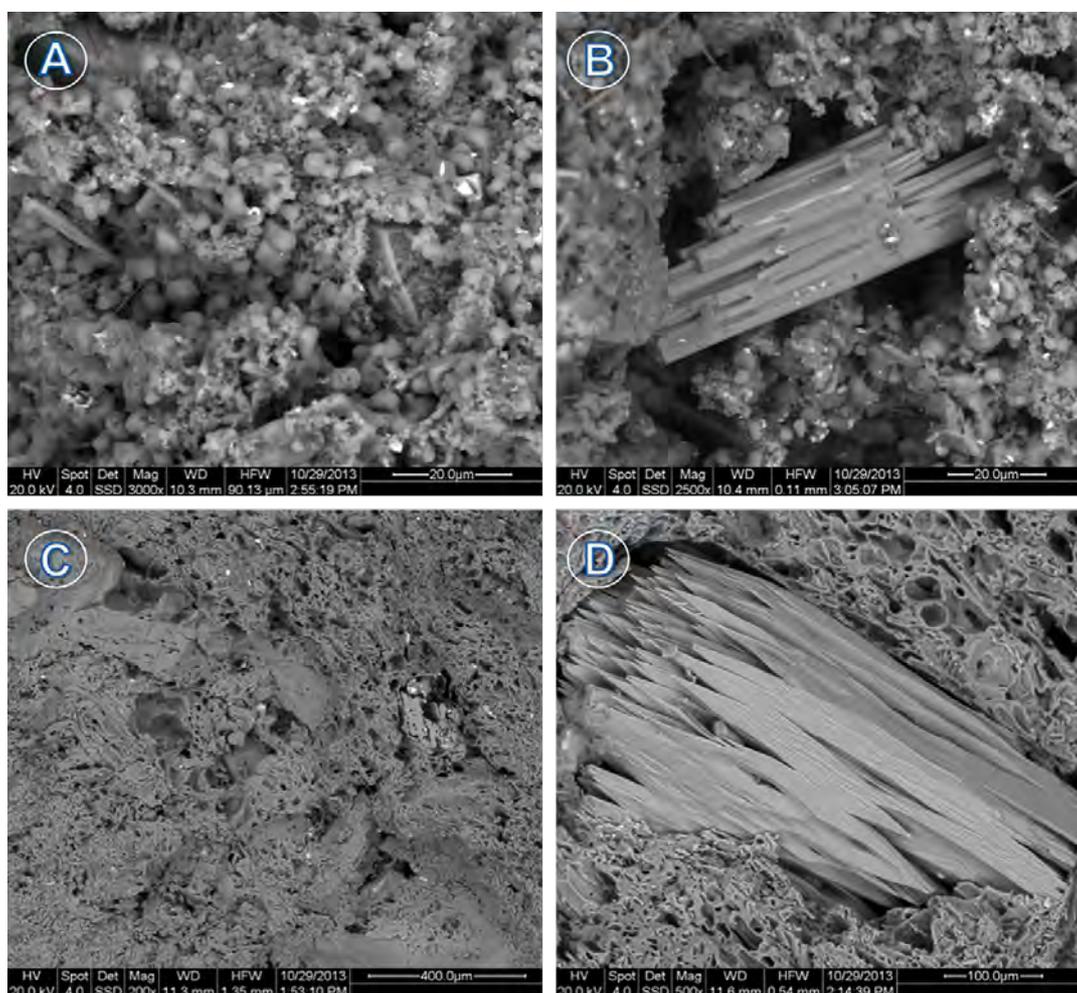
**Figure 172:** Scanning electron microscopy (SEM) images of the RG and SG tuffs. a) Overview of the RG tuff with abundant SiO<sub>2</sub> particles. The porous matrix is clearly visible in this tuff. b) Clast with observable weathering marks, which creates a secondary porosity. c) Overview of the SG tuff, which is similar to RG with its prominent very porous glassy matrix. d) Probable pumice clast, strongly weathered and embedded in a glassy matrix of the SG tuff.

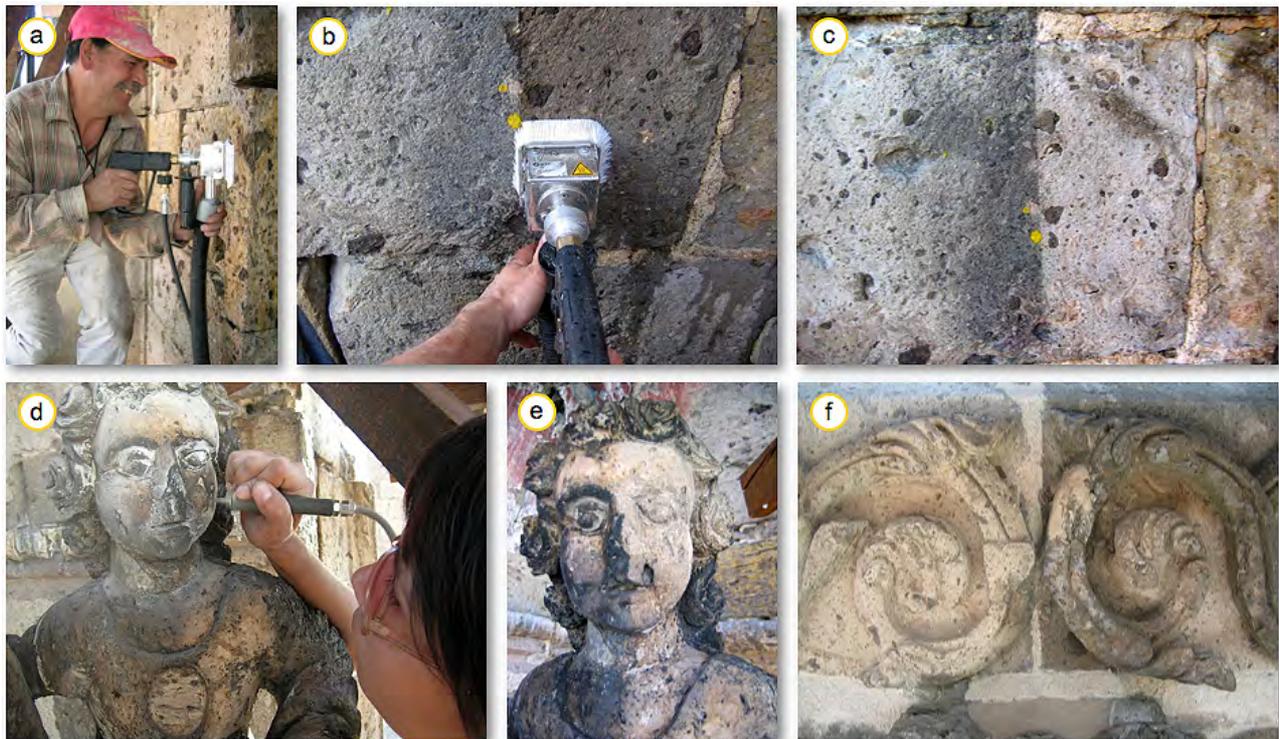
**Figure 179:** Different cleaning techniques used for the removal of loose dirt and compact crusts:  
a) Suction stripper, b) cleaning procedure, c) results of the cleaning.  
d) micro-abrasive cleaning and e and d) results of the cleaning technique.

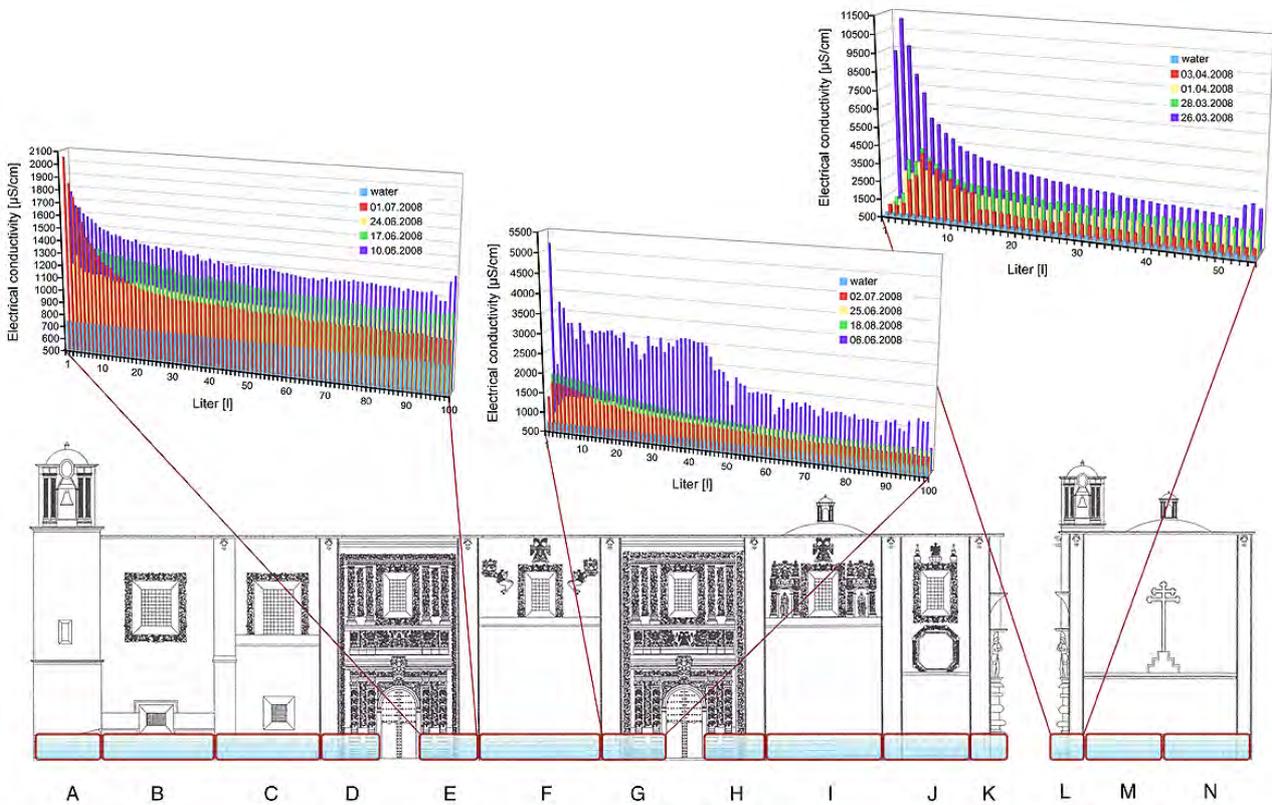
**Figure 180:** Stepwise desalination process of different areas by cyclical sprinkling.

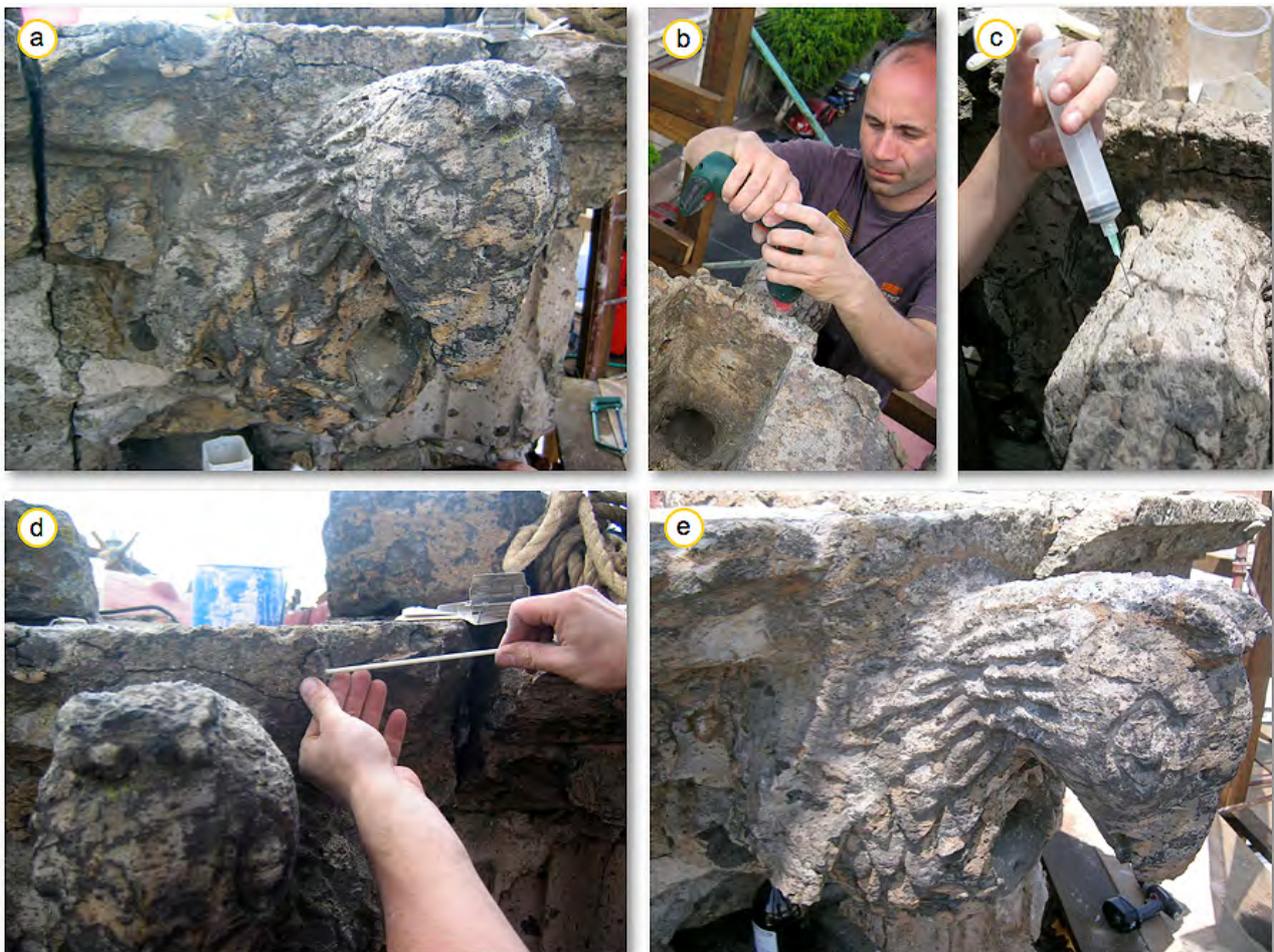
**Figure 182:** a) A gargoyle before conservation. b) Drillings for the fiberglass sticks. c) Cleaning and consolidation of the flanks of the cracks. d) Application of the fiberglass sticks and e) the gargoyle after consolidation and conservation.

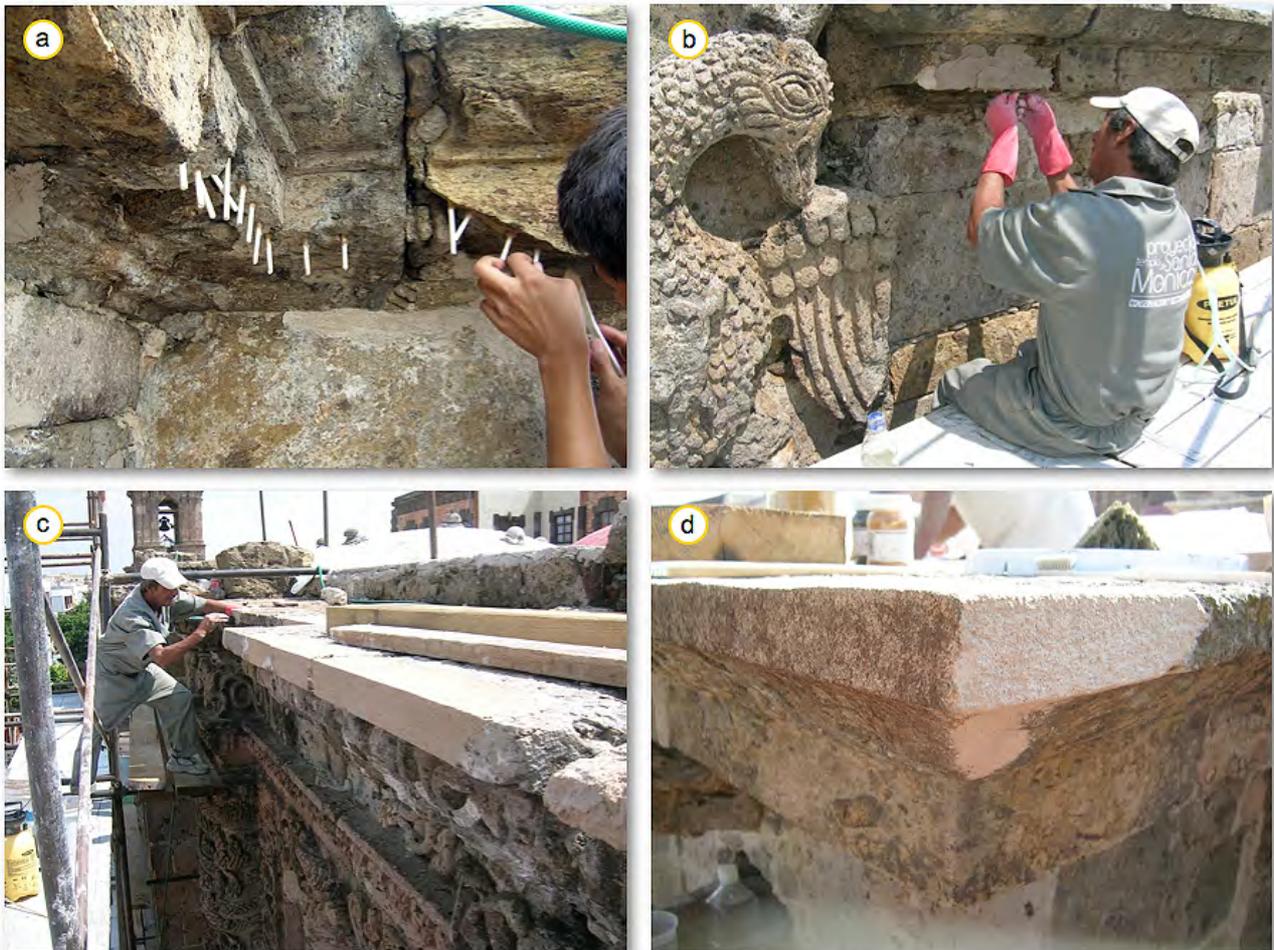
**Figure 183:** a) Glueing of fiberglass sticks within areas of missing parts of the tub profile. B) Fillings with lime mortar, and c) re-profiling. d) Fresco-like retouch of the restored areas.

For detailed fillings of lost stone a lime-based restoration mortar was applied by using hydrated lime and aggregates from sand deposits in the region (Fig. 183). As reinforcement material fiberglass sticks were used (Fig. 183 a). These sticks as well as broken stones were glued with epoxy resin. With the fillings and repair work only 5% of the stone surfaces at the building have had to be replaced by newly cut stones of Cantera Amarilla. The original joint mortar was repaired with a congruent lime mortar (Fig. 184). To protect the roof area from infiltration as well as insolation the horizontal building parts were covered with traditional clay plates (Fig. 178).

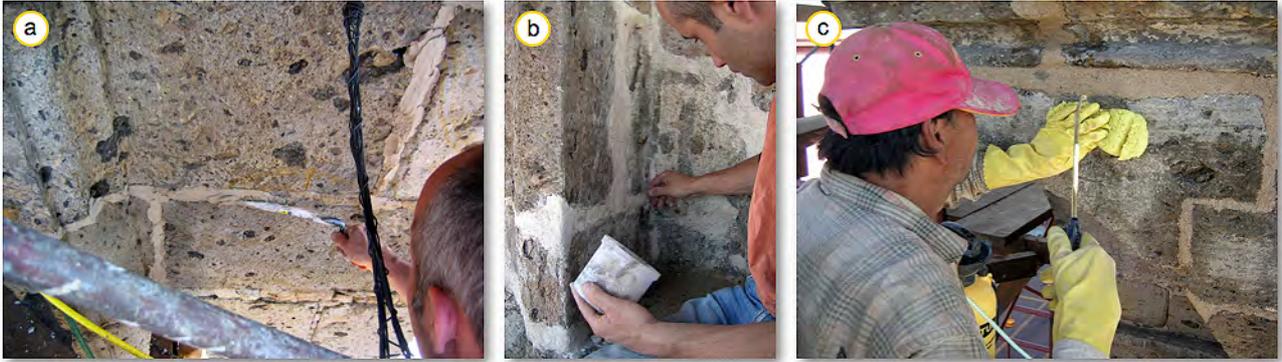
**Figure 184:** a) Application of the jointing mortar, b) egalization after hardening and c) after-treatment of the surface by wetting and washing.

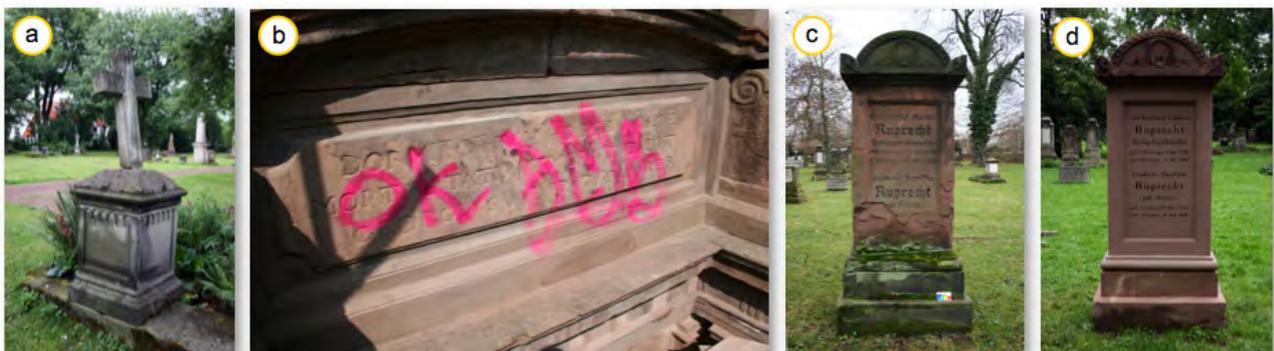
**Figure 185:** Vandalism and destruction at several tomb monuments at the Bartholomew Cemetery. a) Mechanical violence, b) graffiti and c) the historical Rubrecht Tomb and d) the reconstructed one.

The tombs at the Bartholomew Cemetery show different forms of weathering and deterioration mostly related to salt weathering and urban pollution. However, the main weathering factor of the site in comparison to many other historical cemeteries in the region is the lack of maintenance and vandalism (Fig. 185). Damage due to vandalism was not the only factor for tomb destructions, but in the 1960's even the authorities responsible for their care caused the destruction of several tombs (see chapter 3.5.3 a). Damage also occurred due to the reconstruction of original monuments (Fig. 185 d; Wedekind 2008).
